OPERATION AND MAINTENANCE MANUAL

PERUMTHENARUVI DIVERSION WEIR

Doc. No. O&M _ Per _ Div. Weir_KSEBL_22

Kerala State Electricity Board Limited

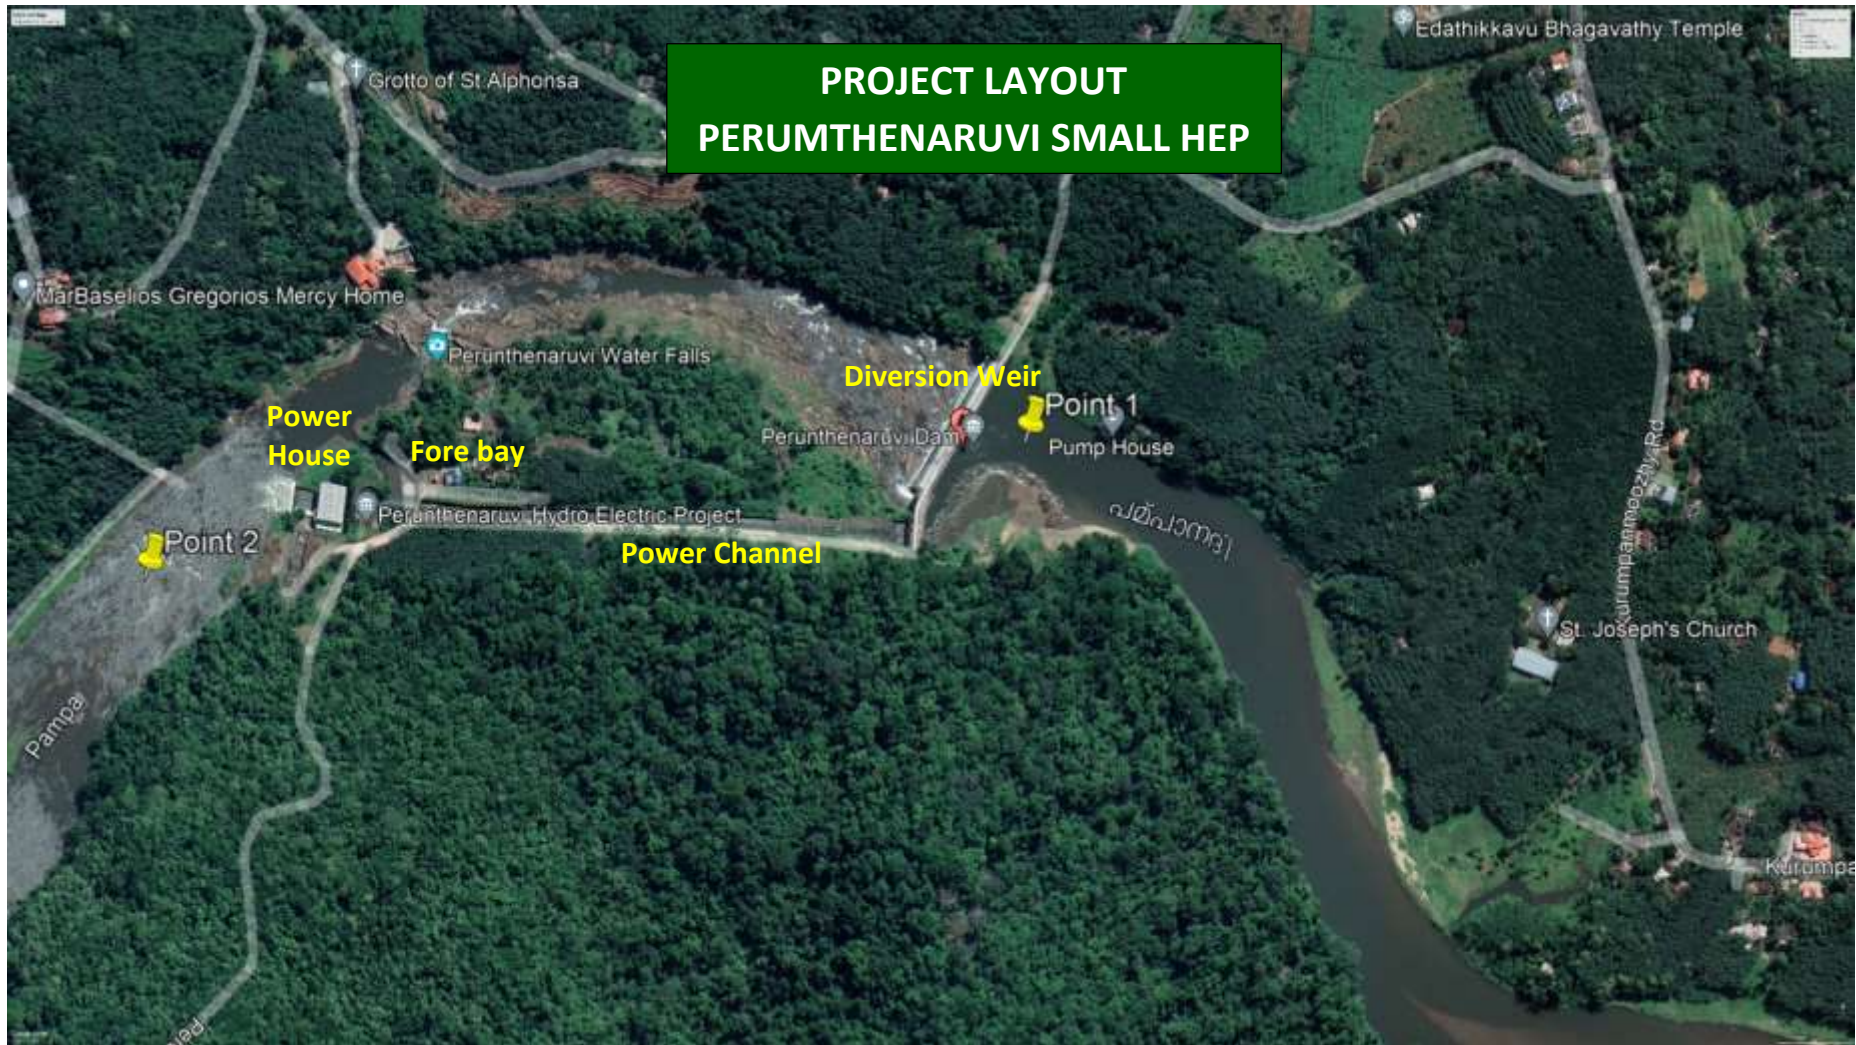
Fig: 1.3: Project Layout

An index map and a Layout map of the Project detailing the Project components is shown below;

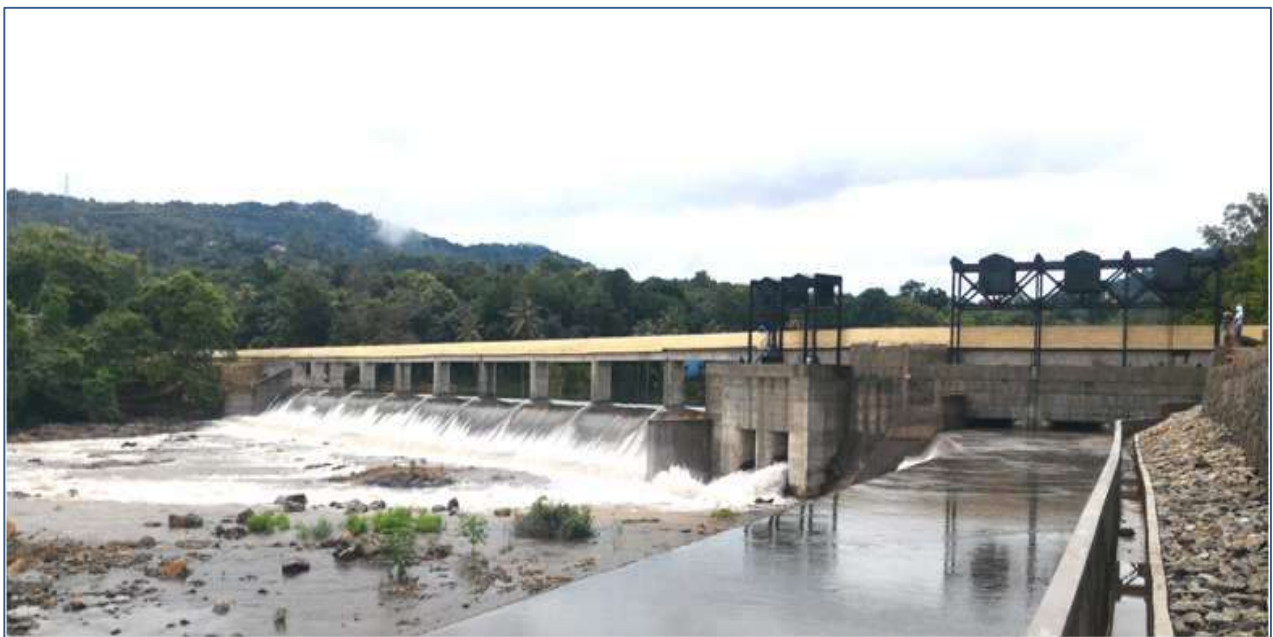
Fig 1.5: Photograph of Diversion Weir

height of overflow structure from average bed level is 5 m. As the maximum height of the weir is more than 10 m & pondage is 1 Mm³, the structure qualifies the requirement of a specified dam as per DSA 2021.

From chainage 174m, the weir axis tilts at 28 degrees towards upstream side. The entire portion of weir is founded over hard rock. The right bank abutment is terminated at Ch-12.00 m and a core wall of width 2.40 m is provided for abutting to the rock facing on the downstream side as per the recommendations of GSI team. Contraction joints with PVC water stops are provided between each block. 76 Nos of curtain grout holes were drilled and grouted along the river bed as per specifications and approved drawing. Permeability tests were also carried out in 7 bore holes. Upstream face of the overflow portion is vertical up to +49.360 m and there after it slopes at 1H:1V towards downstream face until it meets the ogee curve with crest at +51.000m. The tangent point of bucket curvature with weir is +47.57 m. The radius of bucket is 5.50m.

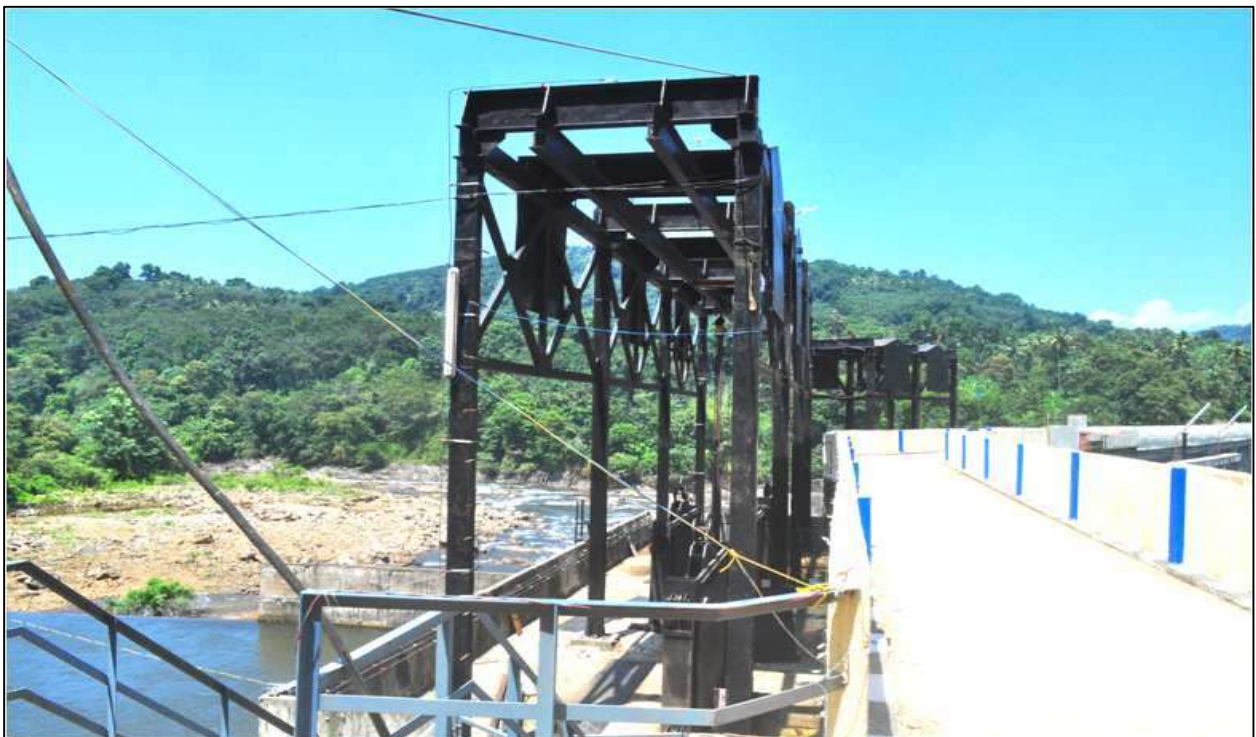
Fig 1.6: Intake and Sluice arrangements

Three openings of 3m x 4.5m size are provided at the intake with trash rack. The spacing of trash bars is 100 mm. The sill level of intake is +47.00m and bell mouth is provided in the intake opening. The length of intake is 8.5 m. top level of opening is +51.50m. Gates of size 3.57m X 4.65 m are provided. The gate hoisting platform is at El + 54. 00 m and is at the exit of intake block. Trash rack arrangement with 100 mm spacing of trash bars is provided to avoid entry of large sized particles into the power channel. The intake arrangement is provided Block No 14 of the Weir.

There are three intake sluices of size 3.00m x 4.50m provided in the left bank non-overflow portion to draw water from reservoir to the channel. Each sluice is provided with one service gate slot in the upstream side and emergency gate slot in the downstream side. Electrical chain hoist with a lifting capacity of 15 Ton is provided for operating the Canal Intake Gate. One emergency gate is also provided in one of the emergency slot and it is always in open position. The emergency gate can be shifted from one sluice to another sluice by a manually operated chain block of 15 Ton capacity with travelling trolley mounted on a mono rail. The operation procedures are detailed in the operations and maintenance manual.

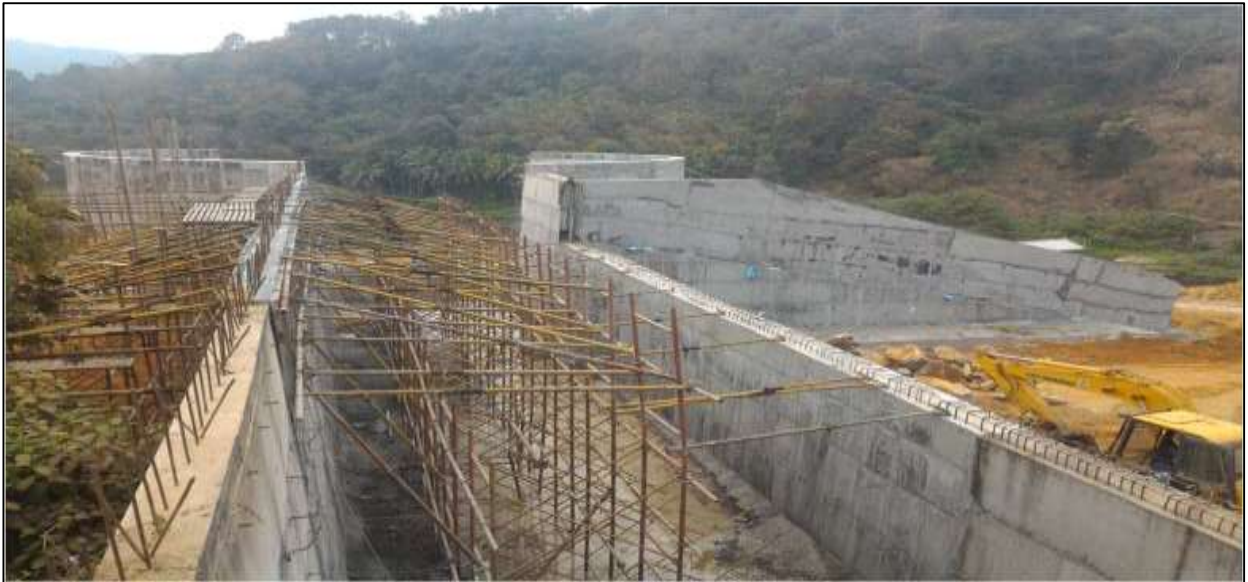
Fig 1.8 : Power Channel during Construction

The power channel is provided in the left bank of the river. The length of RCC rectangular power channel is 461m, and 5.75m width. The bed level of the channel at intake portion is +47.00m. The F.S.L of power channel at inlet is +50.70 m . Drawings attached separately. Maximum power draft for 6000KW is 44m³/sec. The width of channel at chainage 8.5 m is 15m. The ch. 0.0 m is the bellmouth entry point of the power outlet openings. From ch.18.5 m transition starts and the width of channel reduced to 5.75 m. The length of transition is 20.84 m. A surplus escape of 100m is provided in the channel from Ch.20 to 120m with crest level as +50.95m to escape surplus water in the power channel to the river. Bed slope of channel is 1 in 1200. The top level of channel including parapet is as note below.

From Ch 8.50 to Ch 20.00	:	+53.000
From Ch 20.00 to Ch 120.00	:	+52.300 (Left side wall , side surplus escape)
From Ch 120.00 to Ch 340.00	:	+52.300
From Ch 340.00 to Ch 415.60	:	+53.600
From Ch 415.60 to Ch 425.60	:	+54.000
From Ch 425.60 to Ch 429.60	:	+53.000
From Ch 429.60 to Ch 461.00	:	+53.500
Parapet wall	:	0.15m x 0.60 m

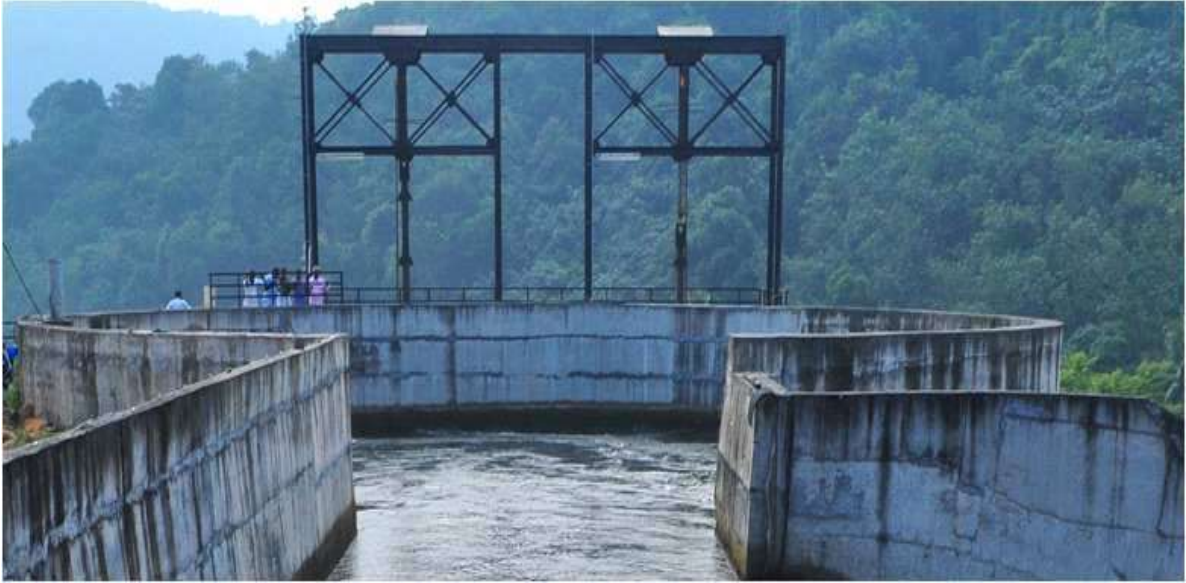
Fig 1.9: Fore bay tank

There are five rectangular trash racks fitted in the concrete slab at +38.20m level. Intake structures are bell mouth type with height of entry 5.34m and breadth 4.48m. Two gate slots in fore bay with two gates of size 3.75m x 3.20m control flow of water into the penstock. Sill level of the gate opening is +29.730m and level of gate hoist slab is +52.700m. Site was handed over to contractor for construction of forebay on 17.02.2012. Preliminary works started on 17.05.2012. After completing the excavation works, concreting started on 13.05.2014 and was completed in all respects on 31.03.2017. Ch 429.50m to 455.50m of the power channel adjacent to the fore bay has the surplus arrangement for diverting surplus water back in to river. The surplus arrangement also helps to maintain the forebay water level when there is a sudden load rejection in the turbine.

Width of surplus channel at the beginning (power channel side) is 26m and at the end is 6.50m. Bottom level at the beginning is +50.700m and +30.240m at the end. There are R.C.C training walls on both sides of the surplus channel. First 12m of the channel is almost horizontal and thereafter sloping towards the river. Top width of the training wall is 30cm (average) and bottom width is 60cm (average). Bottom width varies as per the height of the training wall. There is a parapet of 1m height above the training wall to prevent splash of water. Base of the surplus channel is with dry rubble packing at the bottom, a leveling course with PCC of 100mm thick and then R.C.C lining on top. Bed slope provided is 1 to 0.4. Outer wall of fore bay and power channel are joined in an anchor block of size 1000 x 1500mm. Full supply level of fore bay is +50.50m. Hand rail is provided around the deck slab in safety aspect.

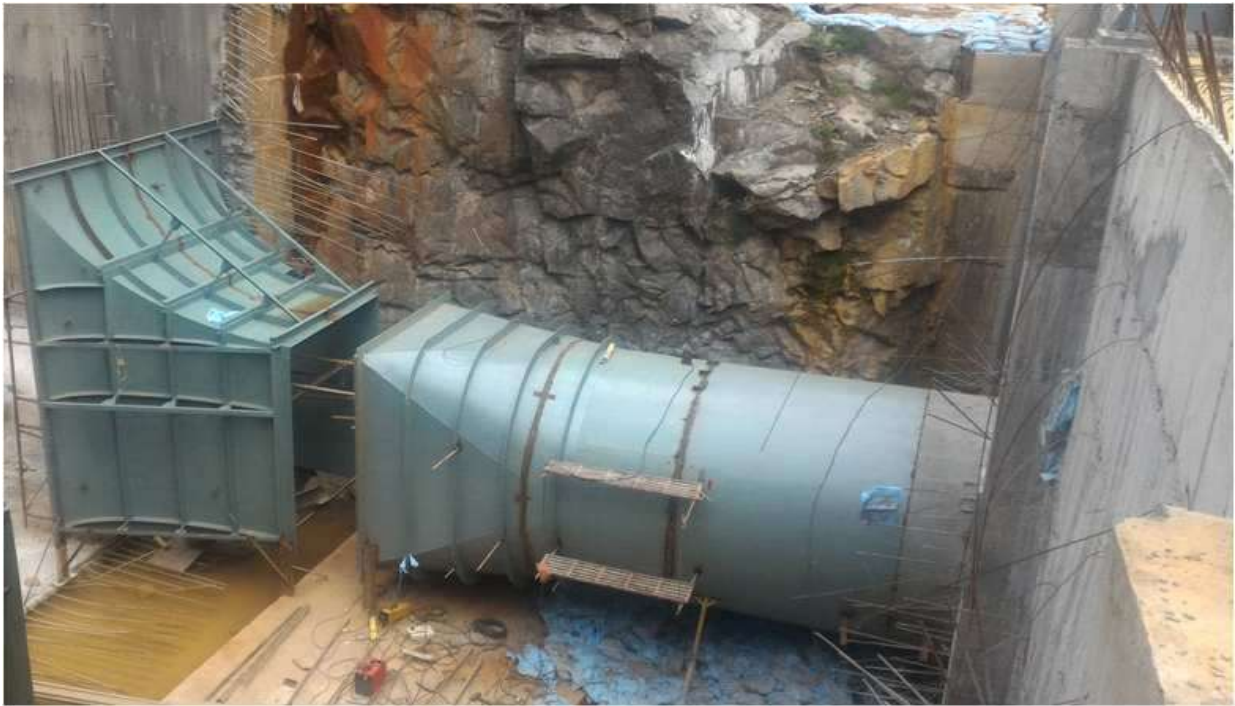
Fig 1.11: Penstock during the Construction

Two penstocks each of 3.2 m diameter and length 9.25 m is provided to carry water to the two machines. The penstocks have made with steel plates IS 2002 having thickness of 12mm. While calculating the thickness of Penstocks, provisions for water hammer is also considered. The penstocks are embedded in concrete up to yard level. Bell mouth entry is provided for the penstock pipe. The dimensions of bell mouth is 4.48 m X 5.34m. Service and Emergency gates are provided to control flow through penstock. Dimension of gate is 3.42m X 3.45 m. Two gates are manually operated using chain pulley block of 10 T capacity.

There are 13 links for connecting the gates to chain pulley. Two air vents of 600mm dia steel pipe are also provided in the fore bay for ventilating the penstock transition. A flash plate is provided in each of the vent pipe to avoid splashing of water into power house due to way unbalancing between upstream and downstream of guide vane.

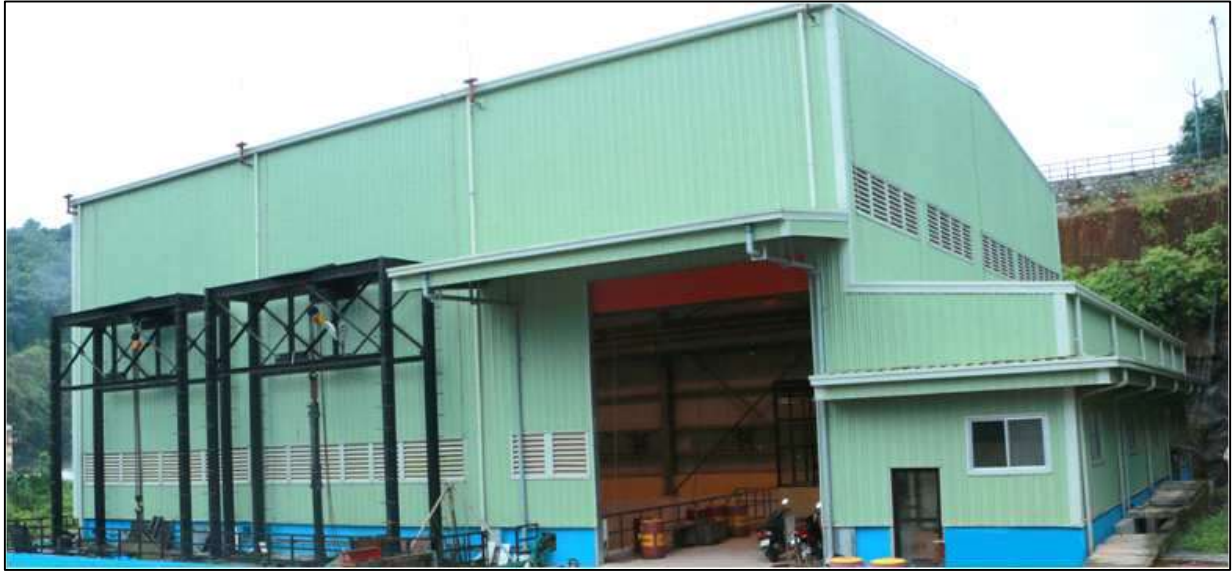
Fig 1.12: Power House – Perumthenaruvi SHEP

The Power House is located on the left bank of the Pamba River at downstream of Perumthenaruvi Waterfalls. The installed capacity of the Power House is 2x3MW (6MW). The average annual generation is 25.77 Mu. The Power House building has a size of 32.20m (Length), 24m (Width) and 11.80m (Height above service bay). Size of machine hall is 23.54 m X 19.80 m X 21 m. Two numbers of horizontal Kaplan Turbine have been installed at the Power House. The center line of Machines are at an elevation of +31.30m from MSL.

There is a sump pit of size 3m x 2m x 2m inside the power house. Three tailrace piers are covering three downstream columns. Pier A & Pier C on either ends of tailrace consists of 2m x 2m dewatering sumps of draft tubes of unit 1 & unit 2 respectively. Tailrace can be dewatered from these sumps. Bottom level of the sump is (+) 25.750m.

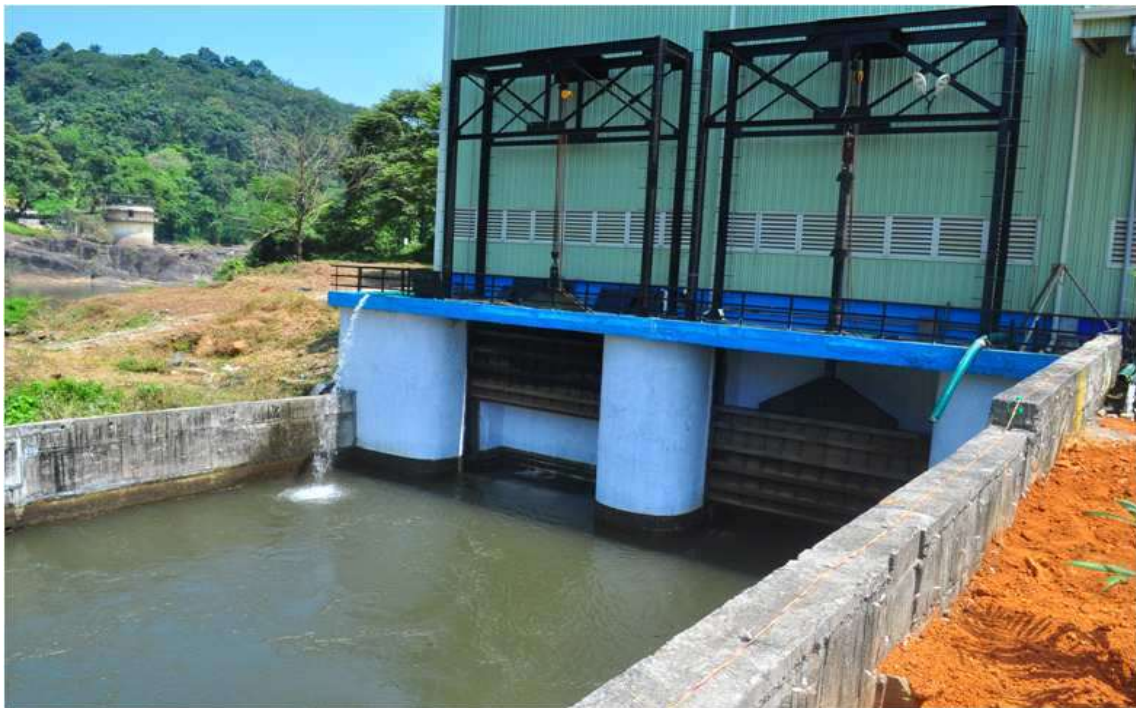
Fig 1.15: Tailrace

The dimensions of tail race is 20 m X 19.9 m and Discharge in to the tail race pool is 44m³/sec. Tail water is discharged in to the river downstream of the power house at +30.00 contours available on river bed. Gates are provided in the draft tube of both machines. Size of gate is 6.25 m X 2.75 m. These gates are of manual operation using 15 Tonnes capacity chain pulley block fixed on hoisting structure Floor of tailrace weir is having a reverse slope of 1 in 4. Crest level of tailrace is at EL+31.700 which starts at Ch.68.50 and top ends at Ch.69.500m. Right side wall of tailrace pool is up to EL (+) 34.50 and right side wall is up to right yard level. There are two gates for the two draft tubes. Top level of the operating platform (deck slab) is +37.500 Sill level of the draft tube opening is at EL+26.743 and top level of the opening is at EL+ 29.211.

Discharge of water after power generation is through tailrace channel to the river. As per tender drawings, size of tailrace was 12m x 14m but due to changes in power house design size of tailrace was modified to 21m x 19.90m.

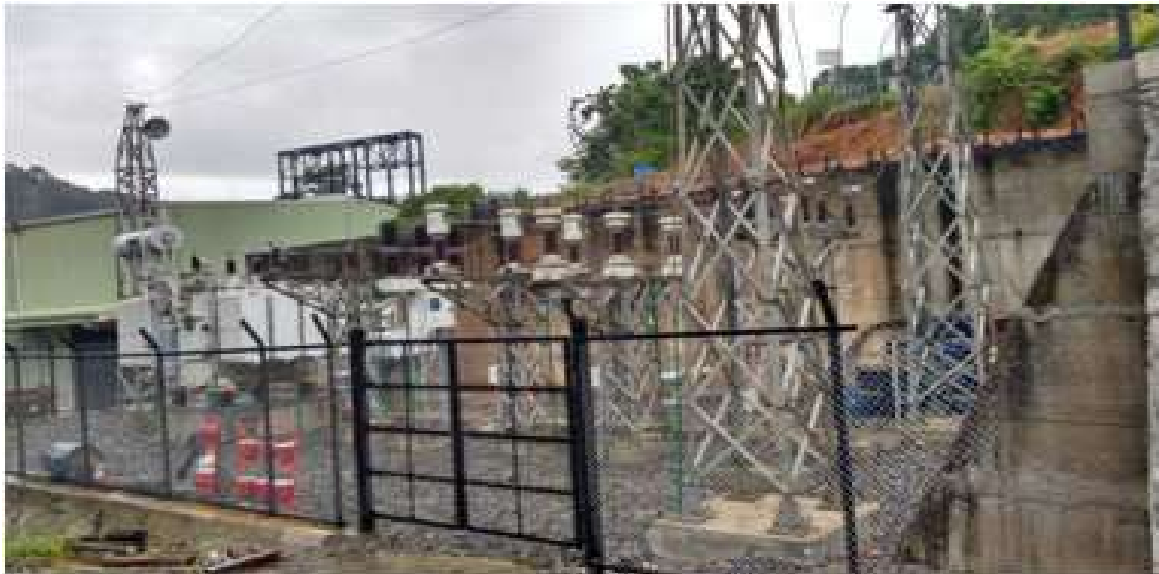
Fig 1.16: Switchyard

Size of the Switchyard is 20m x 10.50m and yard level is +41.00 m. There is one 8 MVA 6.6KV/33KV transformer and another auxiliary transformer of 250KVA in the switchyard. Yard was formed by constructing retaining wall around.

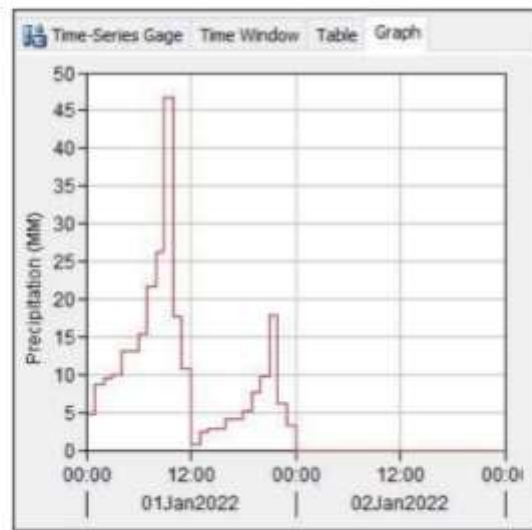
Figure 4.3: Hourly Rainfall after critical sequencing – Kakki

Average rainfall over Sub catchment Kakki is 26.98 cm. 12 hr bell distribution of rainfall is shown in Table 4.5. Hourly distribution of rain fall is shown in Table 4.6 and 4.7. Loss considered is 0.19 cm/hr. The rain fall excess is shown in the Table 4.8 and 4.9. Rainfall series after Critical sequencing is shown in Table 4.10 and Figure 4.3.

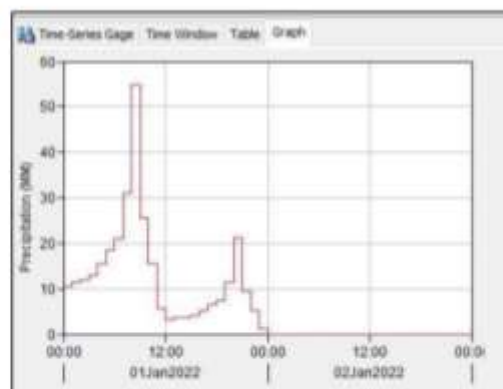
Figure 4.5: Hourly Rainfall after critical sequencing – Downstream Catchment

Average rainfall over sub catchment downstream of Pamba and Kakki dams is 31.41 cm. 12 hr bell distribution of rainfall is shown in Table 4.17. Hourly distribution of rain fall is shown in Table 4.18 and 4.19. Loss considered is 0.19 cm/hr. The rain fall excess is shown in the Table 4.20 and 4.21. Rainfall series after Critical sequencing is shown in Table 4.22 and Figure 4.5.

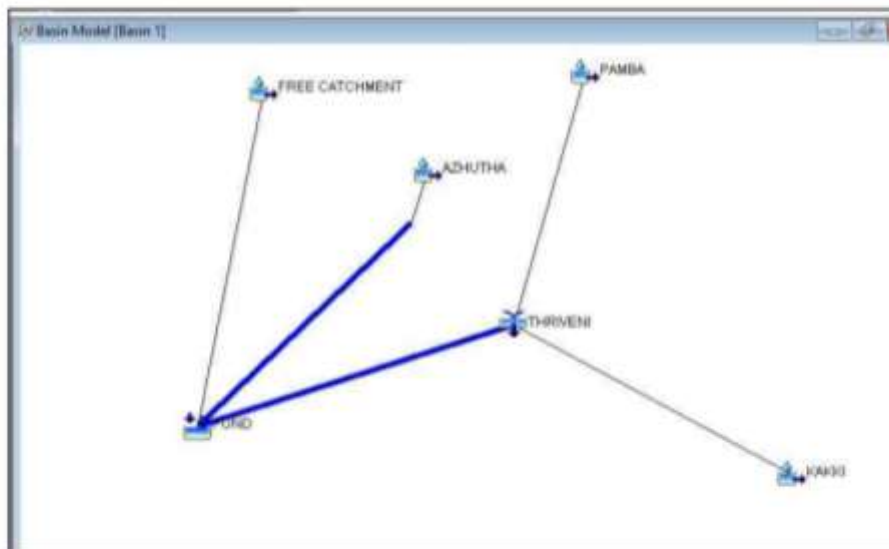
Figure 6.1: HMS Model of Perumthenaruvi Project

The HMS model of the Project is shown in the Figure 6.1 below; The elements considered in the model are sub catchment Pamba, sub catchment Kakki, Sub catchment Azhutha, Downstream Sub catchment, Thriveni – Perumthenaruvi reach, Azhutha confluence – Perumthenaruvi reach and sink as Perumthenaruvi pond.

For reach routing, Muskingum method is considered as the roughness values, cross sectional details etc. of the river to define the river hydraulics is not readily available. For Muskingum method also, estimated parameters for the river is not readily available. Hence K & x parameters are assumed on theoretical basis considering the length of river reach, interval of flood hydrograph ordinates and assumed time of travel between the cross sections under consideration. An average flood velocity of 6 km/hr is assumed as the river downstream of Thriveni is of more or less flat gradient and the flood scenario corresponds to the storm with return period of 100 years. The flow situation in the river may not be extreme like the one caused due to PMP or breach scenario of upstream dams. However, these assumptions are to be validated with the measurements taken at various locations in the river for better precision. The length of sub reaches considered is 6 Km for the reach downstream of Thriveni up to Perumthenaruvi. The K and x value considered for this sub reach is 1 hr & 0.25. K&x of sub reaches considered for routing the outflow Azhutha sub catchment is 0.83 & 0.25.
