**Operation and Maintenance  
Manual for  
Kuttiyadi Augmentation Scheme  
State of Kerala**

**Doc. No. R &DSO\_O&M\_KL29HH0044  
KSEBL\_05\_v1.0**

**Chief Engineer  
(Civil DRIP & Dam Safety)  
Kerala State Electricity Board**

Prepared by the Dam Safety Organisation  
Kerala State Electricity Board Ltd

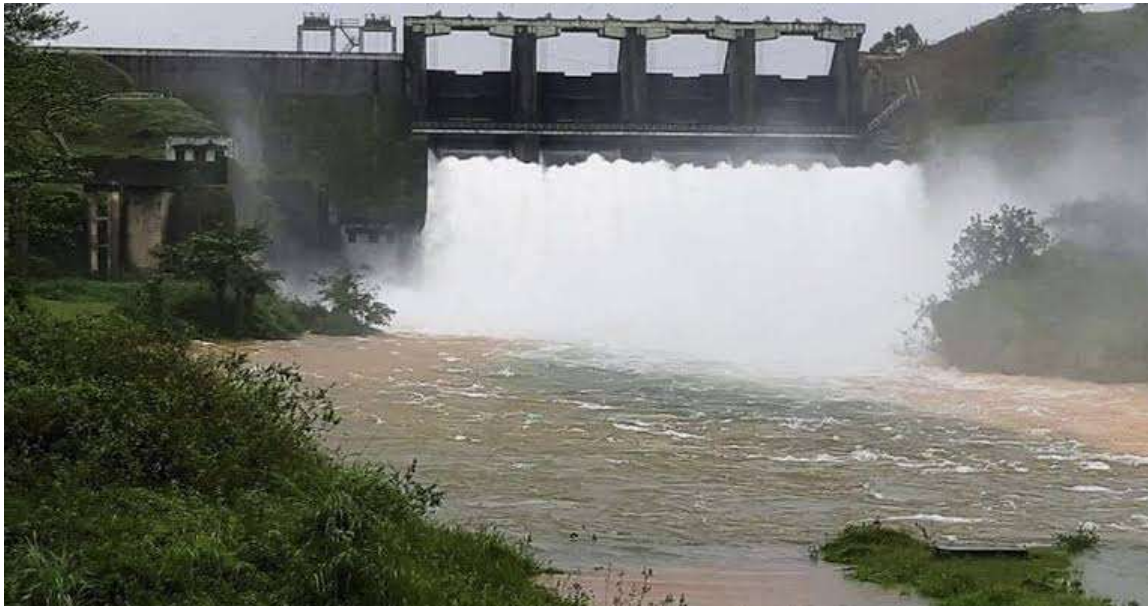
**Fig 1.7 Kottagiri saddle dam**

**Fig 2.2 Spillway**

The spillway dam is a concrete structure. The top level of dam is +778.50 m. The height of the dam above deepest foundation level is 36.50 m and the length at top is 56.38 m. The spillway is Ski-jump type. The spillway has 4 bays and is provided with four radial gates with crest level fixed at +767 m. Size of gate is 10.97 m x 9.20 m. Total Spillway Capacity of all bays is 1664 m<sup>3</sup>/s. Overflow section of spillway is shown in **Annexure 1**.

In the spillway drainage gallery, pressure gauges are installed for recording uplift pressure. Further, to measure the seepage along spillway dam one V-notch is installed inside the gallery.

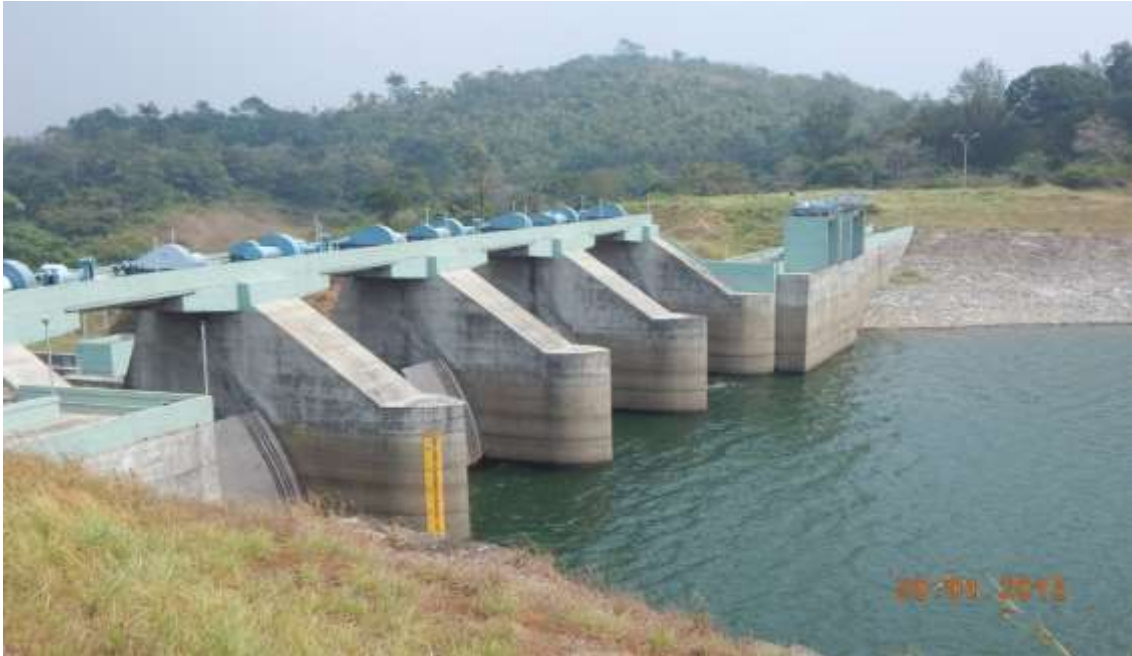
**Fig 2.3 Radial Gates Hoist Bridge**

The main component of hoisting system (rope drum hoists) for operation of the crest gates of spillway is mounted on the spillway hoist bridge. The spillway is provided with radial gates of size 10.97 m x 9.20 m which can be operated both by power and manually. Stop log gates are not provided for the spillway. The gates are operated and tested in every season when the water is below the crest level. Periodical maintenance like painting, greasing, oiling etc. is also done from time to time.

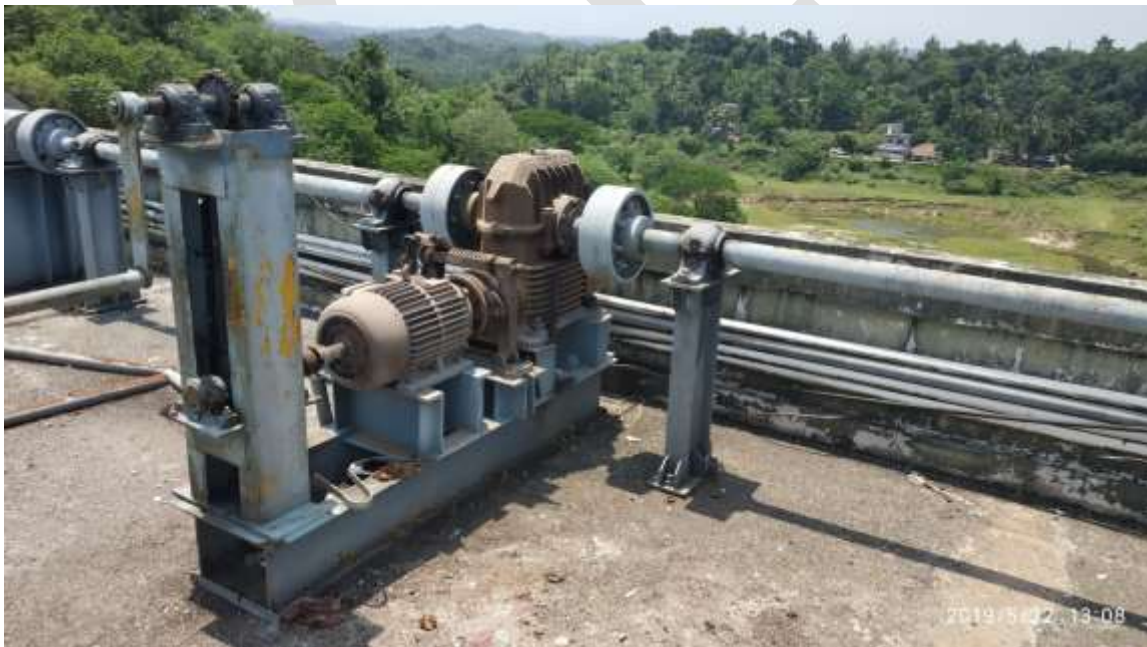
**Fig. 2.4 Radial Gate Hoisting Mechanism**

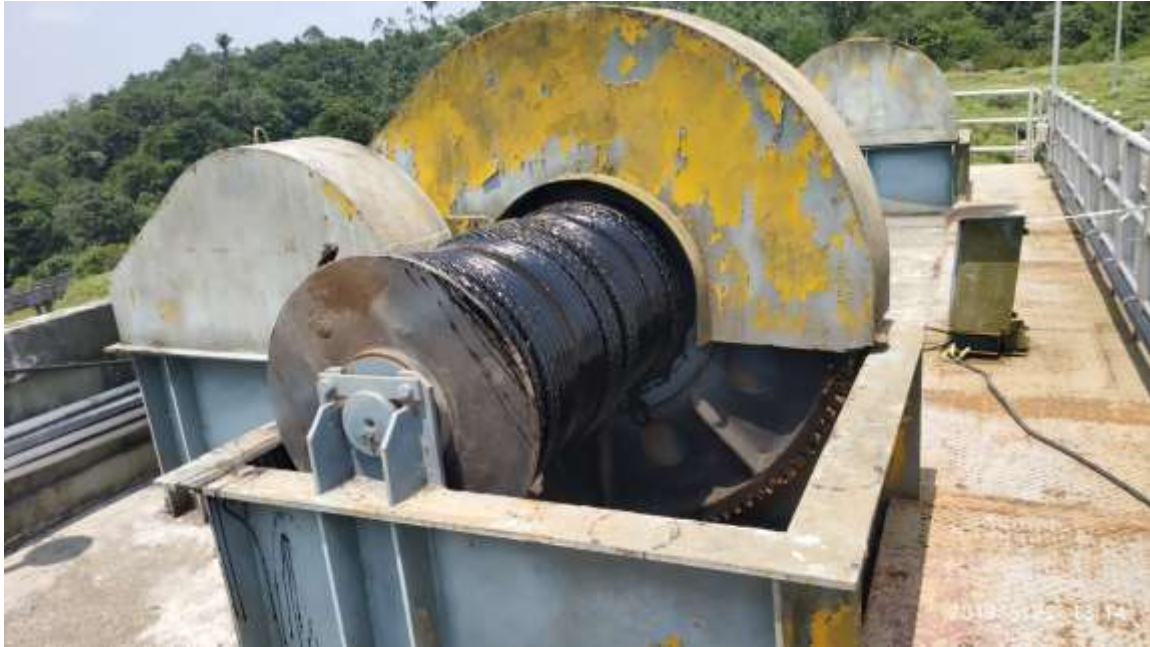
**Fig 2.5 Radial Gate Hoist Rope Drum**

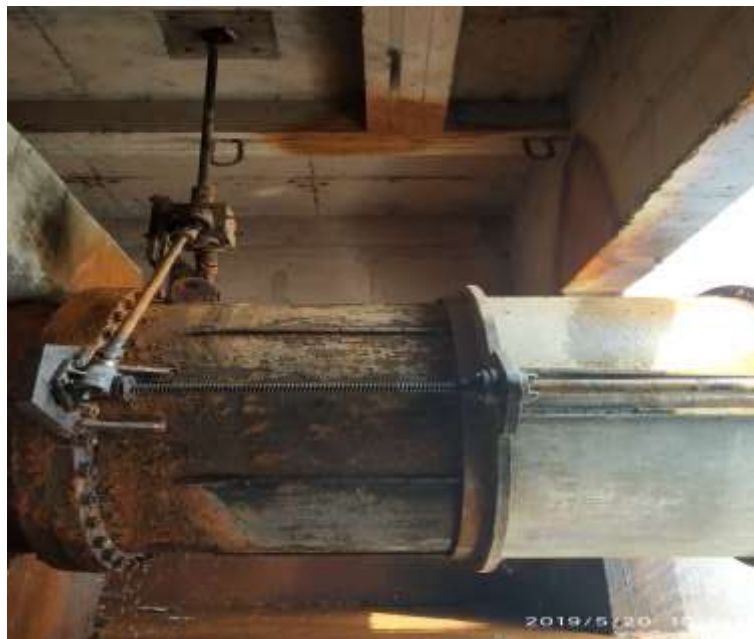
**Fig. 2.6 River Outlet Disperser Valve**

A river outlet is provided in the Spillway Dam at an elevation of +750.75 m for letting out water. The outlet is circular in shape having 2 m diameter. Disperser valve and vertical gate are provided in the outlet. The river outlet has a maximum discharge capacity of 28 cumecs. Cross section through river outlet is shown in **Annexure 1**.

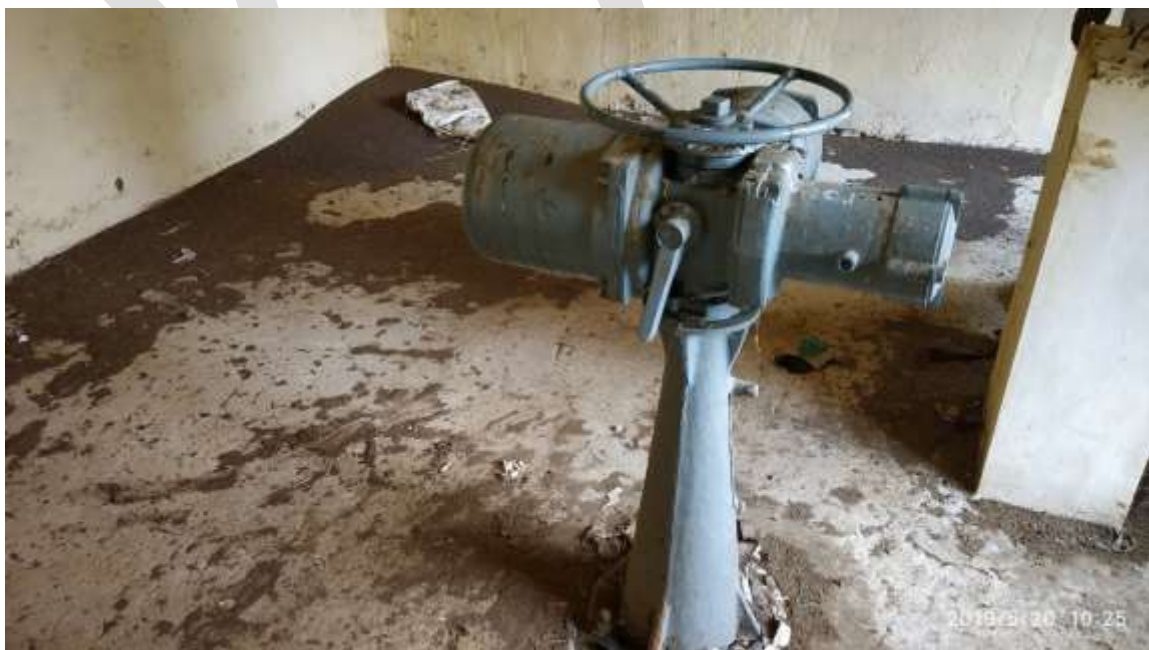
**Fig. 2.7 River Outlet Disperser Valve Opening Mechanism**

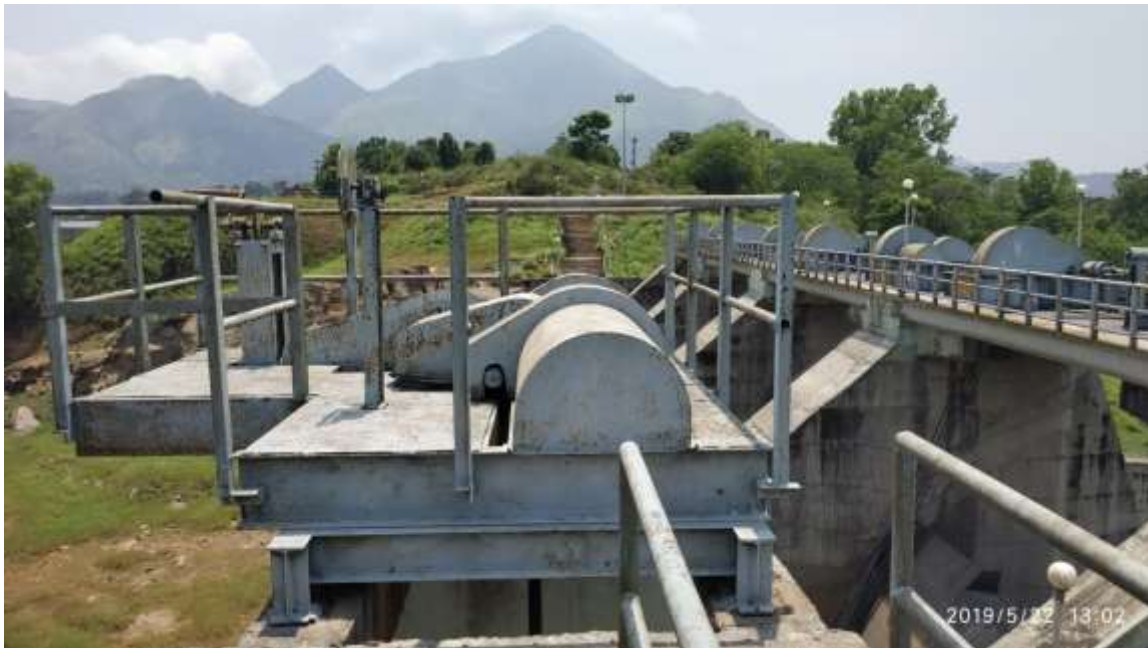
**Fig. 2.8 River Outlet Vertical Gate Hoisting Mechanism**

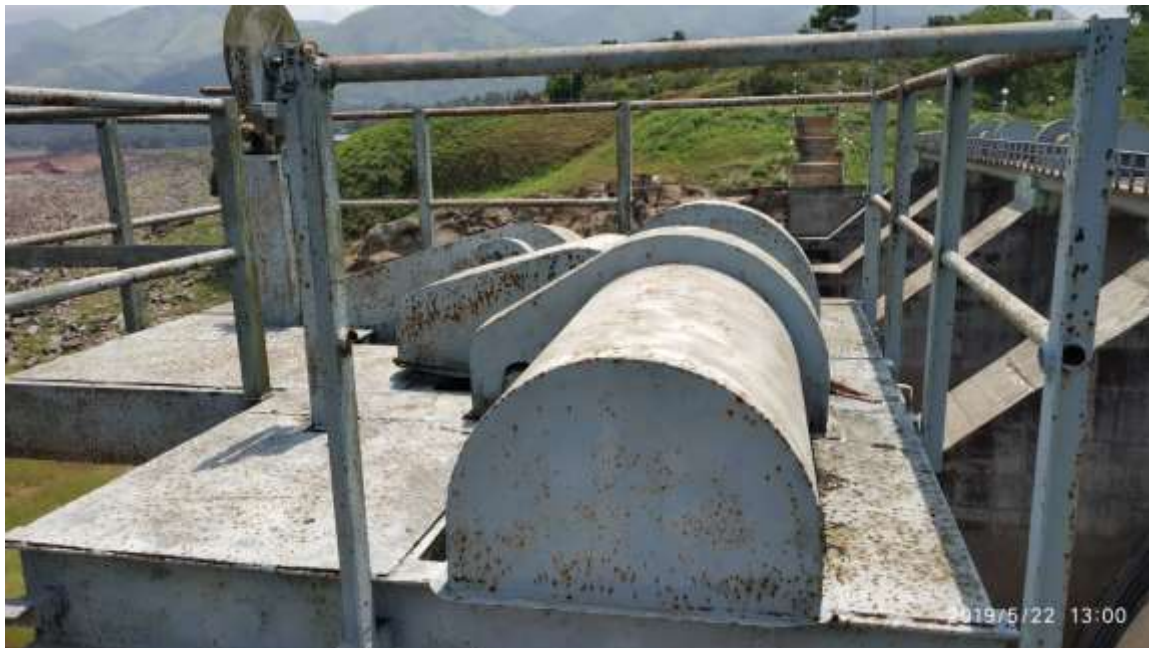
**Fig. 2.9 Irrigation Outlet Vertical Gate Hoisting Mechanism**

One irrigation outlet is provided in the Spillway Dam at an elevation of +759 m for letting out water for irrigation purpose. The outlet is circular in shape having 2 m diameter. Disperser valve and vertical gate are provided in the outlet. Cross section through irrigation outlet is shown in **Annexure 1**.

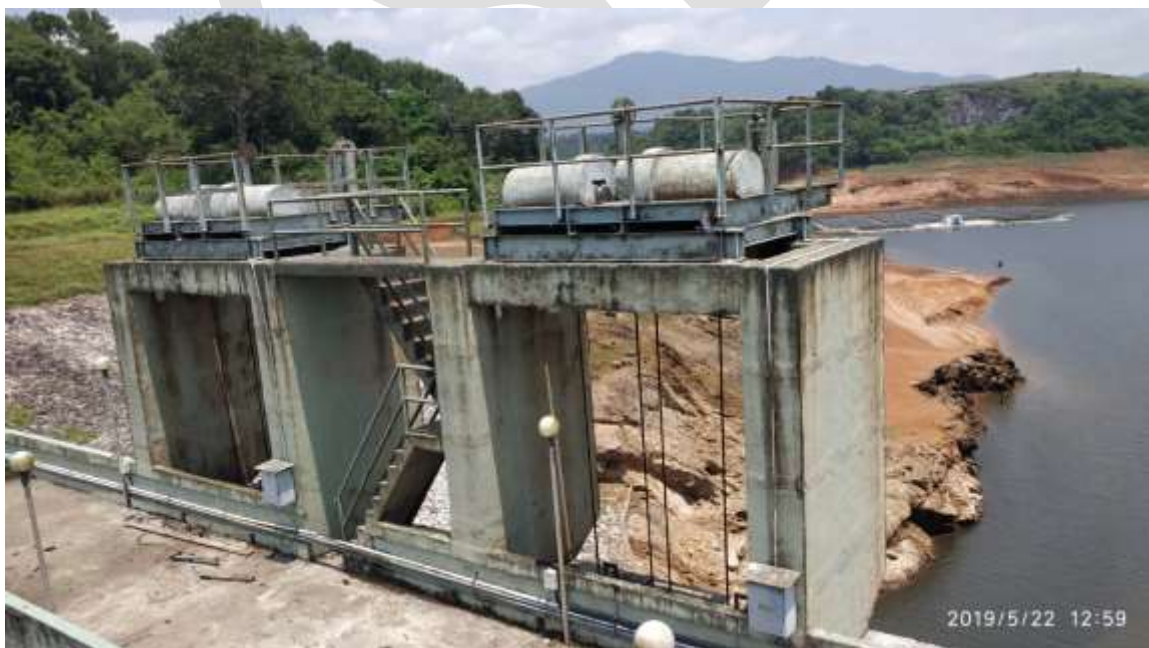
**Fig. 2.10 Hoisting Mechanism of Vertical Gates of River and Irrigation Outlets**

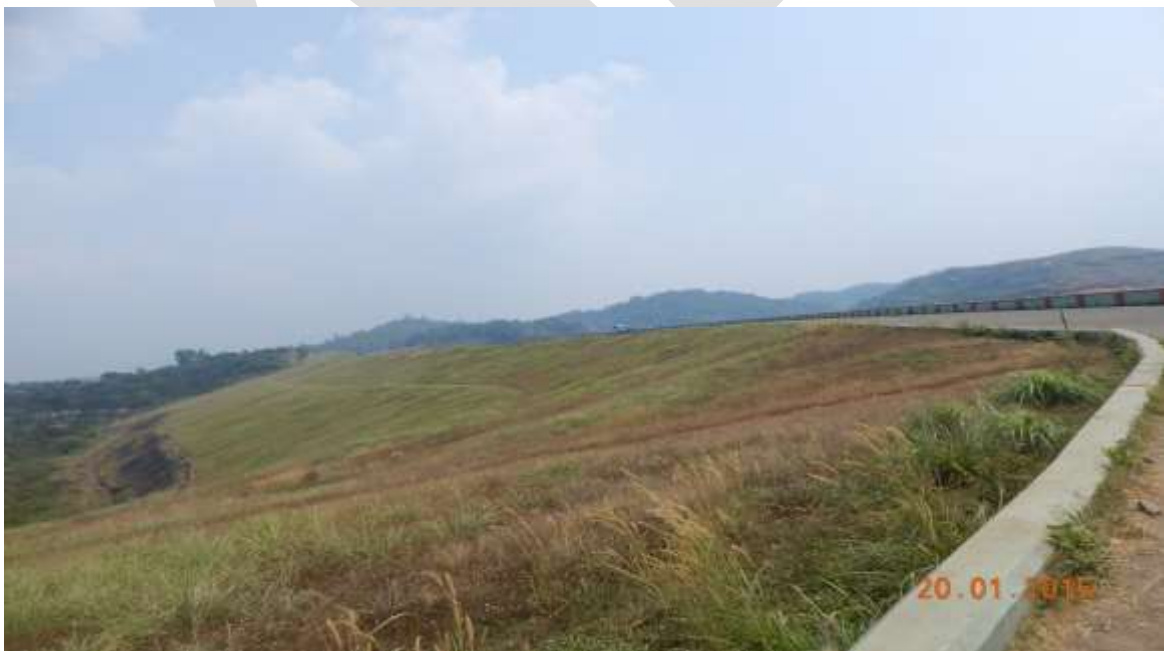
**Fig 2.11 Down Stream View of Main Dam**

To ensure safety of an earthen dam in cases where the cut off is partial, reliance is placed on an upstream blanket for controlling under seepage. It is generally necessary to control the pressures developed below the downstream toe of the dam, especially if a pervious layer is overlain by an impervious layer of soil at the top. This may be effectively done by installing a system of relief wells suitably placed which will relieve the intensity of under seepage. Pressure relief wells render seepage water practically harmless where it may conveniently lead to a natural drainage channel. Three relief wells are provided at the downstream toe of the main dam.

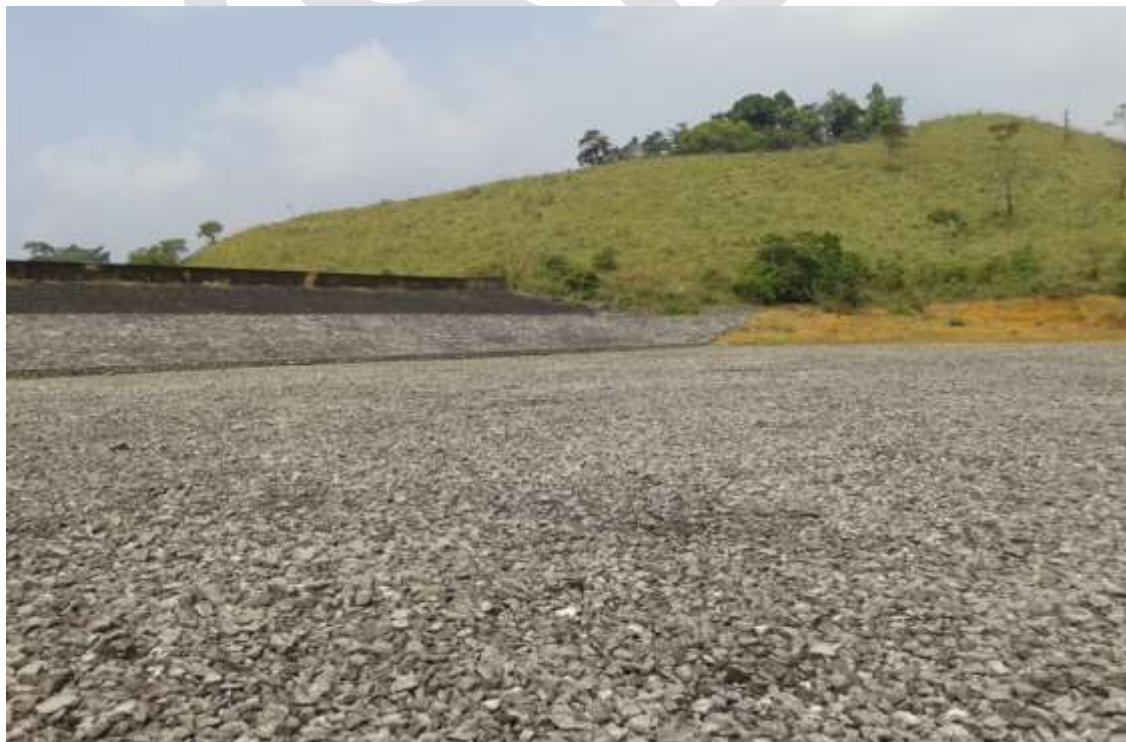
**Fig 2.16 Rubble packing – upstream side of Kottagiri saddle dam**

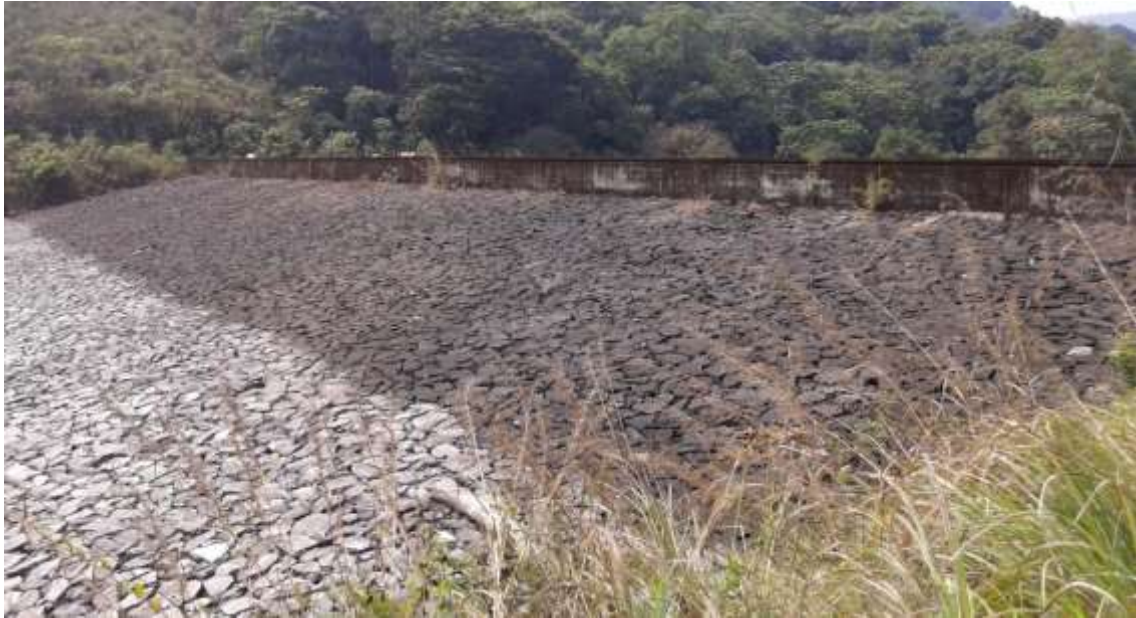
**Fig 2.18 Rubble packing – upstream side of saddle dam near Kottagiri**

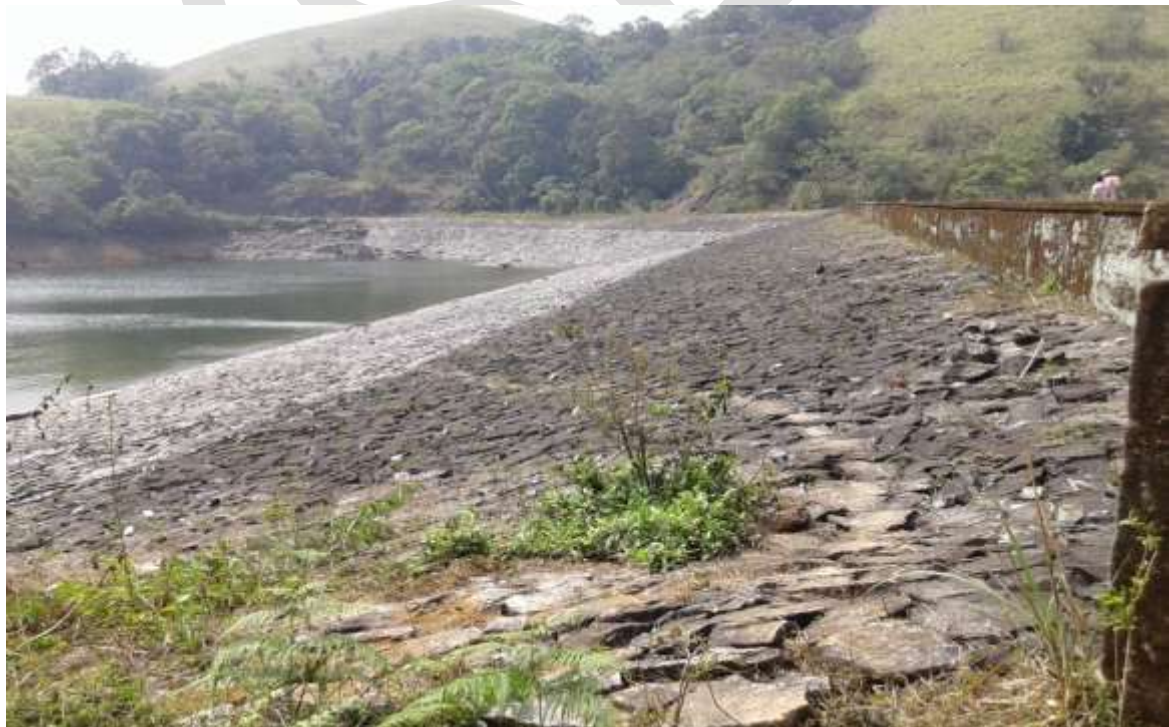
**Fig 2.20 Rubble packing – upstream side of Kosani Saddle Dam**

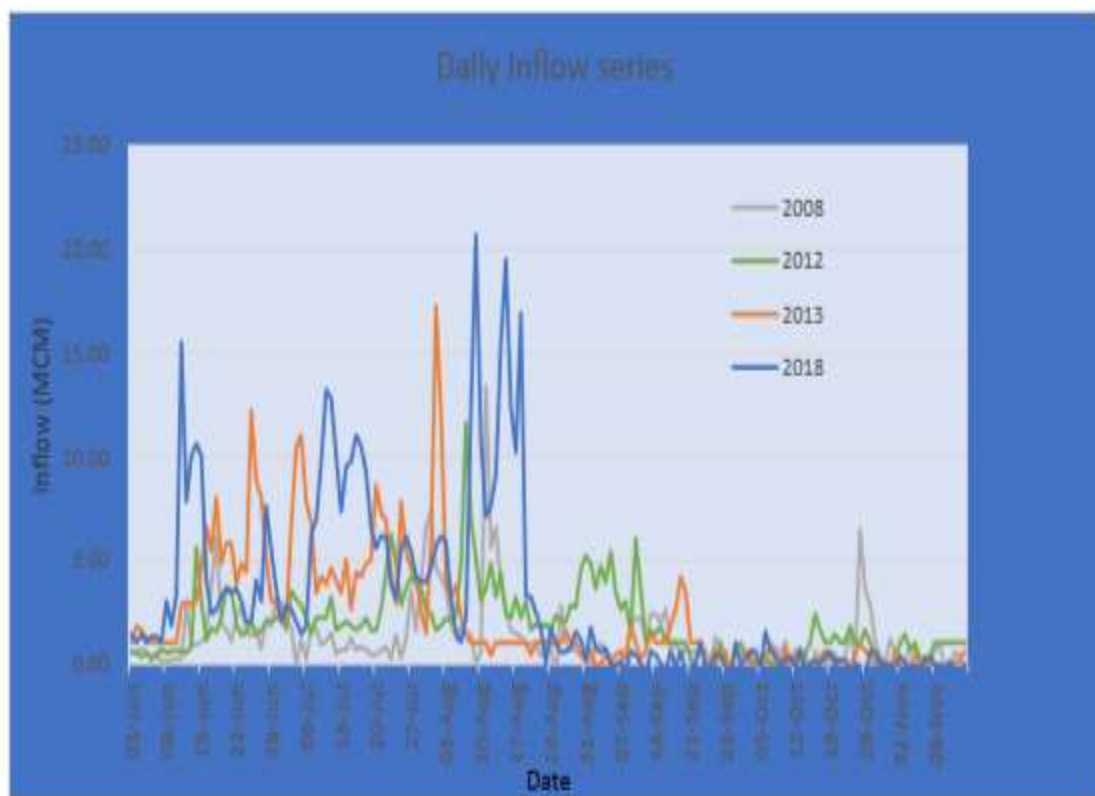
A comparison of daily inflow to Banasurasagar reservoir during the year 2018 (very wet year) is made with the inflow for the year 2008(very dry year), 2012 (normal year), 2013(very wet year) and is shown in the graph below. The extreme peak of inflow in the year 2018 is very well depicted in the graphical representation of the series.

Fig 2.23 Daily inflow series of various years

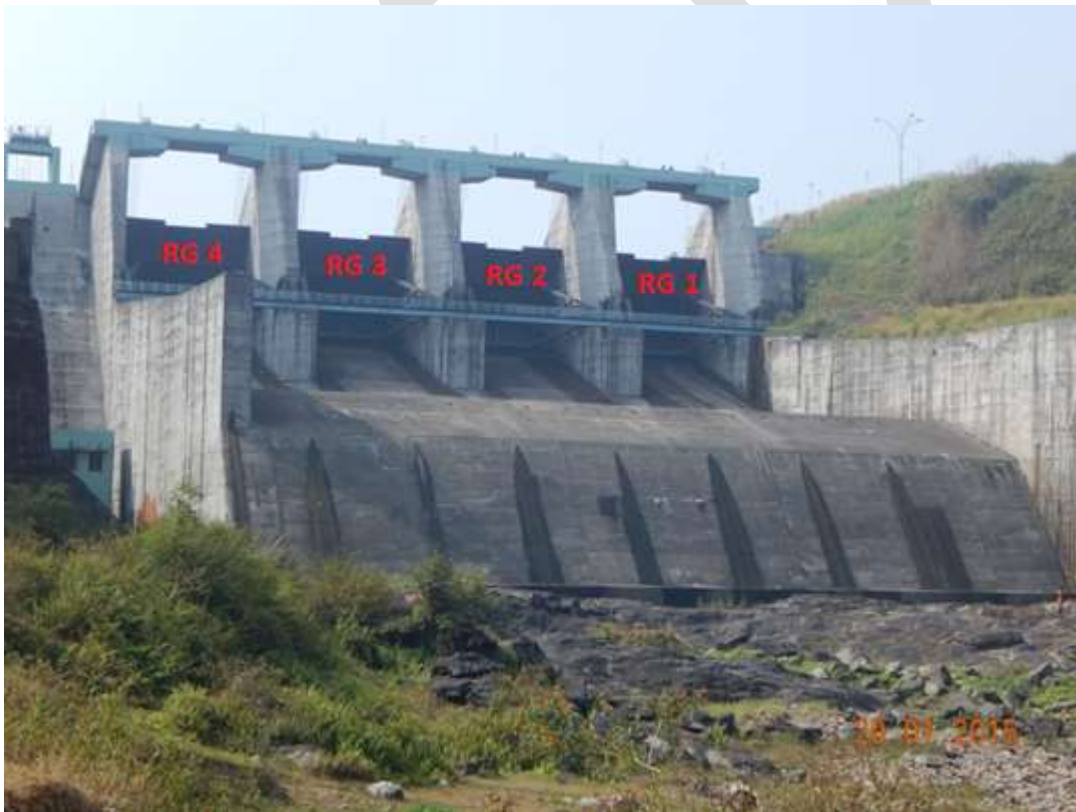
The flood water is released through spillway gates based on the operation manual of gates and flood routing studies. There are four spillway gates. The sequence of operation of spillway gates is Gate no. 3,2,4,1. During the recession part of the inflow hydrograph, it may be necessary to close the crest gates in order to maintain the reservoir level at the rule curve elevation. In such a case, the closure of the gates should be done in the reverse order; the gate opened last being closed first, the entire operation being such that the difference between the adjacent gate openings never exceeds 0.3m.

Fig 2.25 Spillway Radial Gates

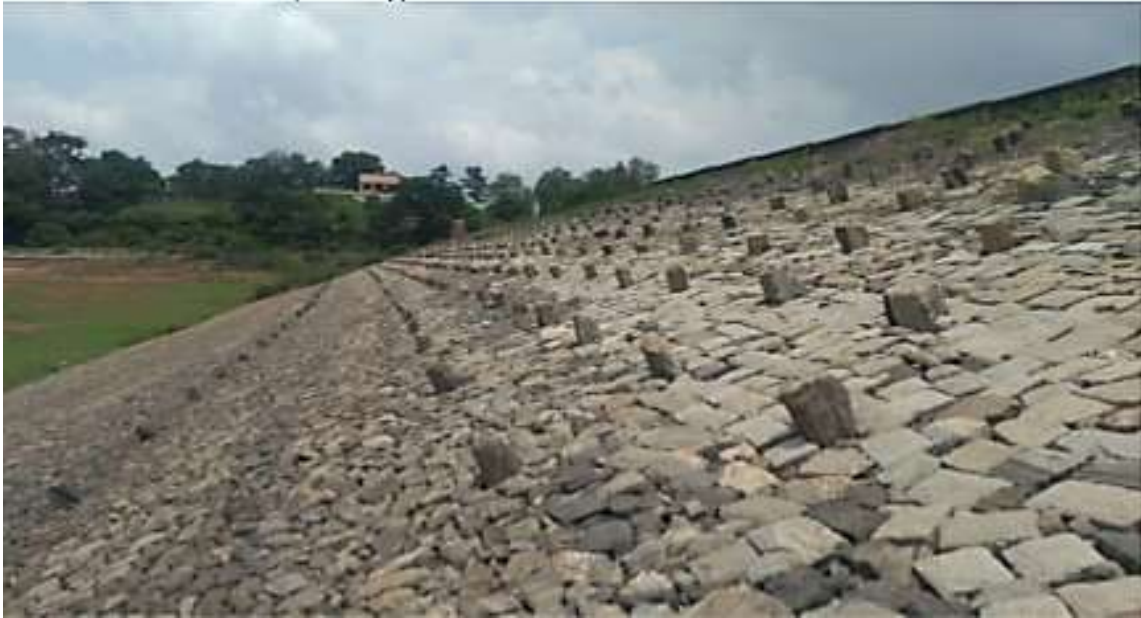
**Fig 4.1 Upstream rip rap**

Nonetheless, erosion can still occur in existing riprap. Water running down the slope under the riprap can erode the finer filter materials under the riprap and soils leaving voids and loss of grade. Wave run up will also undermine the filter layer especially along the full reservoir level and over time wash out finer material. This can be checked through observance of linear embankment settlement. Sections of riprap that have slumped downward are often signs of this kind of erosion.

When erosion occurs on the upstream slope of a dam, repairs should be made as soon as possible. (Refer IS: 8237- Code of practice for protection of Slopes for Reservoir Embankments).

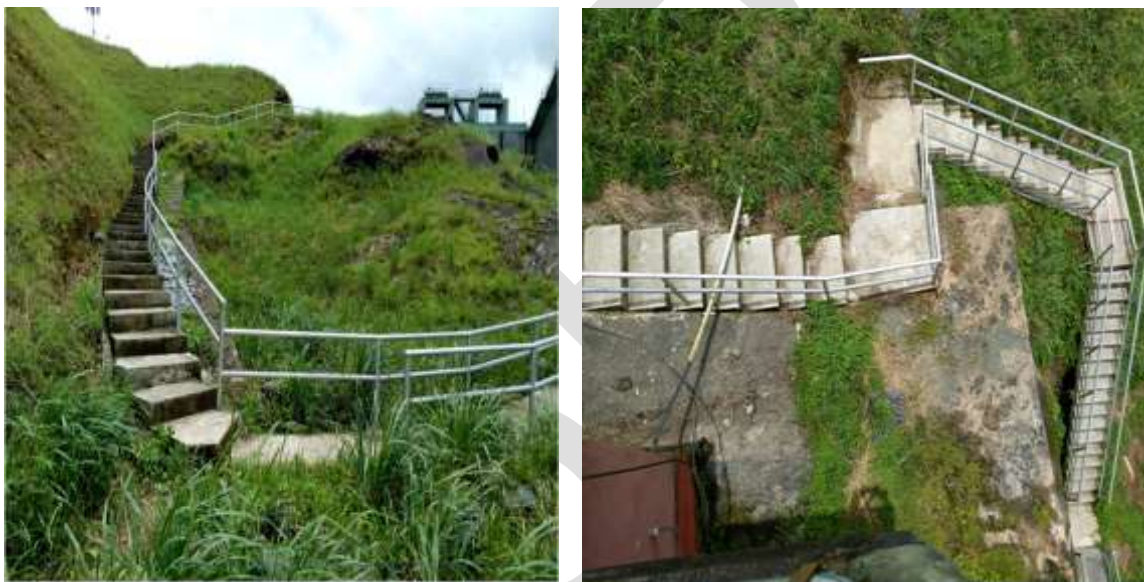
**Fig 6.1 Steps constructed**

The photographs showing the DRIP works are given below:

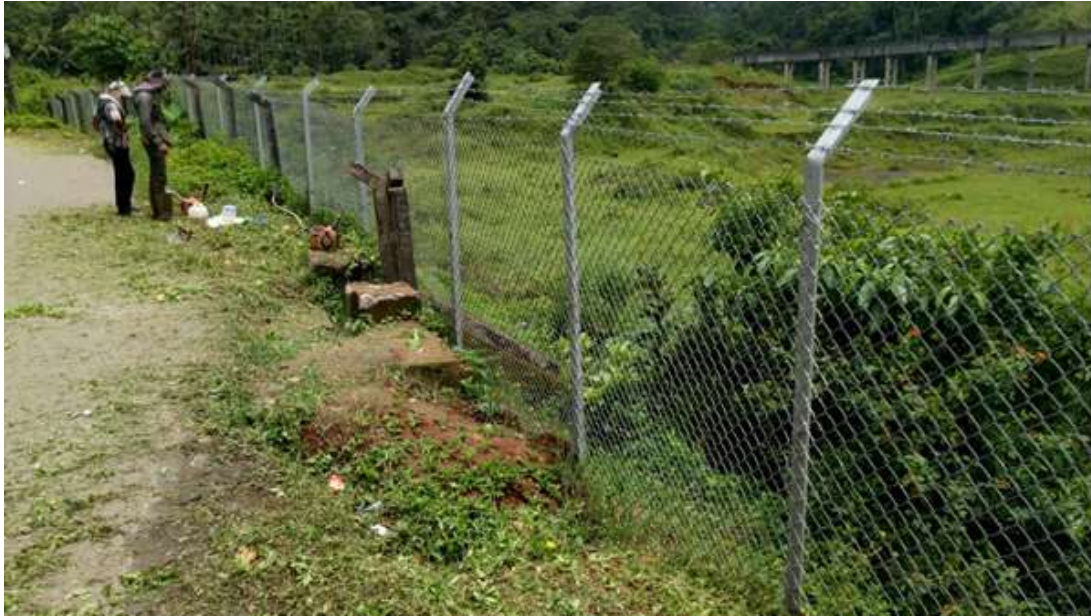
**Fig 6.2 Fencing**

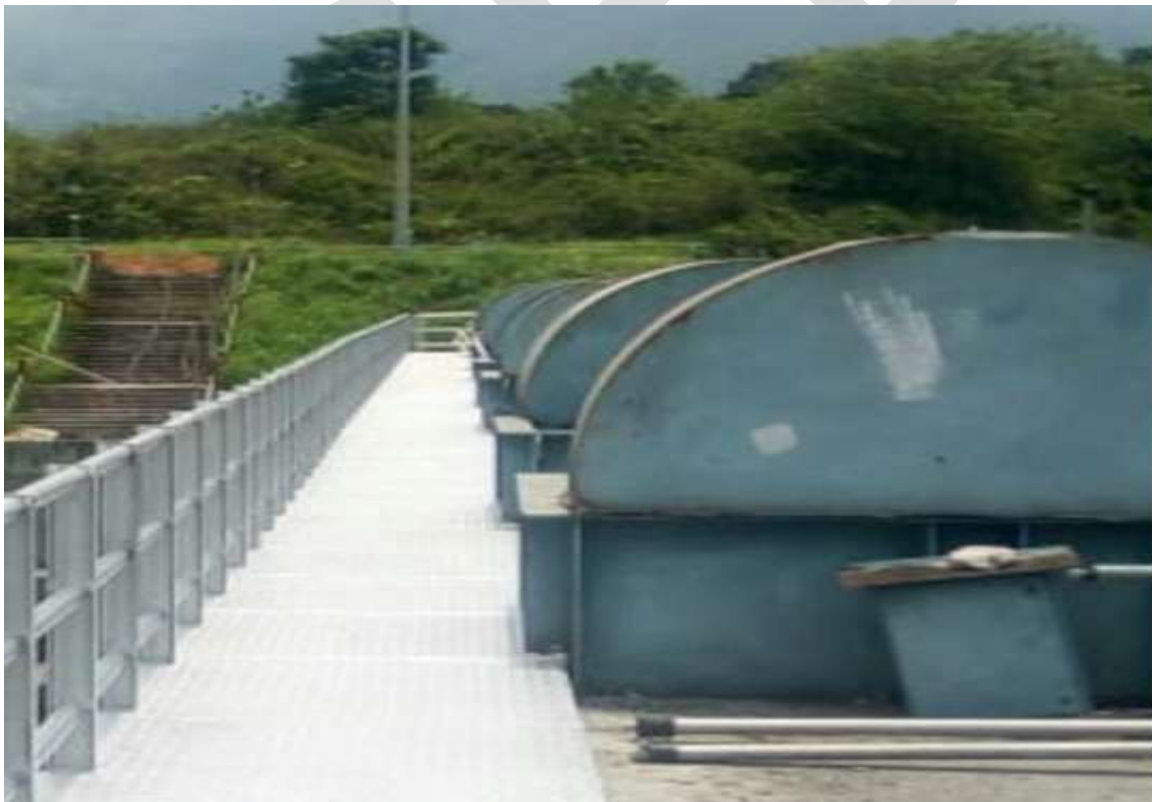
**Fig 6.3 Steel walkway at spillway**

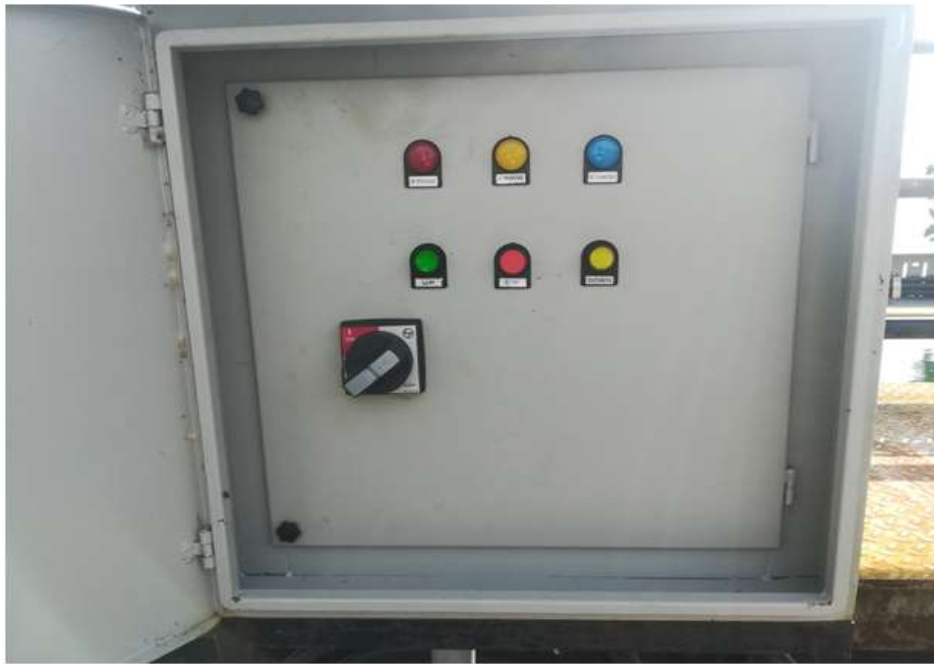
**Fig 6.4 Electrification work**
