Operation and Maintenance
Manual for
SHOLAYAR DAMS
State of Kerala

Doc. No. R & DSO_O&M_KL29MH0015
SHOLAYAR DAMS
KSEBL_04_v1.0

Operation and Maintenance Manual for Sholayar Dams

Prepared by the Dam Safety Organisation
Kerala State Electricity Board Ltd

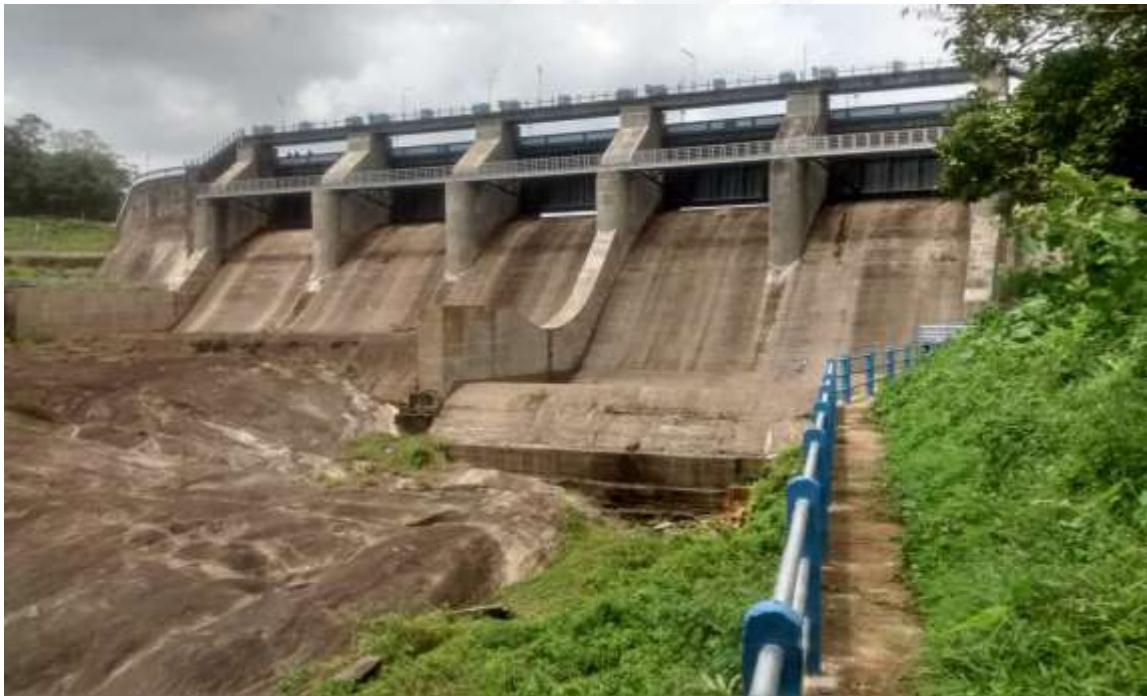
Fig 2.2 Downstream view of spillway

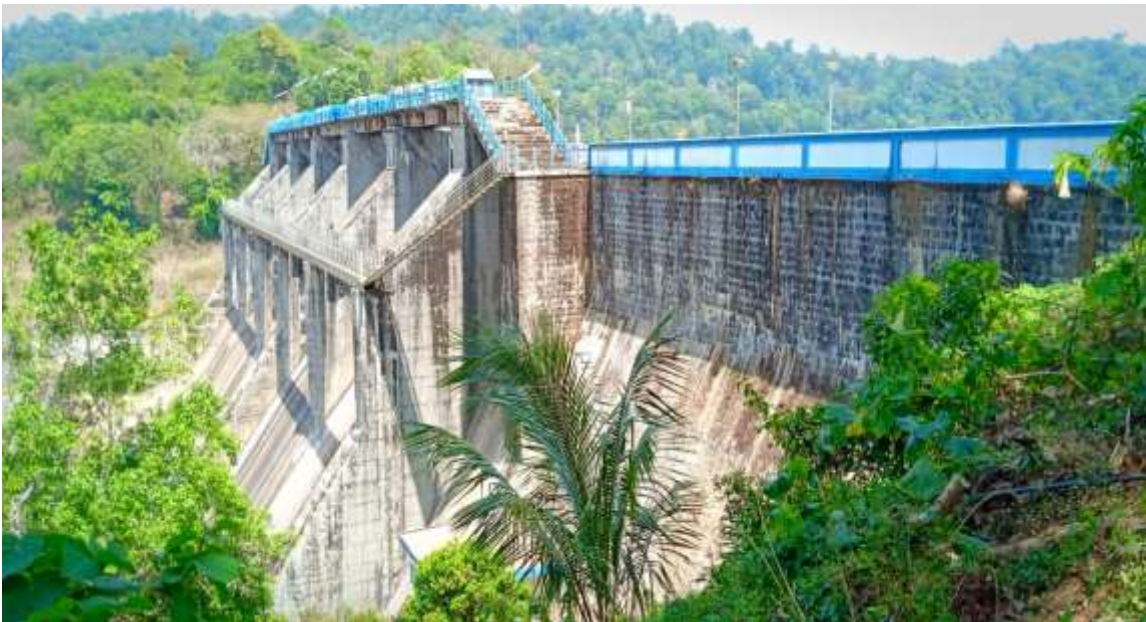
Fig 2.4 Spillway of Sholayar Flanking Dam

5 Nos. of Radial Gates of size 10.97 m x 6.40 m are installed for controlling the flood discharge. The embedded parts of the radial gates consist of sill beams of I-section of welded construction and anchorages, sliding plates of sides of angle section with anchorages. The cross beams at piers are made of box type steel. These cross beams support the trunnions of the gates. The main body of the gates consists of skin plates and stiffeners of plate angles. There are two main girders of welded I-section and two arms made out of I-section having hubs trunnions and bearing body.

The Spillway is designed for a maximum designed flood discharge of 1710.32 cumecs. Dissipation of energy of the water falling from the ogee crested spillway is effected by providing up turned buckets with inverted levels at +786.99 m and +791.56 m. The radius and lip angle provided for the upper bucket are 10.67 m and 45° respectively, while the corresponding values for the lower bucket are 12.19 m and 45° . The dam is made accessible over the spill way portion by the spillway bridge and the motors of the radial gates, the winches and the control panels are located on the hoist bridge at R.L. +815.95 m

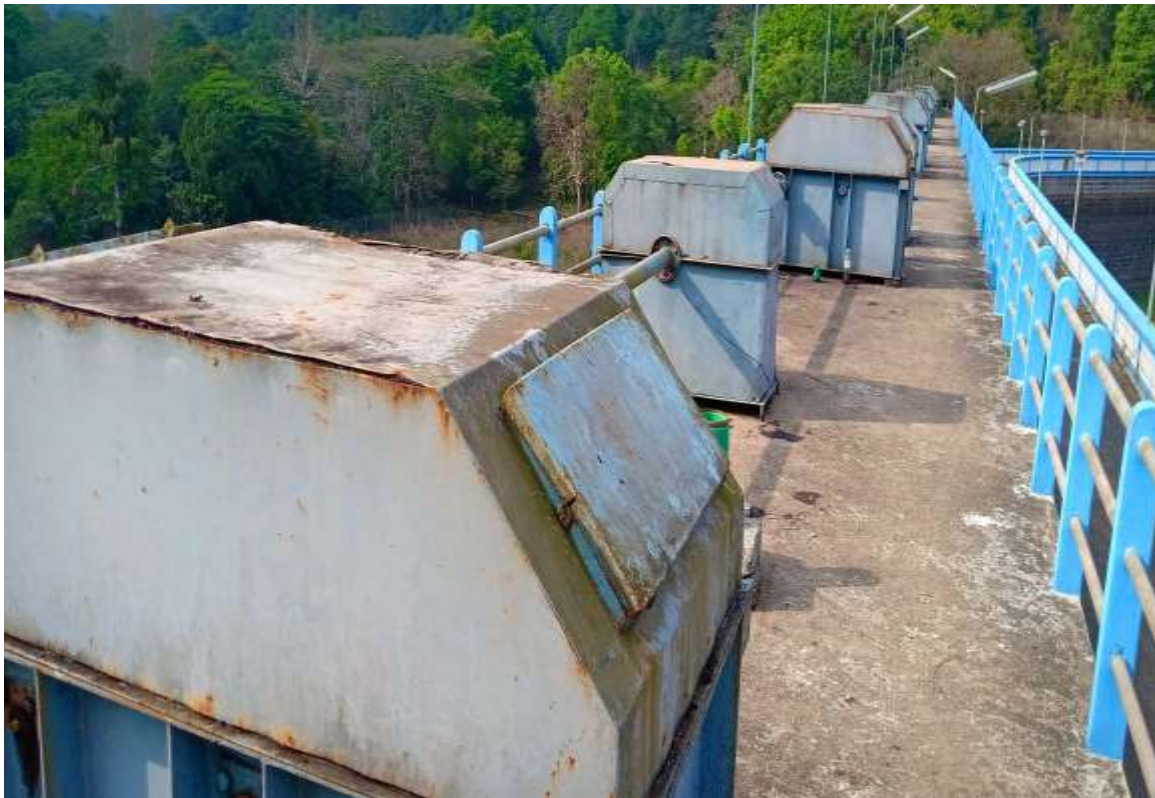
Fig 2.5 Radial gate Hoists

The hoisting mechanism consists of a central drive and two lateral drives coupled by pipe shafts. The central drive has spur type reduction gear, self - arresting worm gear, a double shoe brake with electro hydraulic control device. The hoist can be either electrically or manually operated. For hand operation there is a hand crank and a safety device for switching off electrical system when the hand crank is introduced. The lateral drums have got spur type reduction gears and a rope drum. There is a positive indicator in the control panel for indicating the extent of opening of the gates. It has got two concentric

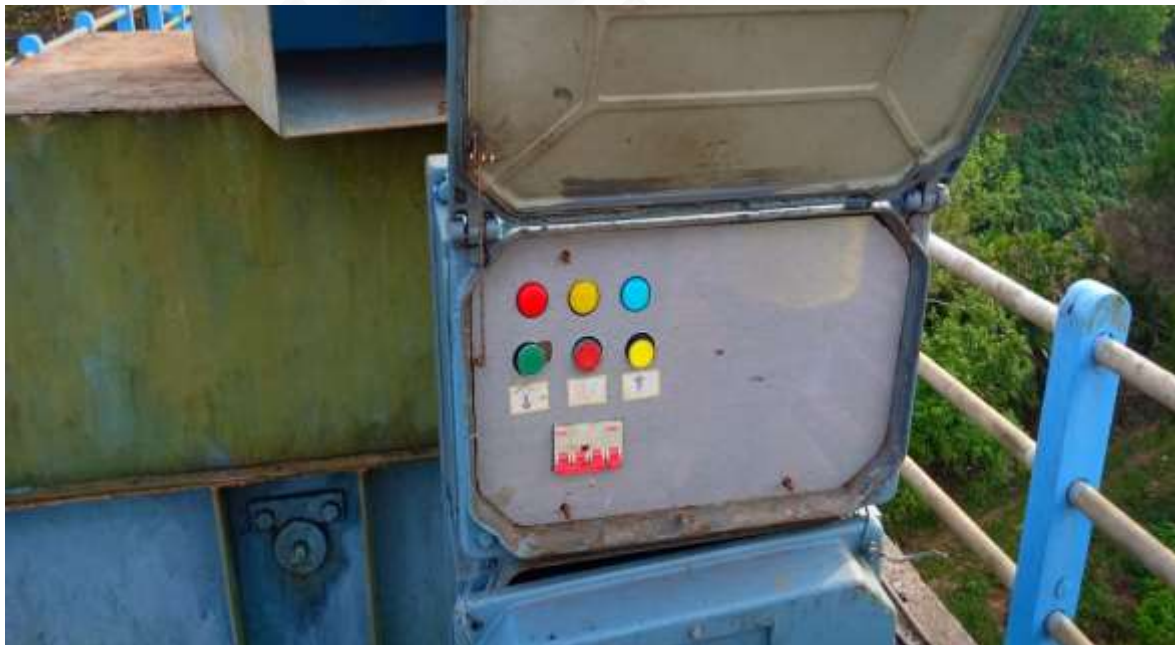
Fig 2.7 Control panel of Hoisting mechanism

needles, one for indicating the opening in metres and the other for fraction of metre i.e. centimetres. There are electrically controlled limit switches for the top and bottom positions of the gate. The hoisting and lowering speed when electrically operated is 0.31 m per minute. The electrical equipment consists of 3 phase synchronise motor with short circuit rotor 2.5 kilo watts, 1400 rpm magnetic hydraulic brake unit, spindle limit switches for top and bottom position of the gates. The motors of the radial gates, the winches and the control panels are located on the hoist bridge.

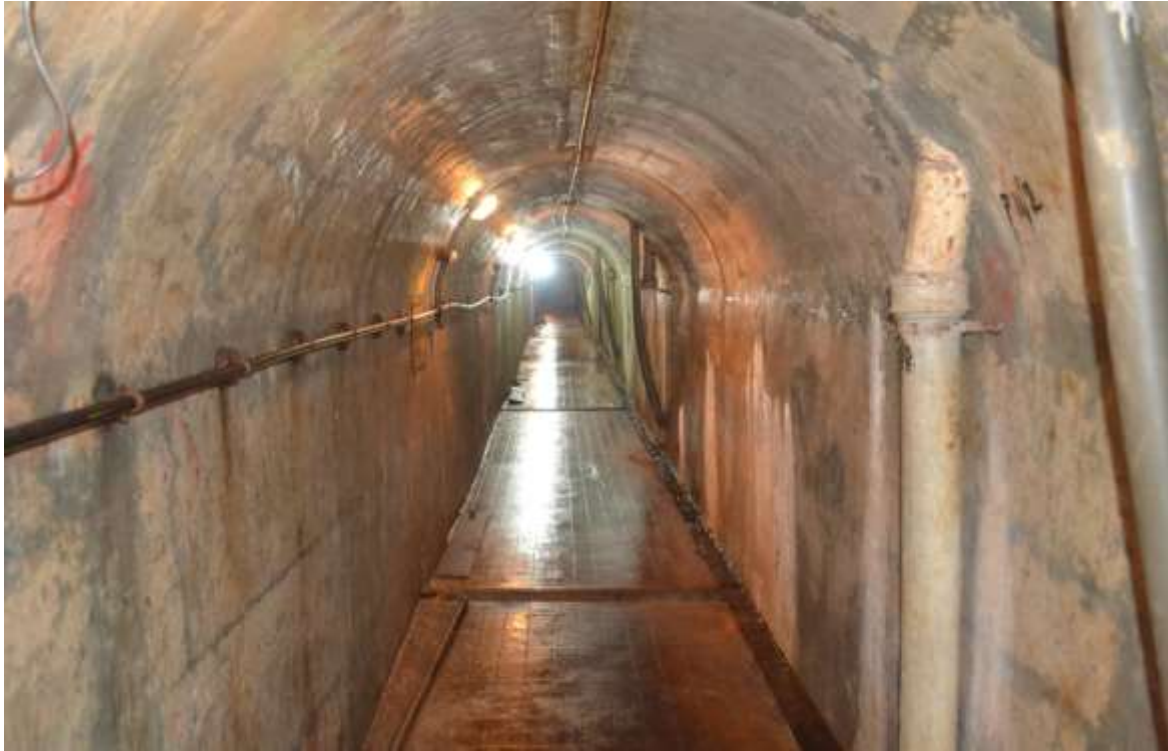
Fig 2.9 Drainage and inspection gallery

A transverse gallery of size 1.52 m x 2.74 m in size is located in Block No.3 with an ADIT house at entrance at the downstream side of the dam. This is only entrance and exit provide for the drainage gallery.

The drainage holes in the gallery are located at the downstream face of the gallery and the water coming up through these are led out to the longitudinal drain on the upstream face of the gallery through cross drains. There are 90 Porous Drain Holes and 76 Foundation Drain Holes. Monthly observations of these holes are being carried out. Total seepage is measured using V-notches fitted in the gallery.

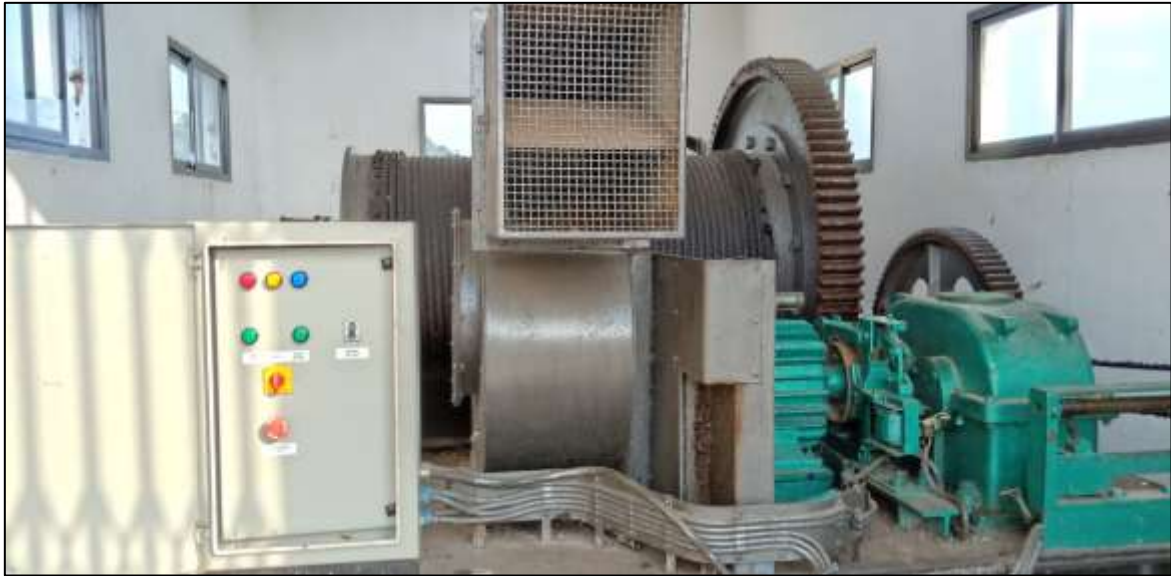
Fig 2.15 Rope drum of Emergency gate

There is a mechanical hoist erected at elevation +812.67 m with capacity of 20 tons for operating the gate. The hoist consists of electric motor, solenoid brake and a rope drum. There is a fan brake of sturdy construction, independently acting under different brake torques. There is a suspension beam for the hoist gate, which moves along with the gate during its downward movement, so that the gate is supported by 2 ropes, till it reaches the bottom near the opening. Beyond this, the suspension beam is held in position and from there the gate is suspended by 4 ropes, so that the effort on the motor is reduced at the higher reaches and maximum effort is put when the gate contacts the frame work. Two guides of angle sections are provided for guiding the gate during its upward and downward movements. There is a position indicator attached to the hoist frame work, which indicates the position of the gate and also there are two limit switches for limiting its upward and downward movements. The hoisting speed is 1.52 m per minute and maximum lowering speed is 2.44 m per minute.

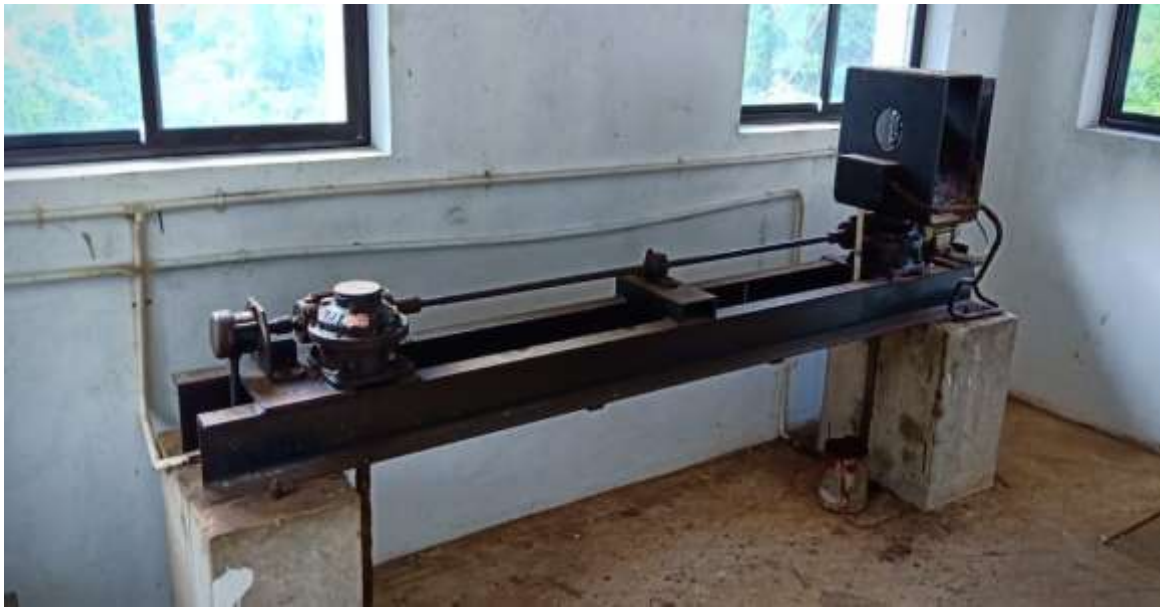
Fig 2.17 Operating gear of Disperser valve

4. **Operating gear:** The valve is operated by 2 worm gears located in horizontal plane passing through the axis of the valve and consists of a chrome steel work, steel bevel gear and bronze driving nut. The operating gear gives only longitudinal motion to the worm. The worm gears are driven by the motor unit

via shafts and bevel gearing. There is a mechanical position indicator with limit contacts, which indicates the opening of the gate. The valve can also be manually operated in the case of power failure. There is a safety device for cutting off the electric supply when the crank handle is introduced. The maximum discharge through the discharge regulator under full head is 29.34 cumecs. The center of outlet pipe and disperser is fixed at + 768.10 m level.

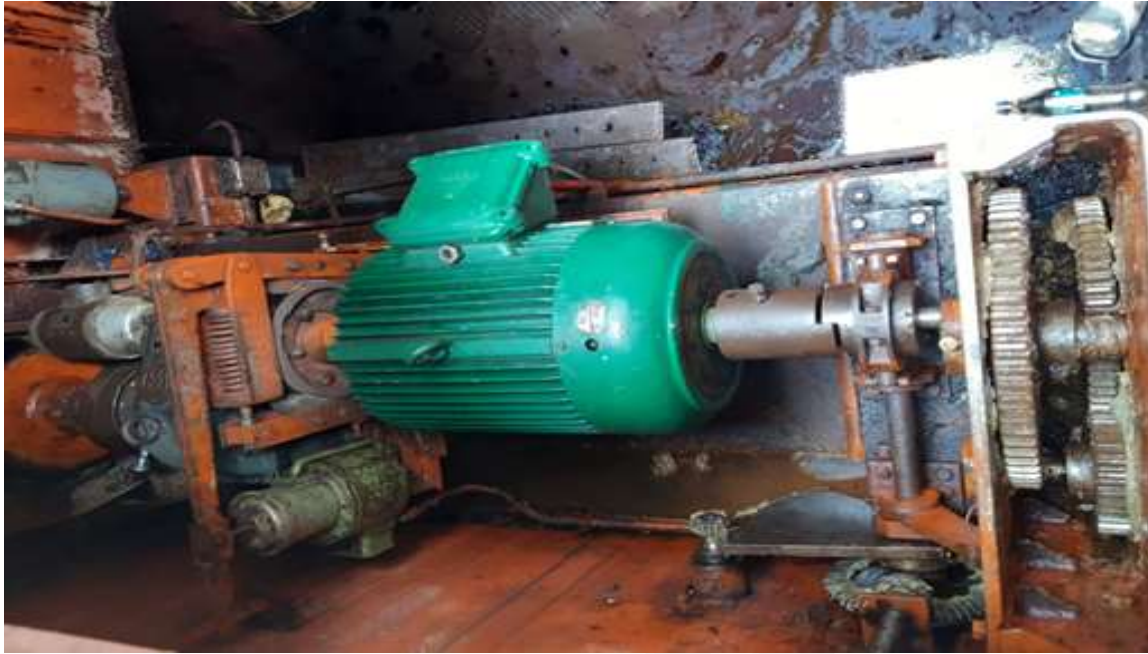
Fig 2.18 Motor of opening arrangement of disperser valve

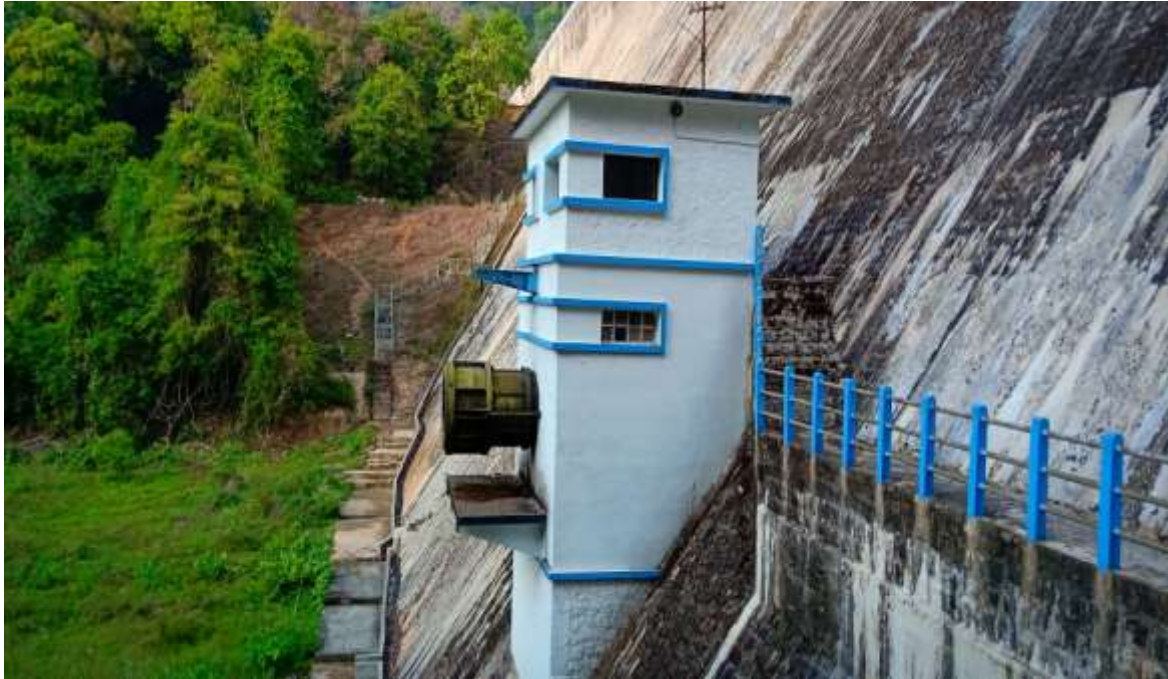
Fig 2.19 Disperser valve

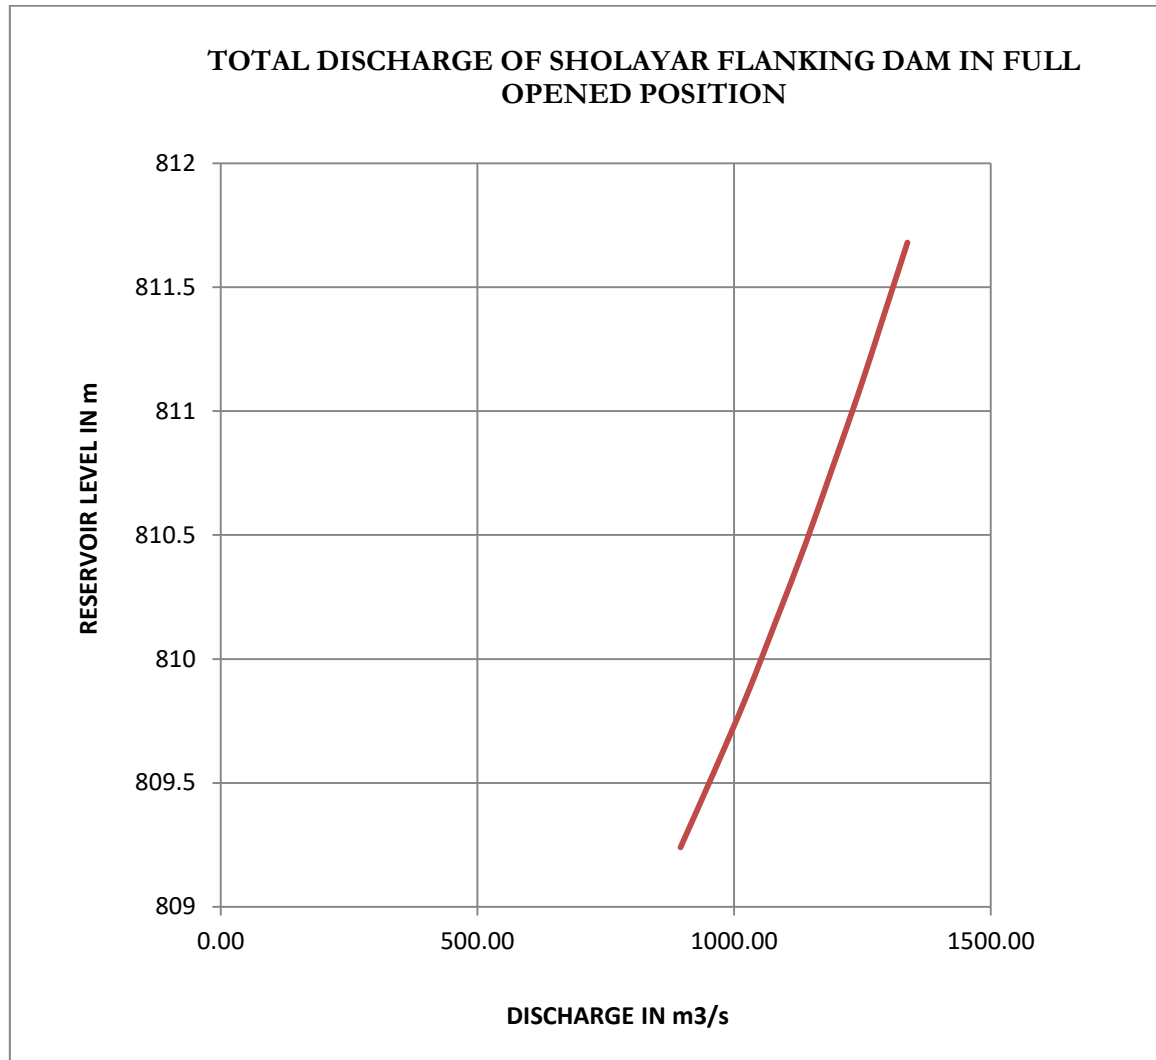
Fig. 2.22 Total Discharge in full opened position

Sholayar reservoir was being operated as per "Guidelines for Operation of Reservoirs" (IS:7323;1994), for storage reservoirs for conservation purposes like power generation. The reservoir water is released through spillway gates as per rule levels fixed. Discharge through single spillway for different reservoir levels with different gate openings is tabulated in **Table 2.4**. Discharge (Rating) curve showing discharge through one radial gate at various reservoir levels is given in **Fig. 2.21**. Total discharge in full opened position is given in **Fig. 2.22**.

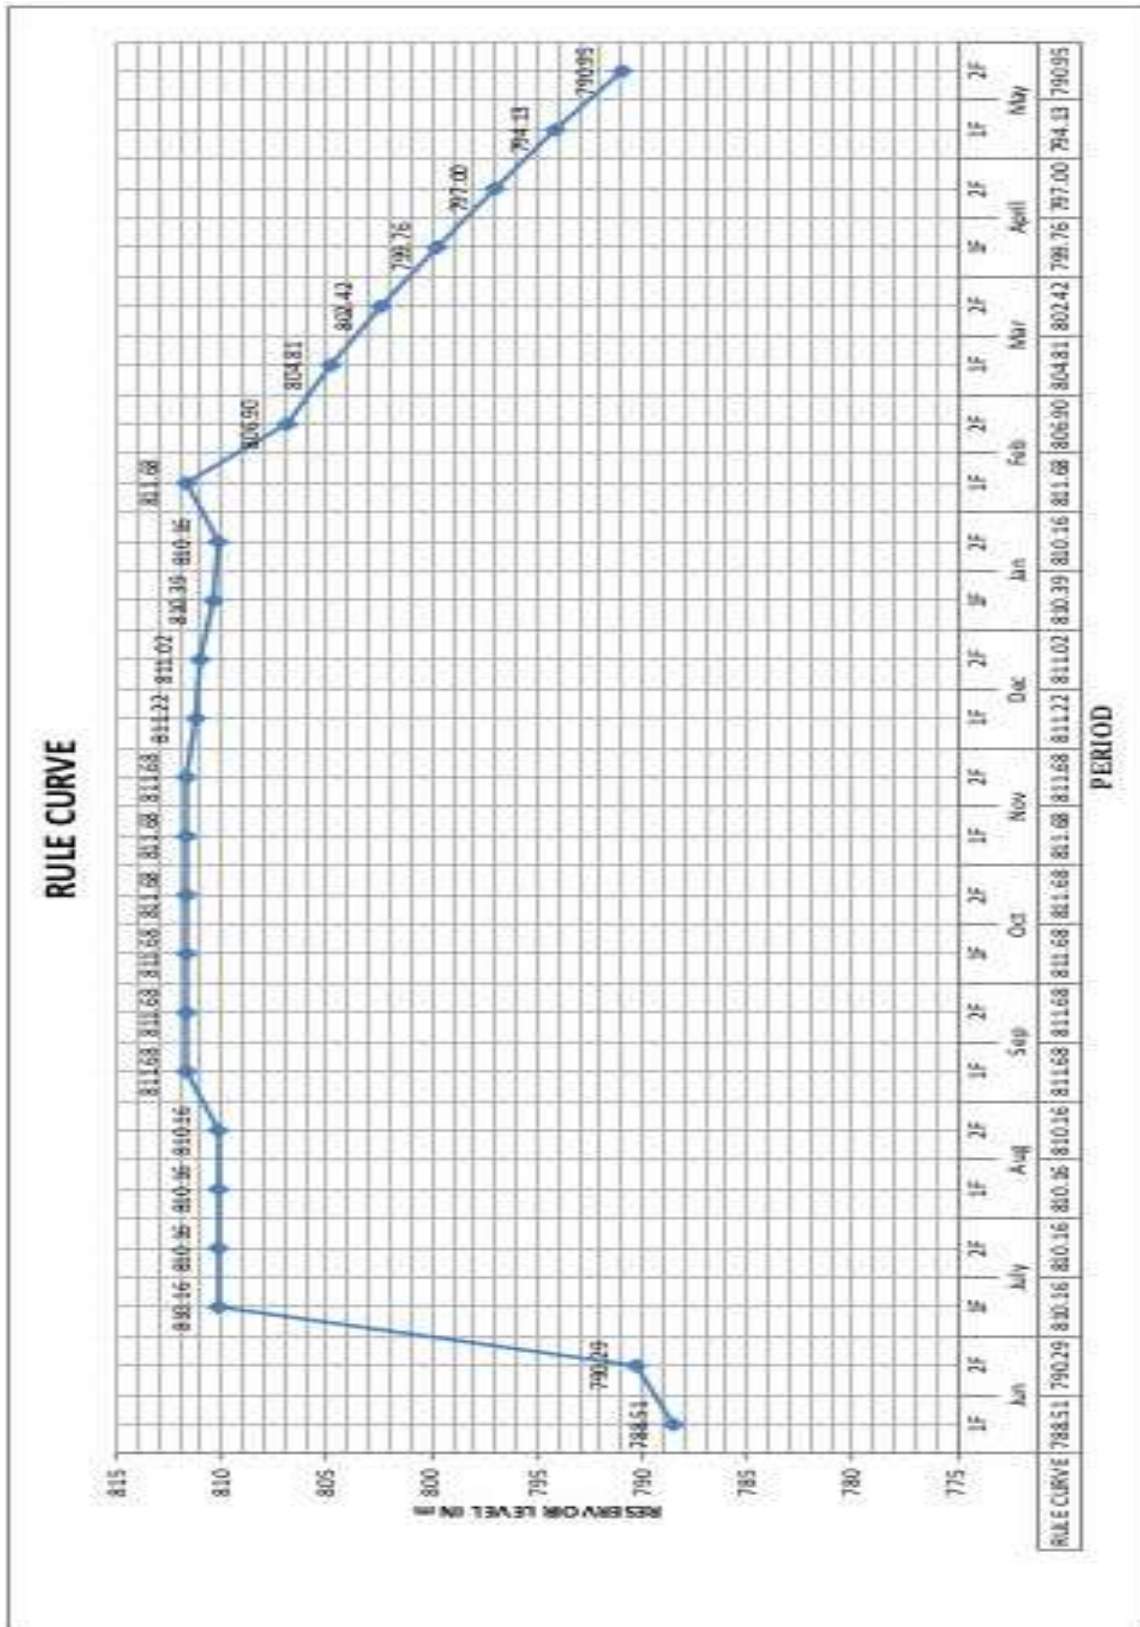
Fig 2.23 Rule curve

Accordingly Rule curve for Sholayar Flanking Dam is given in **Fig. 2.23**.The reservoir water exceeding the rule curve level will be spilled or adjusted with power generation. This can be used till further revision.

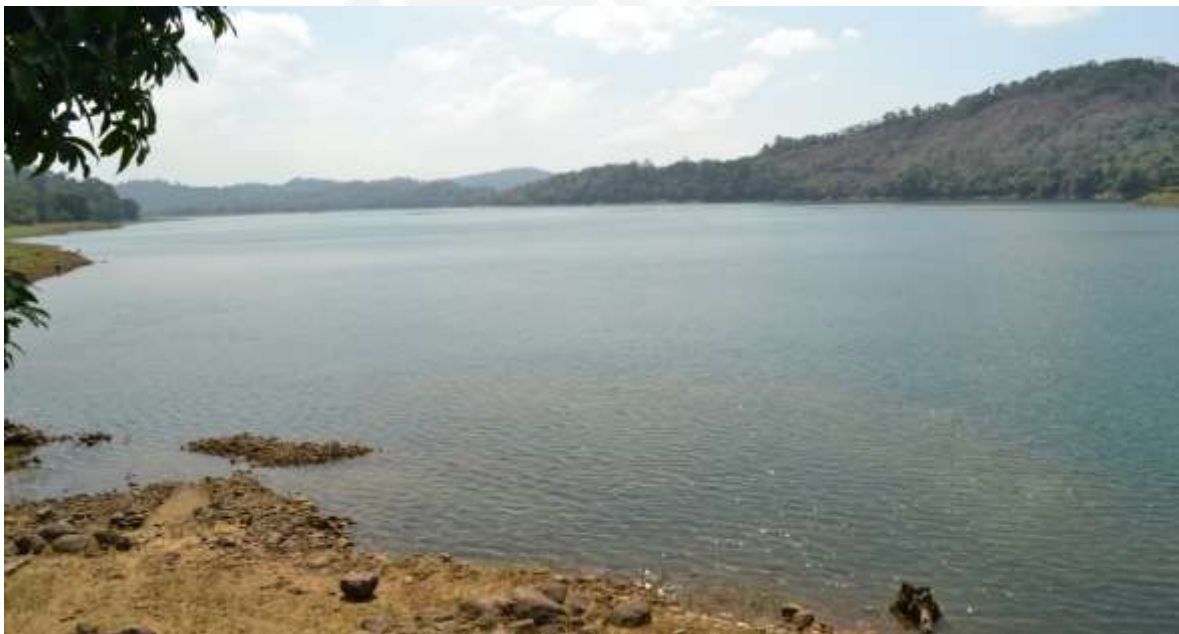
Fig 2.24 Sholayar Reservoir

The Gross storage of the reservoir is 153.48 Million Cubic Meters and the effective Storage is 150.08 Million Cubic Meters at FRL of +811.68m.

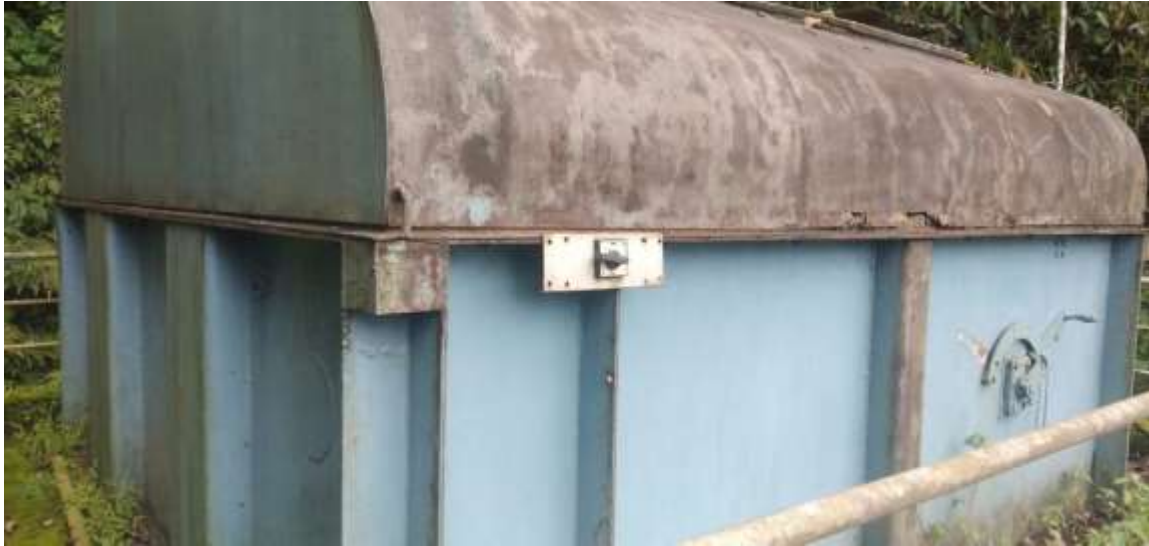
Fig 2.25 Intake gate hoisting structure

Trash rack structure is extended out into the river and from that point of the bell mouth, 28.49 m long, 3.20m dia. steel pipe starts. Beyond that there is 27.43 m long tunnel and there is a transition from tunnel section to rectangular section near the gate for a length of 6.10 m. At this point intake shaft is constructed vertically for a height of 46.63 m with the hoist chamber and control arrangements above it. The hoist is erected on the top slab of the hoist chamber constructed above intake shaft at El. +819.91 m. The hoist chamber is used for the maintenance of intake gate. There is a position indicator fixed to the hoist, which indicates the position of the gate from the sill.

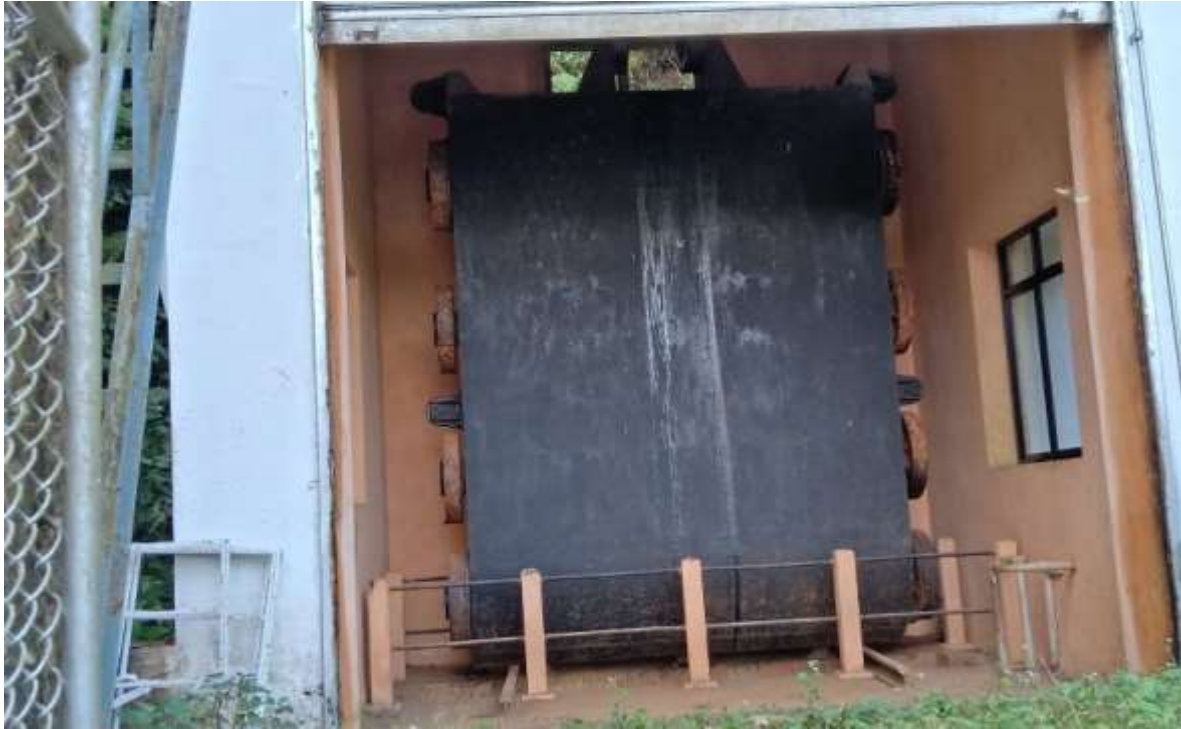
Fig 2.27 Intake Gate

The order for the supply of intake gate and hoist was placed with M/S VOEST, Austria. The size of the gate is 2.87 m (span) x 3.96 m (height) suitable for the opening provided in the structure of size 3.66 m x 2.44 m. The sill level of the gate is +773.32 m and the hoist was erected at +825.70 m. The hoist is operated by an electric motor of 12KW at 725 rpm. Provision is given for operating the hoist manually in case of power failure and safety provisions are made to cut off power supply when manual operation is done. The lifting speed of the gate is 1.52 m per minute when electrically operated and 10.16 cm per minute when manually operated. The lowering speed under emergency which is by gravity is 2.44 m per minute. In emergency lowering the free drop of the gate is being stopped by a brake electrically operated. The gate by means of a gear operates a D.C. generator which produces available current according to speed of the fall and this actuates the brake. The details of intake gate hoist are provided in **Annexure 6**.

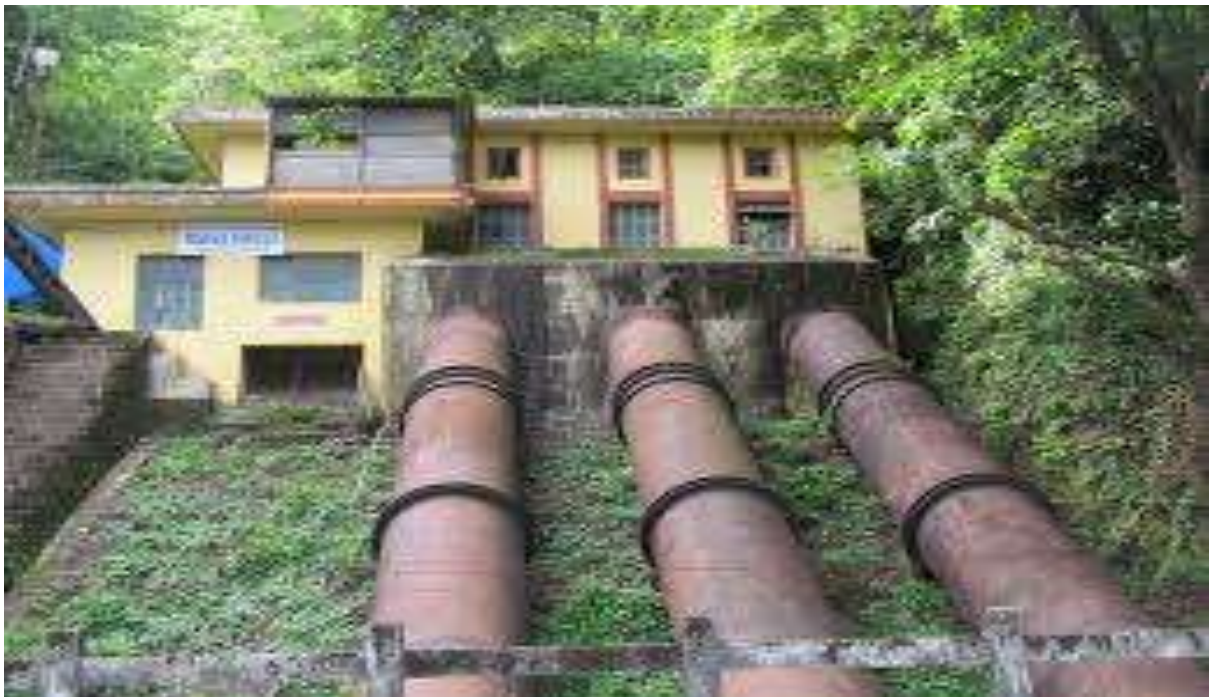
Fig 2.28 Penstock and valve house

The water from the reservoir is diverted to the Power House at Anakayam Valley through the tunnel and through 3 penstocks, each leading the water to one of the turbines in the Power House. The penstocks are running in exposed conditions and are made of steel plates of thickness varying from 10 mm to 32 mm. The internal diameter of the penstocks is 1438 mm at the top, ie. at the point where the penstocks branches from the Trifurcation piece and is 1312 mm dia. at the Power House end. Penstocks supply water under pressure at an average head of 320.04 m and form the link between the fore bay and the Power Station.

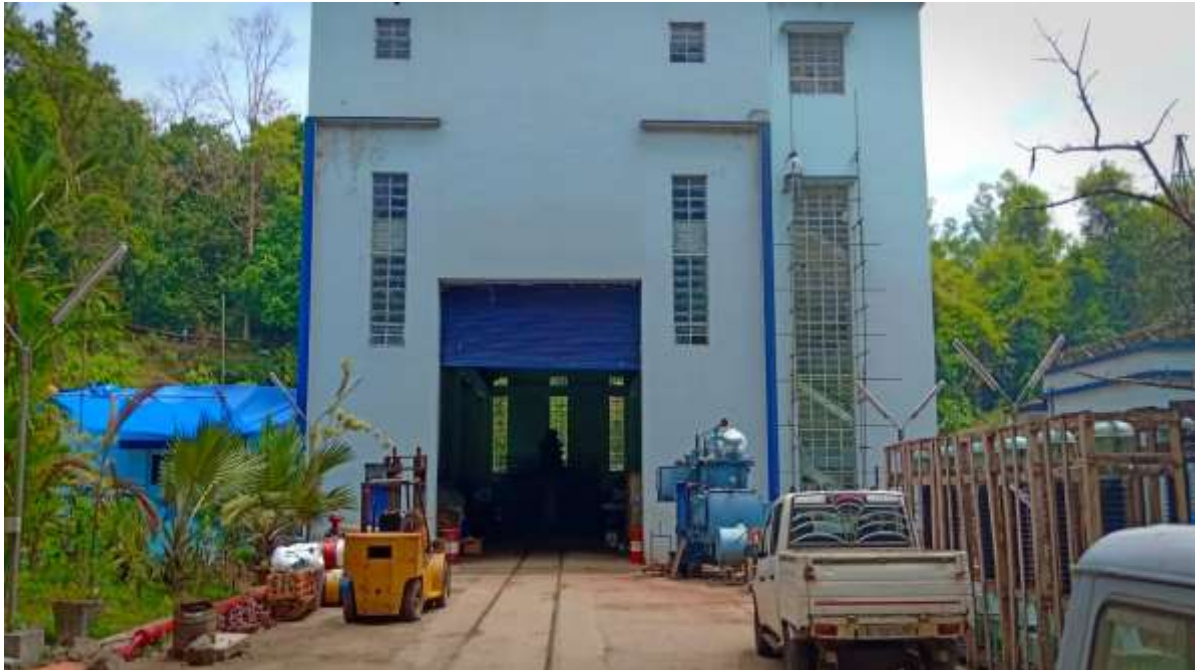
Fig 2.29 Power House

capacity each are installed in the Power House. Size of the Power House is 50.29 m x 14.02 m x 16.76 m. The maximum head on turbines is 339.24 m.

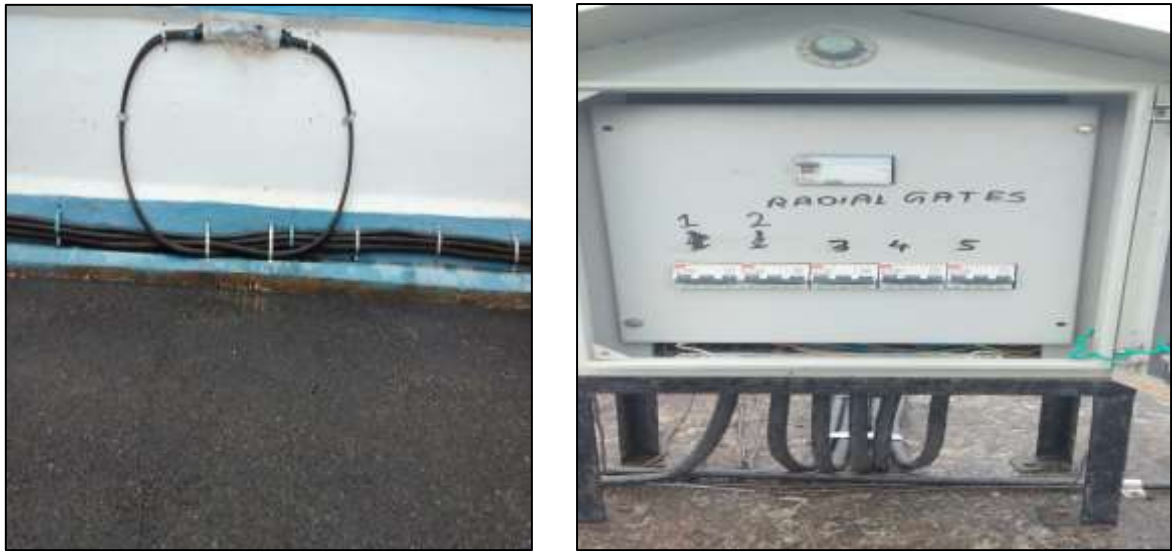
Fig 6.5 UG cabling systems

17. Providing UG cabling systems including fixing of generator, switchboard, distribution board etc. at Sholayar dam and premises.
18. Supply and commissioning of high mast light with cost effective lightening system with accessories at Sholayar main dam.

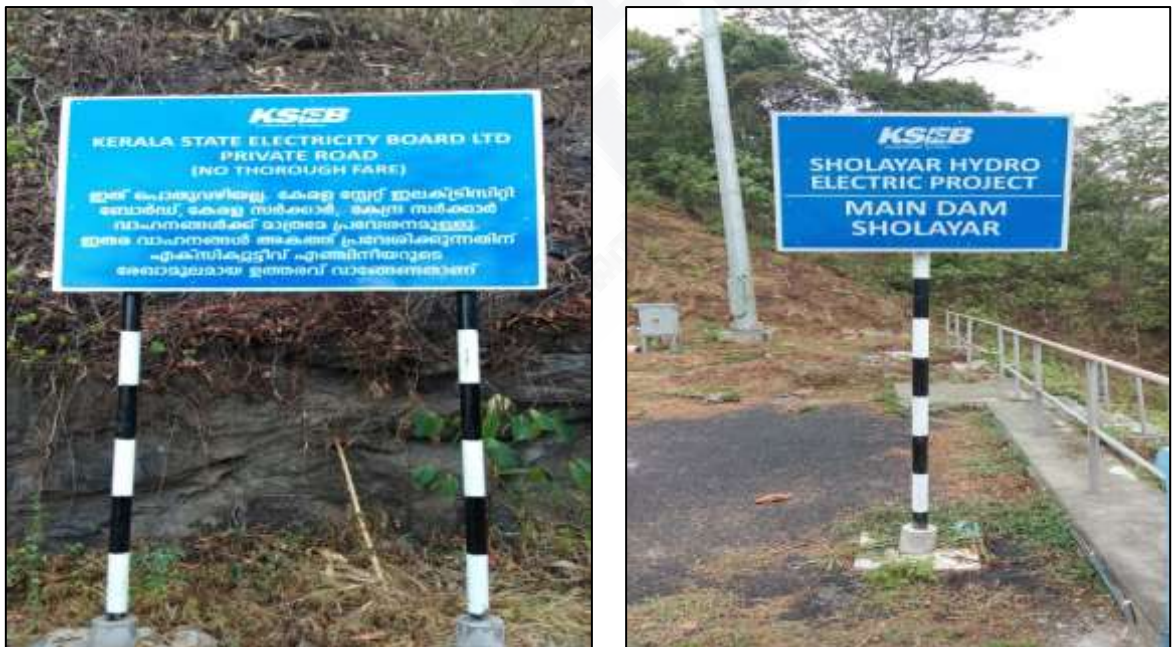
Fig 6.6 Retro reflective sign boards

19. Supply and commissioning of high mast light with cost effective lightening system with accessories at Sholayar flanking dam.
20. Reaming the existing drain holes at Sholayar Main dam & Flanking dam.
21. Supply of speed boat at Sholayar dam.
22. Providing and fixing retro reflective sign boards.

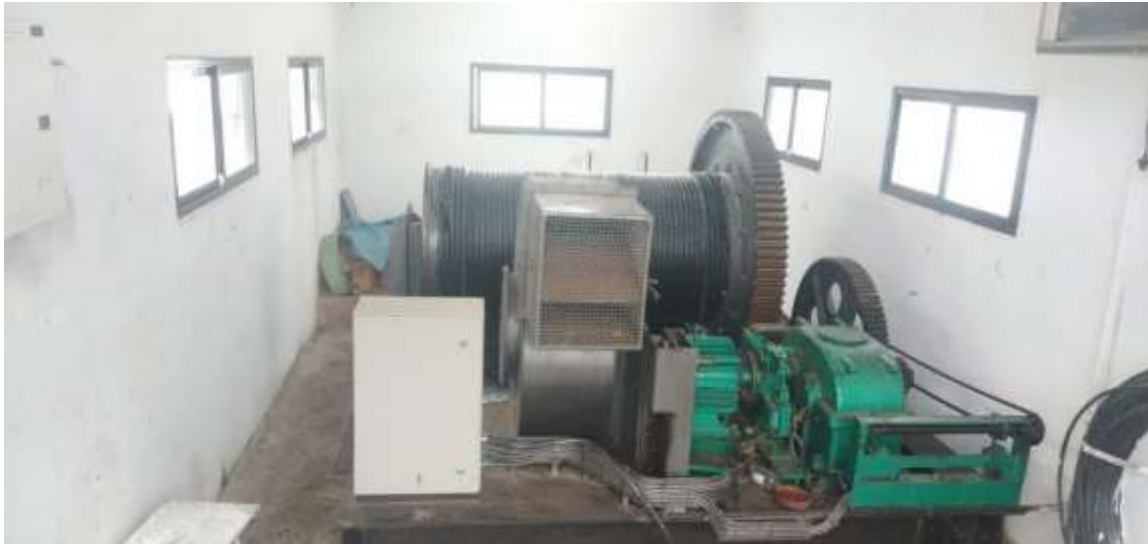
Fig 1 Emergency gate hoisting mechanism

- a) Designation : Emergency Gate.
- b) Code/standards : IS 4622 – 1992.
- c) Type : Vertical lift
- d) Quantity : 1 No
- e) Gate size (width x height) : 3100 mm X 1630 mm
- f) Mode of operation : Rope drum hoist Mechanism.
- g) Vertical travel : 46 mtr.
