**Operation and Maintenance
Manual for IDAMALAYAR Dam
State of Kerala**

**Doc. No. DSO_O&M_IDAMALAYAR_DAM
KSEBL_01_v1.0**

Dam Rehabilitation & Improvement Project

**Chief Engineer
(Civil- DRIP & Dam Safety)
Kerala State Electricity Board**

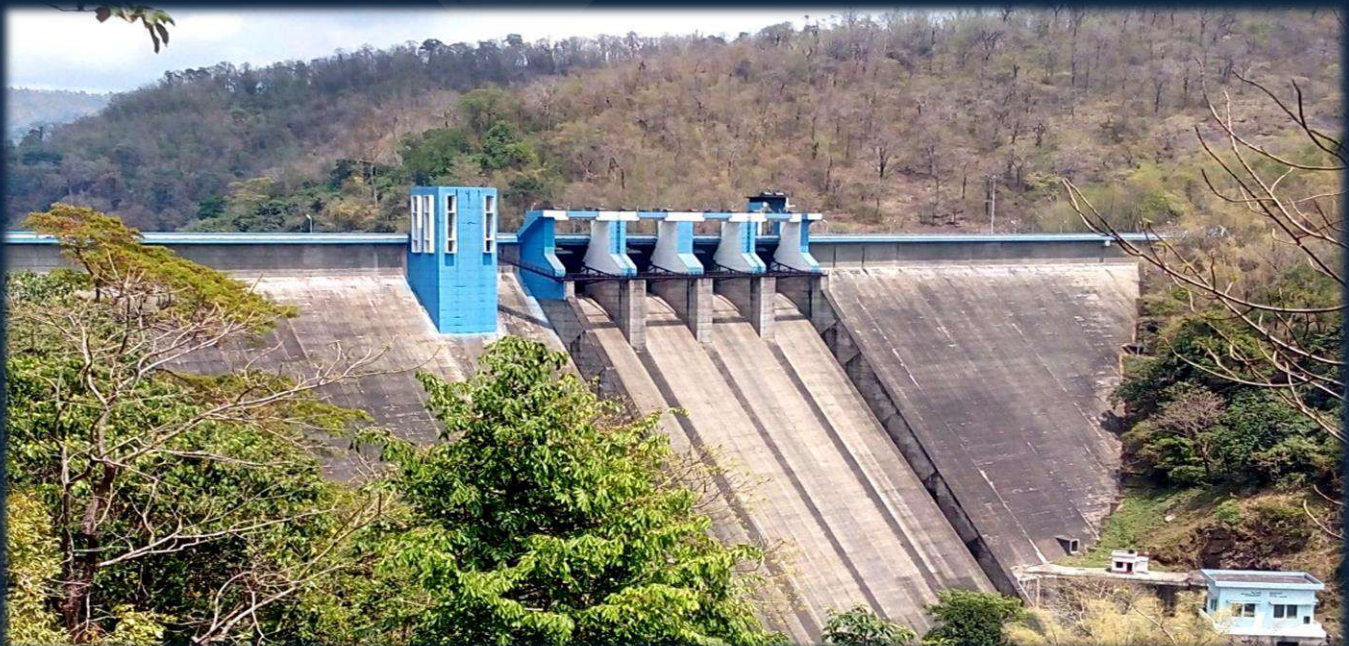
Front Cover Photograph: Downstream and Upstream view of Idamalayar dam

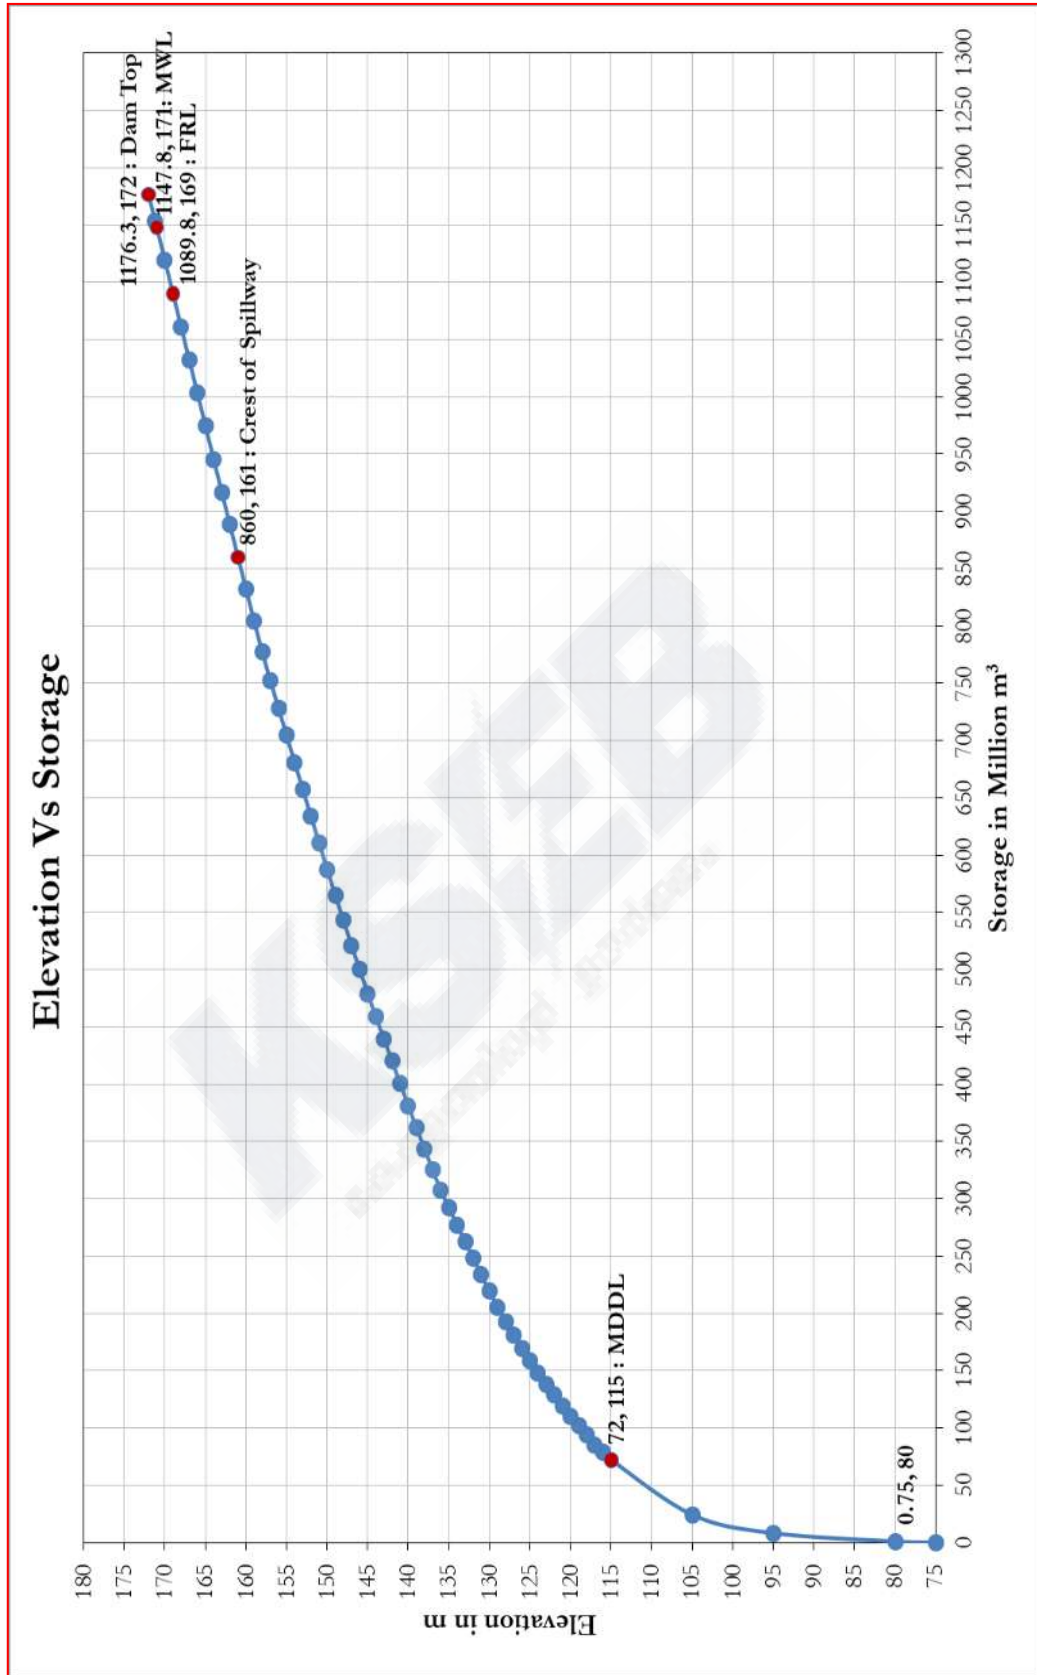
Fig 2.1 Elevation - Capacity Curve

The elevation storage curves for Idamalayar Dam in tabular and graphical form are shown in **Fig 2.1** and **Table 2.1**.

465.88	142	419.9	
469.16	143	439.25	
472.44	144	458.6	
475.72	145	479	
479	146	500	
482.28	147	521	
485.56	148	543	
488.85	149	564.67	
492.13	150	587.34	
495.41	151	610.5	
498.69	152	633.66	
501.97	153	656.82	
505.25	154	680.48	
508.53	155	704.24	
511.81	156	728	
515.09	157	752	
518.37	158	777	
521.65	159	804	
524.93	160	832	
528.22	161	860	Spillway Crest Level
531.5	162	888.3	
534.78	163	916.8	
538.06	164	945.5	
541.34	165	974.3	
544.62	166	1003.1	
547.9	167	1031.9	
551.18	168	1060.8	
554.46	169	1089.8	Full Reservoir Level
557.74	170	1118.8	
561.02	171	1147.8	Maximum Water Level
561.68	171.2	1153	
564.3	172	1176.3	Dam Top Level

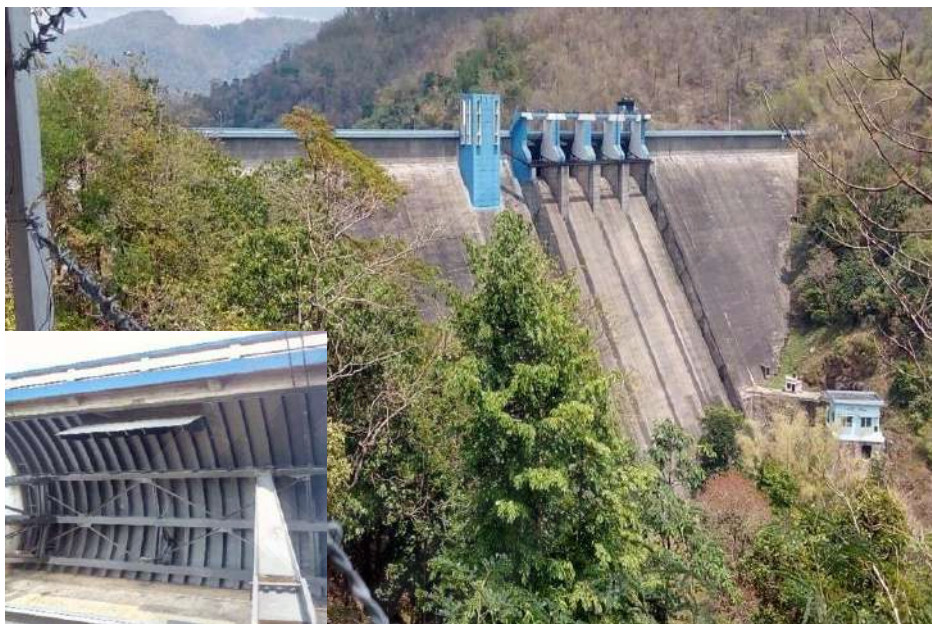
Fig 2.2 Idamalayar Spillway

The spillway of Idamalayar dam (**Fig 2.2**) has four numbers of radial gates. The spillway consists of four spans of 11.5 m clear, with two single piers 1.75 m thick each and three double piers of thickness 3.5 m each. The single piers extend as guide walls throughout the spillway and as training walls below that up to Ch. 105.05 m downstream. The elevation of the crest of the spillway is 161 m and the FRL is 169 m, i.e. 8 m above the crest. The extra height of 0.5 m to

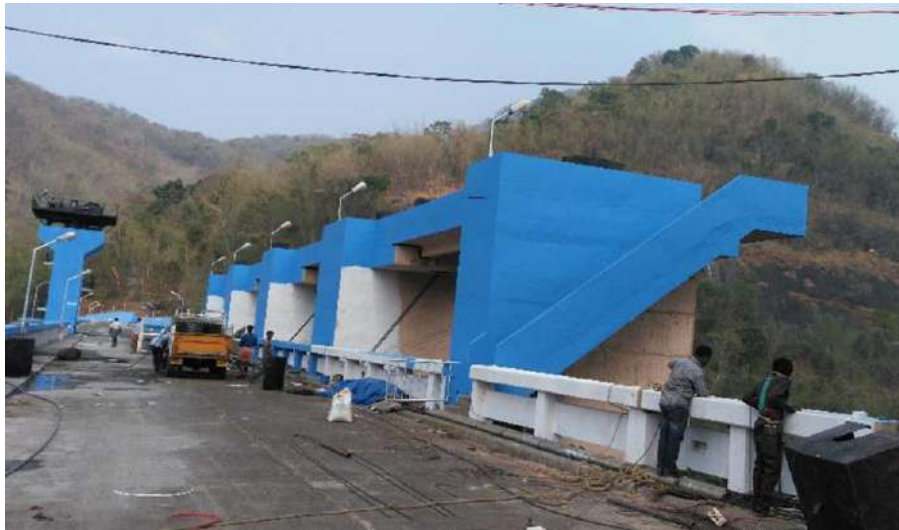
Fig 2.3 Radial Gates Hoist Bridge

The main component of hoisting system (rope drum hoists) for operation of the crest gates of Idamalayar Dam spillway is mounted on the spillway hoist bridge downstream side (**Fig 2.3**). The spillway is provided with radial gates of size 11.5 m x 9.7 m which can be operated both by power and by manually. The gate operation platform is at an elevation of +174 m leaving a clearance of over 2 m above the gate in the lifted position. The gates are operated and tested in every season when the water is below the crest level. Periodical maintenance like painting, greasing, oiling etc. is done from time to time.

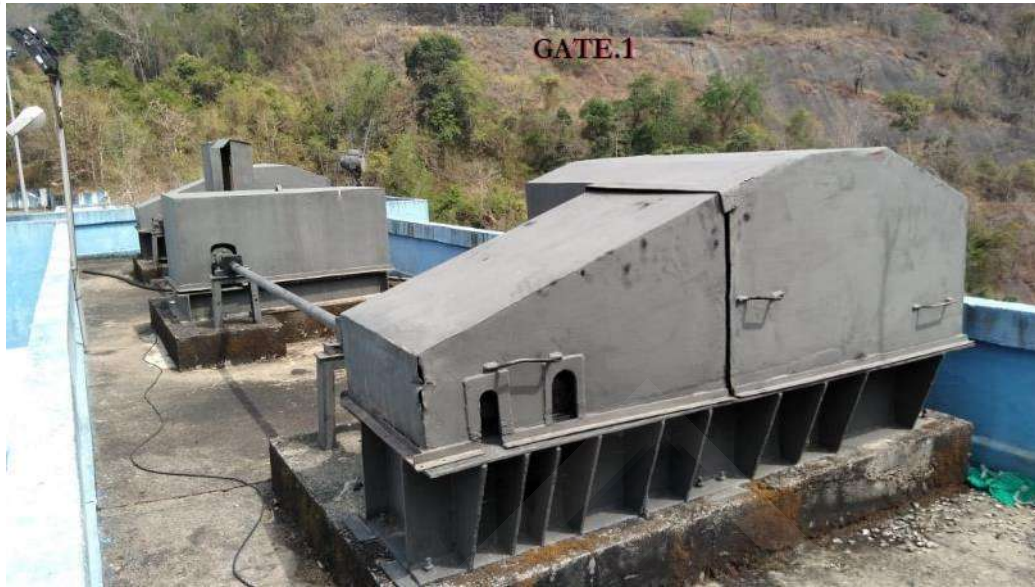
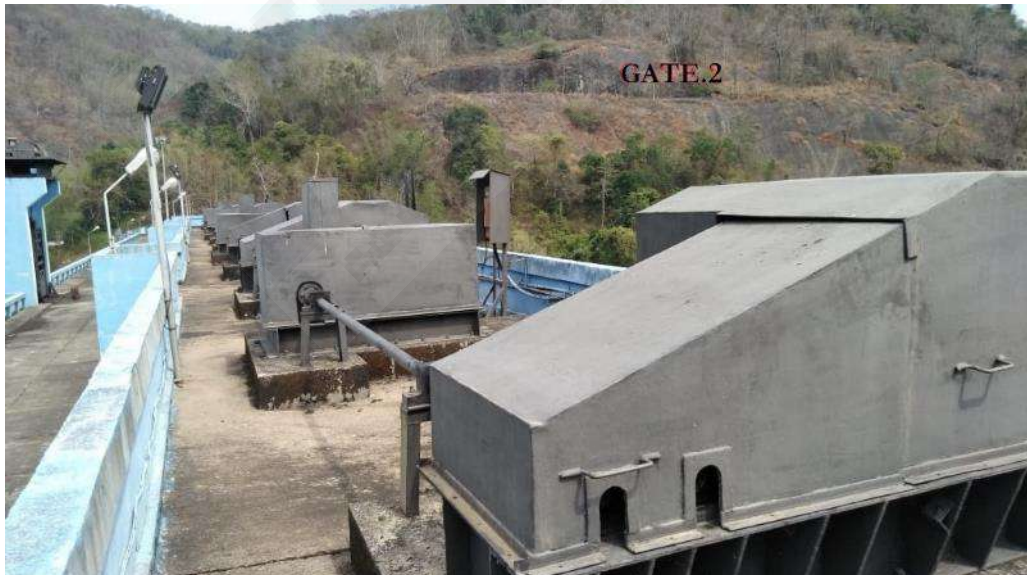
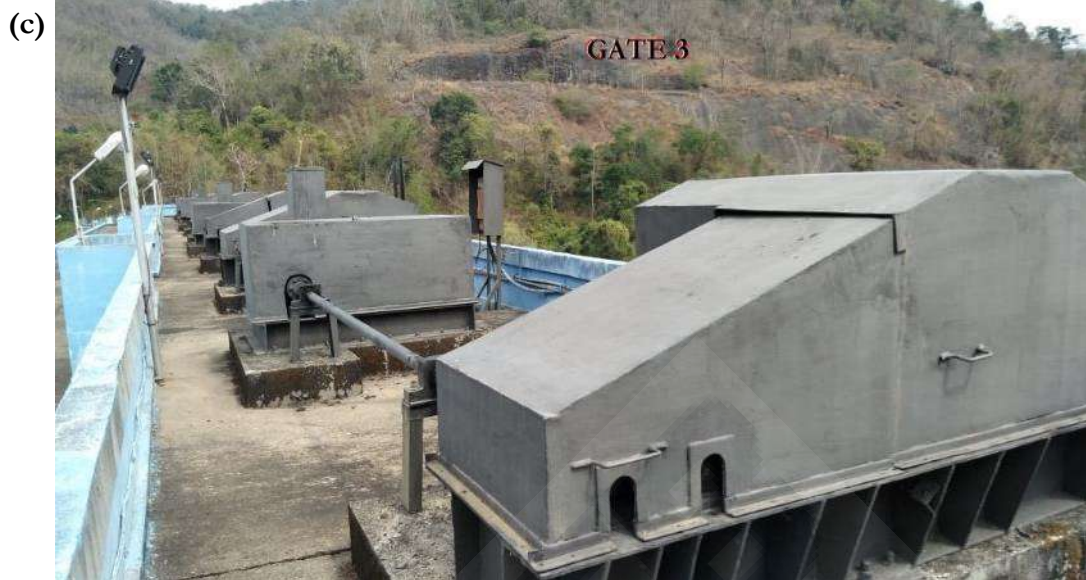
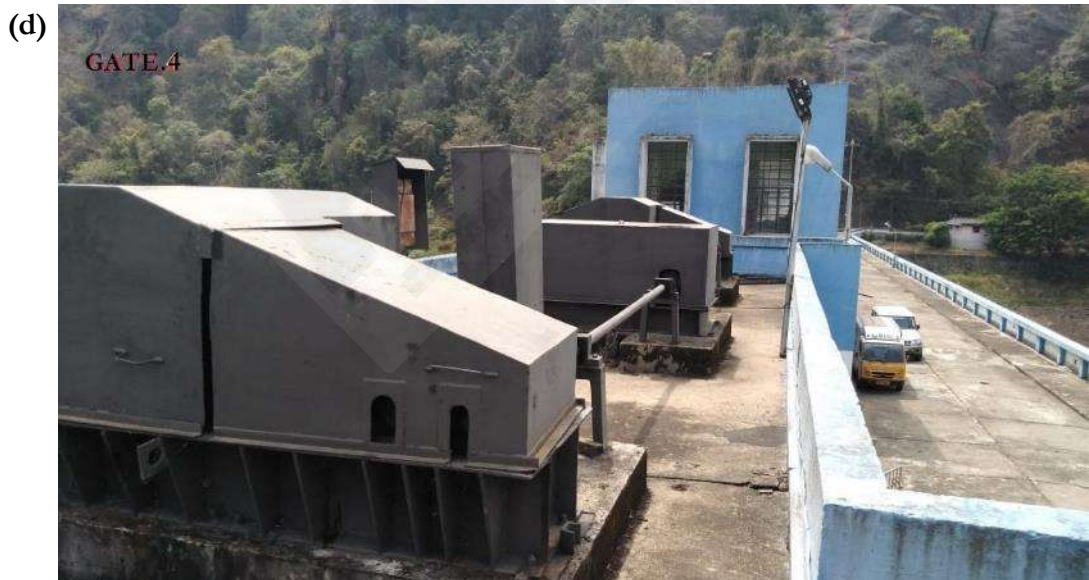
Fig 2.5 Radial Gates Hoist Mechanism (a, b, c, d)

Individual gate hoisting is given in **Fig 2.5a, Fig 2.5b, Fig 2.5c & Fig 2.5d**. The control panel arrangement of all the four radial gates and intake gate are as in **Fig 2.6**.

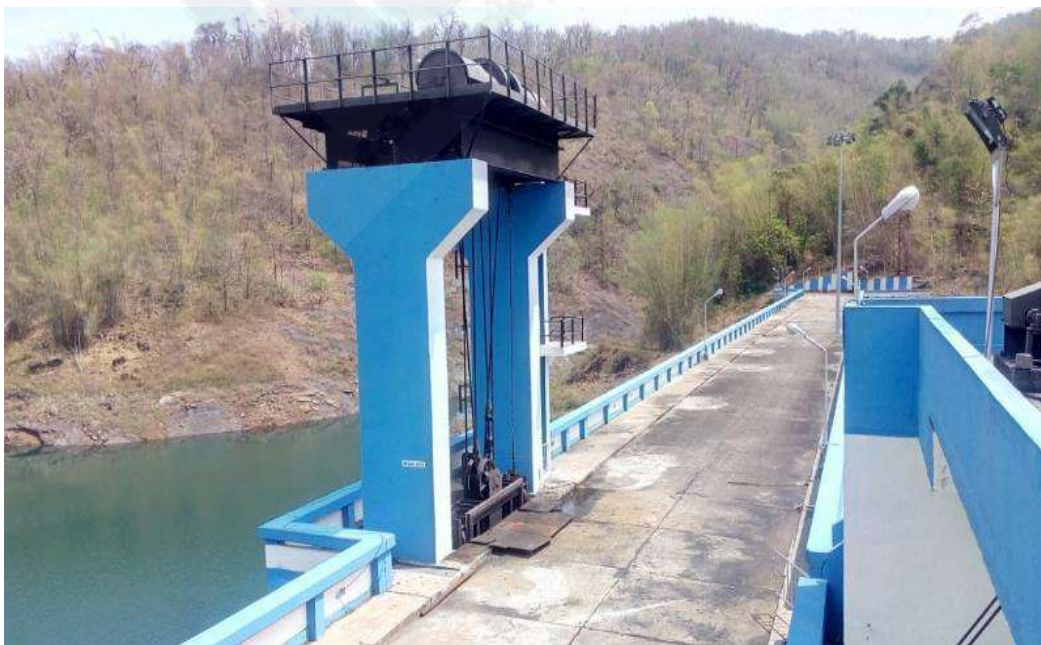
Fig 2.10 Idamalayar Dam Vertical Gate

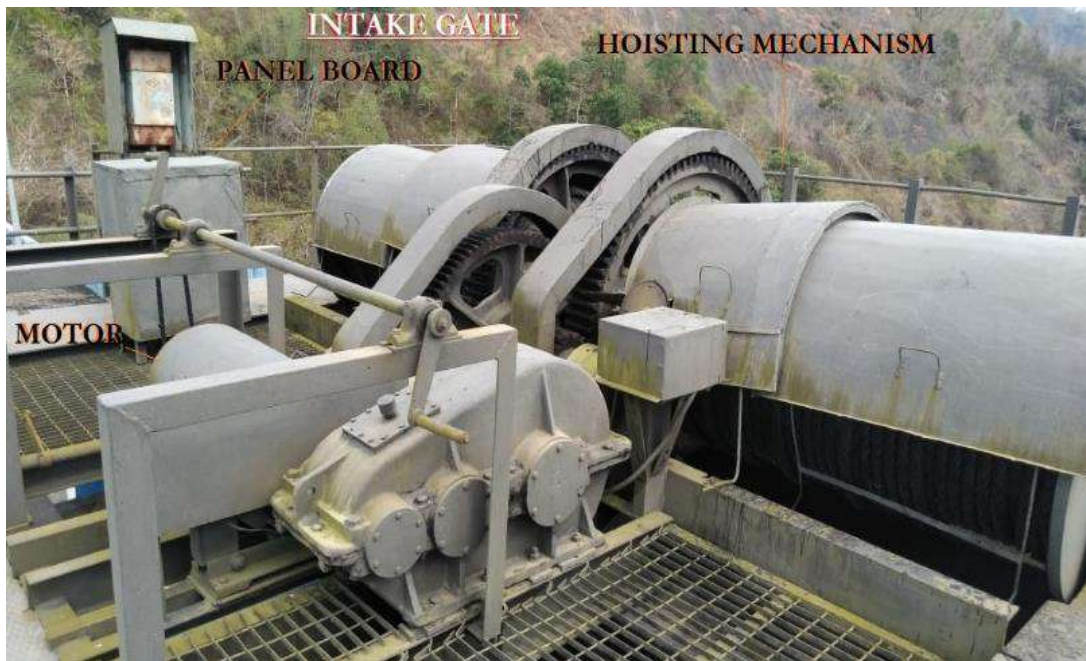
Fig 2.11 Idamalayar Dam Intake Gate Hoist Mechanism

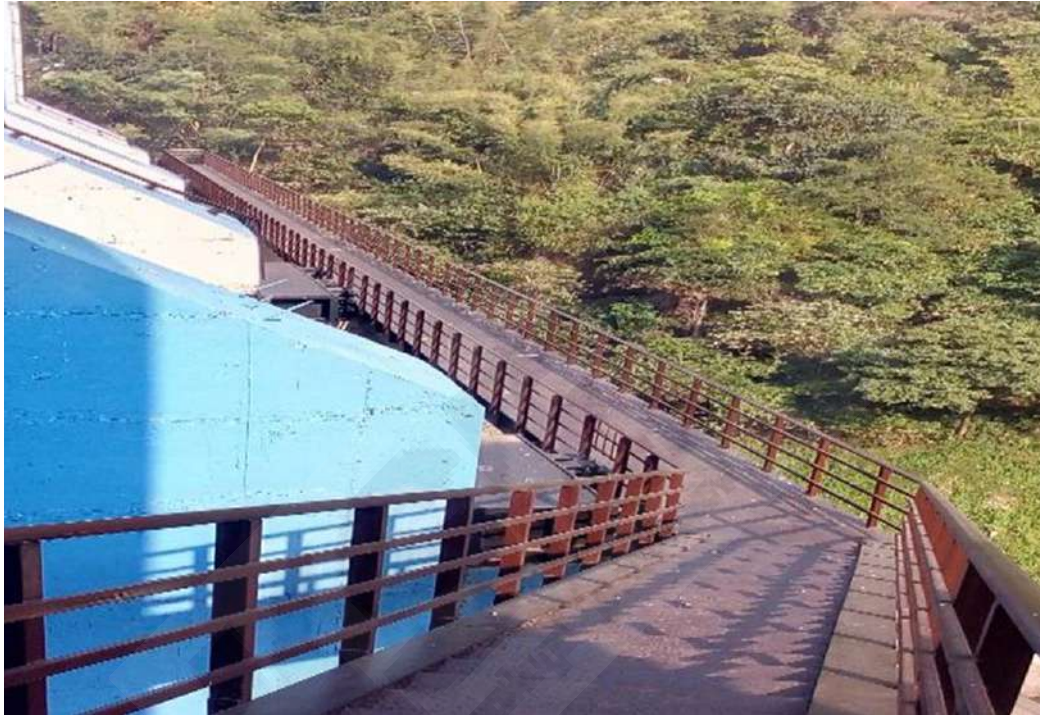
Fig 6.2 Catwalk connecting Radial gate trunnions

There was no access to spillway gates trunnion for inspection, maintenance and repairs. A steel catwalk bride is provided in 2017 under DRIP. See **Fig 6.2**.
