Operation and Maintenance Manual for IDUKKI, CHERUTHONI & KULAMAVU DAMS

Doc. No. DSO_O&M_ Idukki, Cheruthoni & Kulamavu Dams
KSEBL_09_v1.0

Operation and Maintenance Manual
Of
Idukki, Cheruthoni & Kulamavu Dams

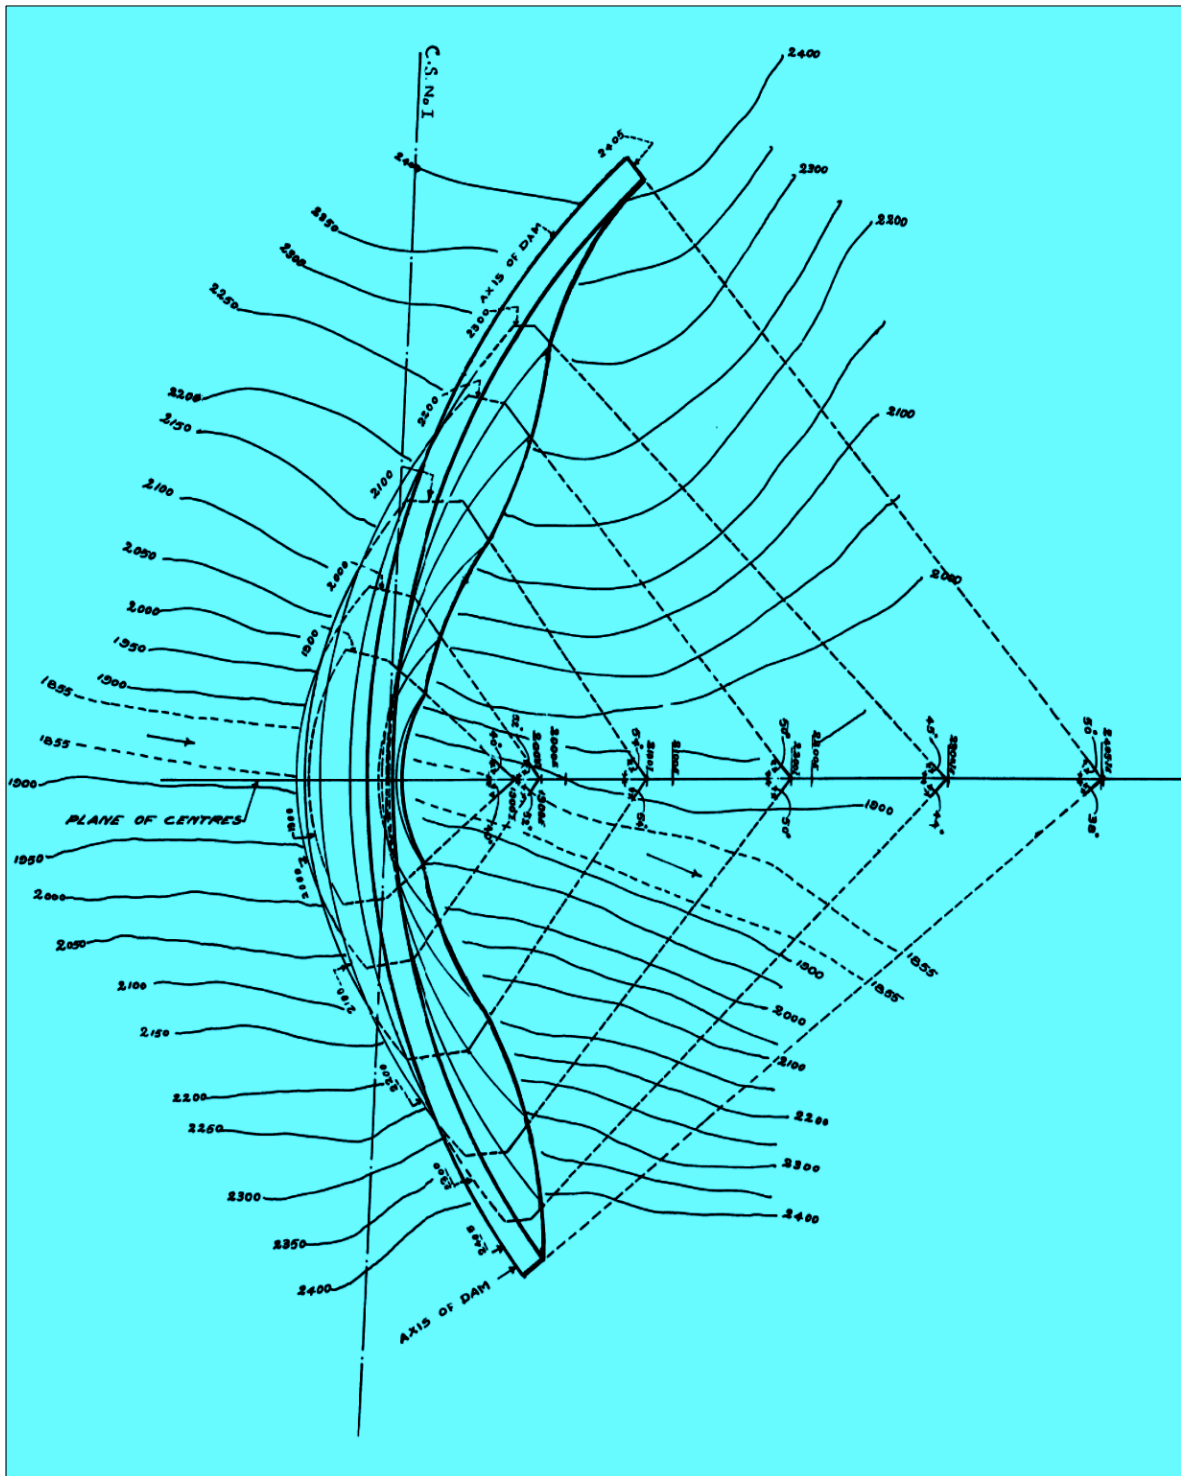
Fig 1.7a Geometric Definition of Idukki Arch Dam

The geometric definition, plan and cross section of Idukki Arch Dam are given in **Fig 1.7a & Fig 1.7b, Fig 1.8 & Fig 1.9**. Google view of the dam is given in **Fig 1.10**. The photographs of Idukki dam from upstream and downstream sides are given in **Fig 1.11a & Fig 1.11b**. The photographs of Idukki dam downstream bottom from central block-01 and downstream view of left & right banks from dam top are given in **Fig 1.12a and Fig 1.12b**.

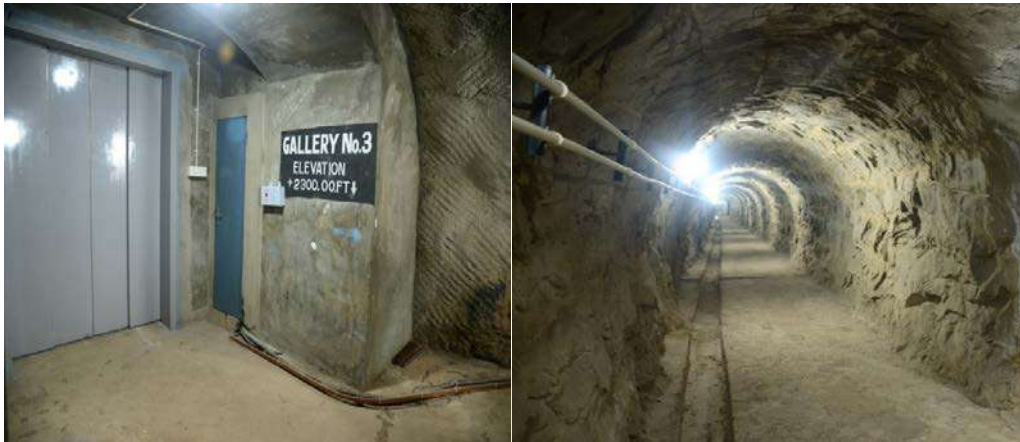
Fig 1.14a Inspection gallery at El. 2300'

Photographs showing inspection gallery at El. 2300’ & at El.2100’ and foundation gallery at El.1900’ are given in **Fig 1.14a**, **Fig 1.14b** and **Fig 1.14c**. In addition to the horizontal galleries, the dam comprises one bottom gallery which traverses the dam periphery near the rock abutments and merges with the 1900’ gallery. Stairway landings are provided for every 50’ increment in elevation. Also, a vertical 8’ shaft is incorporated in the lower left abutment. Each horizontal gallery is formed of a series of straight sections along the curvature of the dam each of which traverses one block of the dam. The gallery extensions, into the rock abutments, are also straight, except for the left and right abutment bottom galleries at elevation 1900’ which extend into the rock with one change in direction. A distance of 50’ in each rock gallery measured from the rock concrete interface into the rock mass is concrete

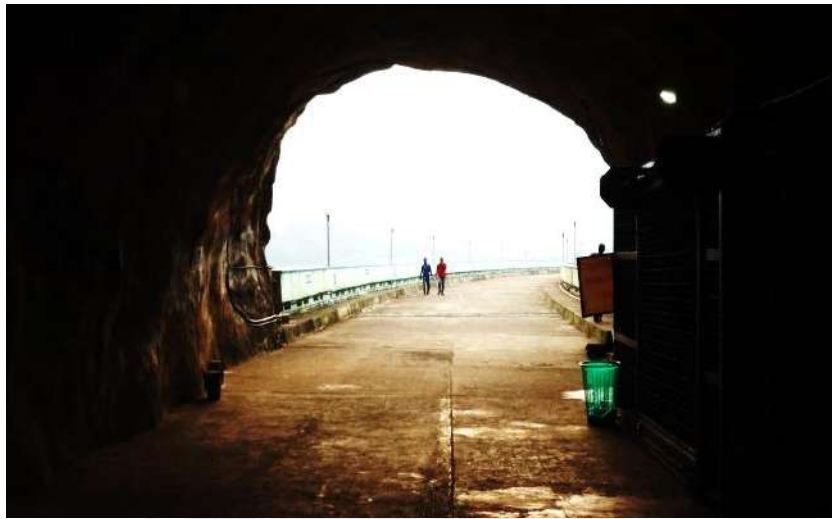
Fig 1.15a View of Idukki dam from road tunnel at right bank

The road tunnel on the right bank at El. 2415 was driven 390 ft through massive charnockite. The crown was reinforced with rock-bolts, wire-mesh and guniting. Photographs showing the view of Idukki dam through road tunnel at right bank and entrance tunnel at right bank are given in **Fig 1.15a** and **Fig 1.15b**.

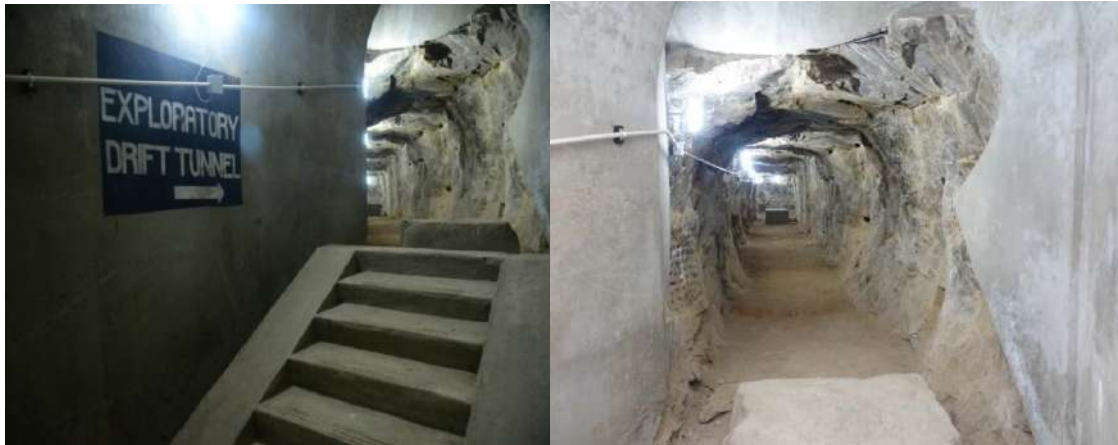
Fig 1.16 Exploratory drift tunnel at El.1925 Right bank

and is now serving as a drainage gallery. Incorporated in the design of foundation drainage are Six Nos (6 ft x 8.5 ft) rock galleries totaling 1664 ft. Instruments to monitor the vertical and horizontal movements of the dam have been placed in all these galleries. **Fig 1.16** shows exploratory drift tunnel at El.1925 (right bank).

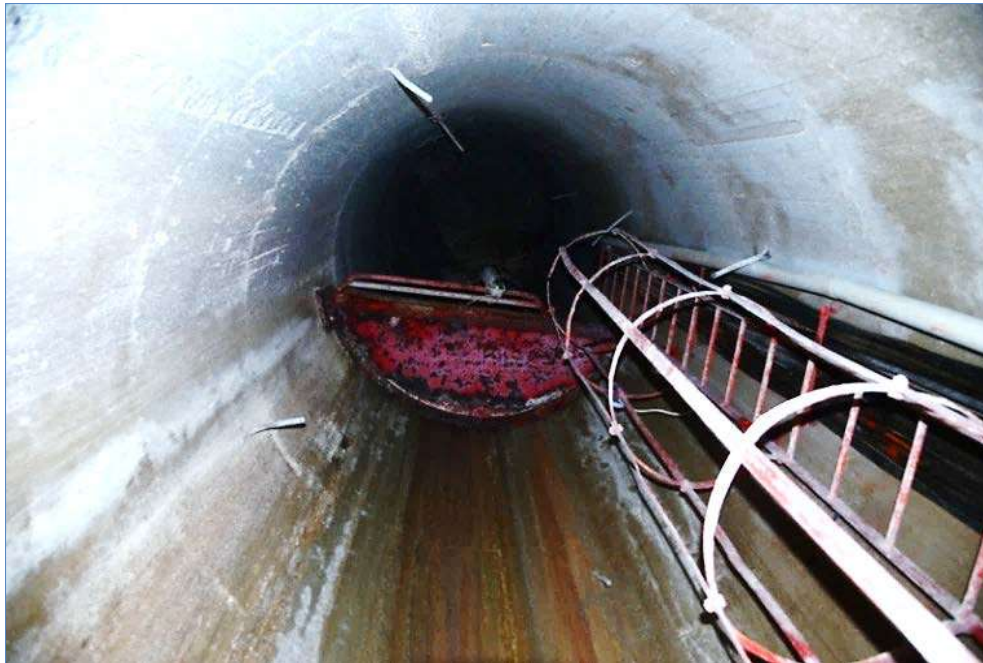
Fig 1.18a Vertical shaft at right bank

The elevator shaft (**Fig 1.18a**) is vertical, 13 ft circular and 550 ft deep. It is situated on the right bank and opens into the road tunnel. Its purpose is to connect the three rock drainage galleries from the exterior with a modern elevator.

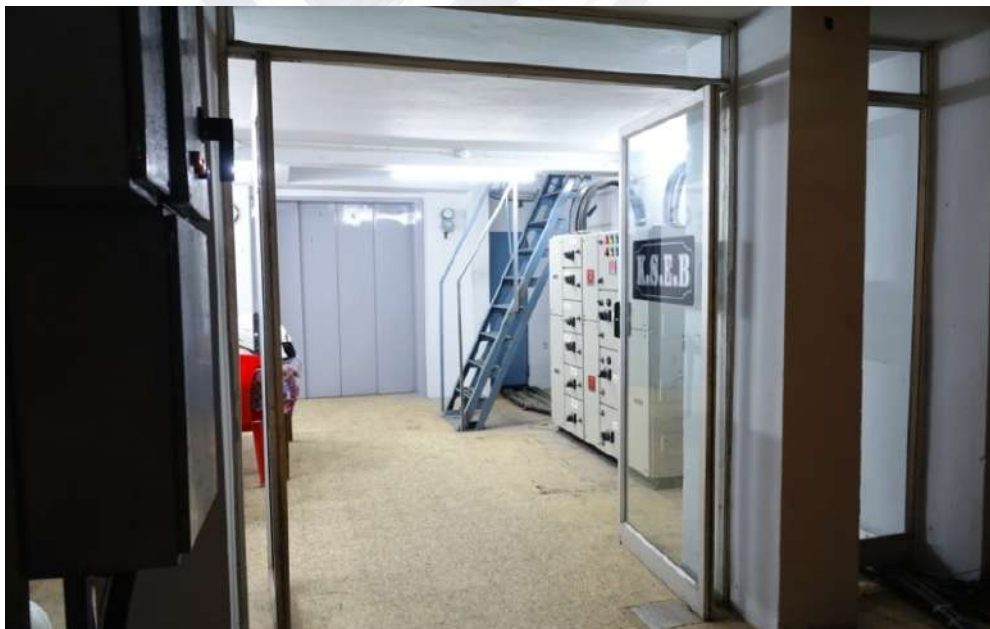
Fig 1.18b View of lift entrance and electrical panel board

The rated capacity of the passenger freight elevator to be installed is 2268 kg. Its travel speed is 30 metres per minute with a constant potential at the controller of 400 volts 3 phase 50 cycles A.C. The size of platform is 2200 mm wide and 2100 mm deep (outside dimensions). The car will travel from El.1905' to El. 2417' (ie. about 156 m) stopping at four floors and serving four openings located on the same side. The elevator is installed in a shaft driven in rock in the right abutment. Photograph showing lift entrance and electrical panel board is given in **Fig 1.18b**.

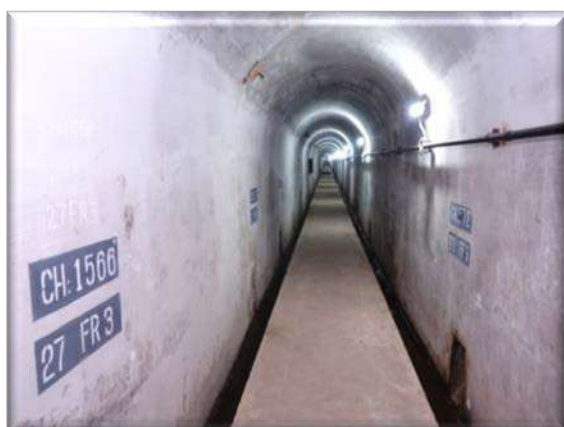
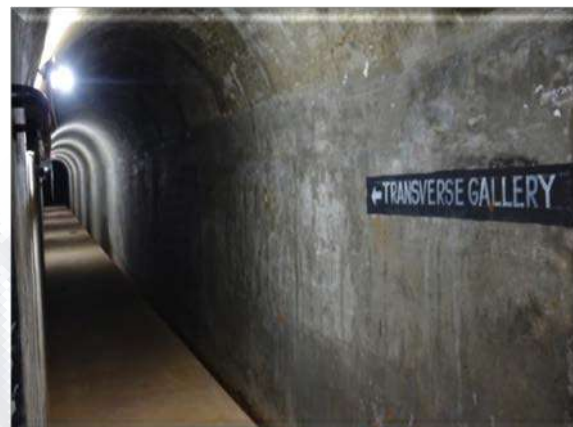
Fig 1.22a Inspection gallery - Cheruthoni dam **Fig 1.22b Transverse gallery**

Likewise, the dam foundation contains a system of drain holes to drain foundation and grout holes for consolidating the foundation and to make a grouted cut off curtain beneath the foundation. For the purpose of monitoring the performance of this combined drainage system, to drill and grout the foundation if necessary at a future date, to give access to the outlets, to aid inspection of the dam structure. The dam and its abutments incorporate a system of galleries 6' x 8' size. Five of these galleries traverse the dam horizontally (longitudinally) from one abutment to the other at Elevations 2000 ft, 2004 ft, 2092 ft, 2173 ft, and 2291.5 ft. The gallery at Elevation 2004 ft is located 190 ft downstream of the axis of dam. The one at Elevation 2291.5 ft is at 15'6" and others at 18' 6" from the axis of the dam. There is also a transverse horizontal gallery in block 28 at El. 2070 ft. **Fig 1.22a** and **1.22b** shows inspection gallery and transverse gallery of Cheruthoni dam respectively. The elevation along the centerline of galleries is given in **Drg 1.10** of **Annexure 1**.

Five rock galleries driven for foundation exploration, treatment of abutments and drainage abutments are also connected to this gallery system. The rock galleries at right bank are 660 ft long and at left bank 1050 ft long. The galleries have access by an elevator provided in block 26 and through a number of Adits from the downstream face of the dam near both abutments. These Adits can be reached by a system of roads and footsteps. The downstream elevation, typical section of elevator shaft & inspection gallery is given in **Drng 1.11** of **Annexure 1**.

In addition to the horizontal galleries the dam has one bottom gallery also which traverses the dam periphery near the rock abutments and merges with the gallery at El. 2000 ft. A similar system is provided for the longitudinal gallery at El. 2004 ft. Stairways and landings are provided in this bottom gallery. The rock galleries are concrete lined, and have a finished section of 6 ft x 8 ft.

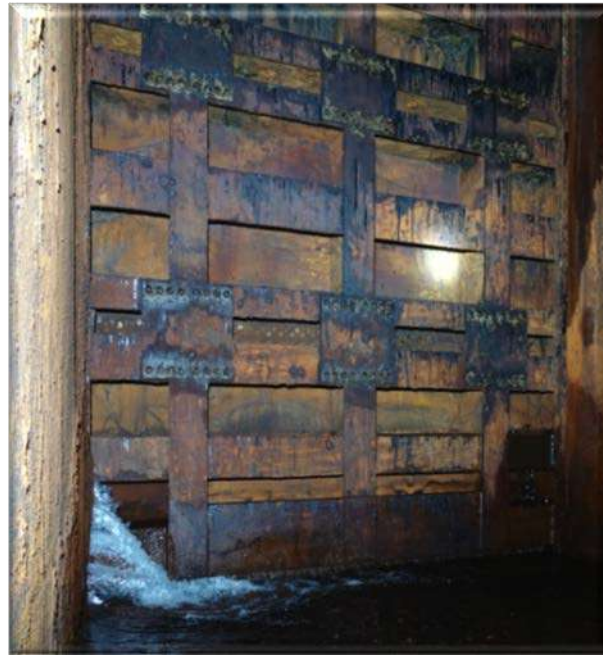
Fig1.23 Sluice gate downstream side view from manhole

Fig 1.23 shows downstream side view of sluice gate from manhole. The downstream view of sluice opening from inside of outlet is given in **Fig 1.24**.

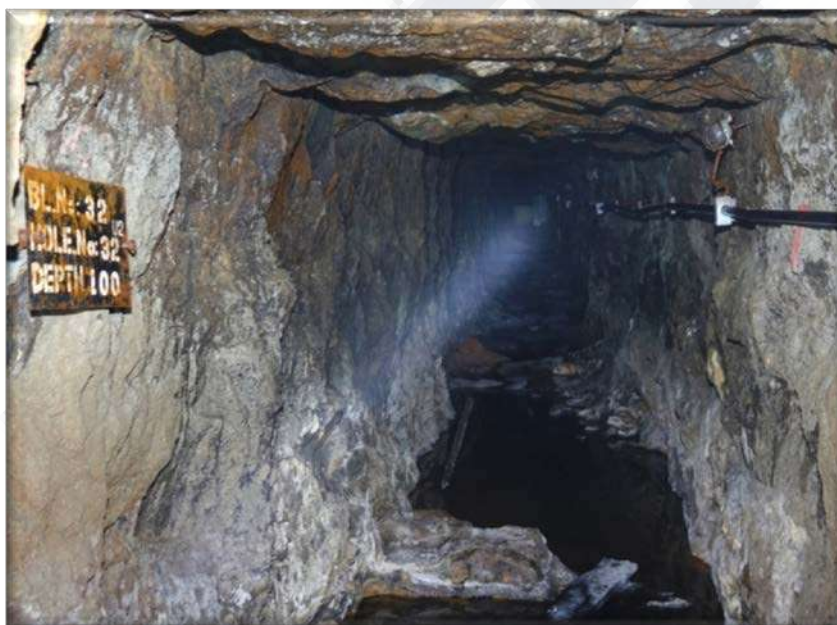
Fig 1.25 View of Drift tunnel at Cheruthoni dam

Two exploratory rock drifts (**Fig 1.25**) were driven at El. 2026' at left bank and El. 2026' at right bank. The left bank drift projected into the reservoir for some length. A 65 ft long section of this tunnel is plugged with concrete. The right bank drift has a branch at Ch. 1602.66 and because this branch traversed a fault, a concrete plug has been provided between Chainages 1635 and 1668.18. Three more rock drifts were driven on the abutments and have been joined to the gallery system. Two drifts are in the left bank at El. 2121' and 2213' and one at El. 2131' on right bank. The total length of all these rock drifts is 1700'.

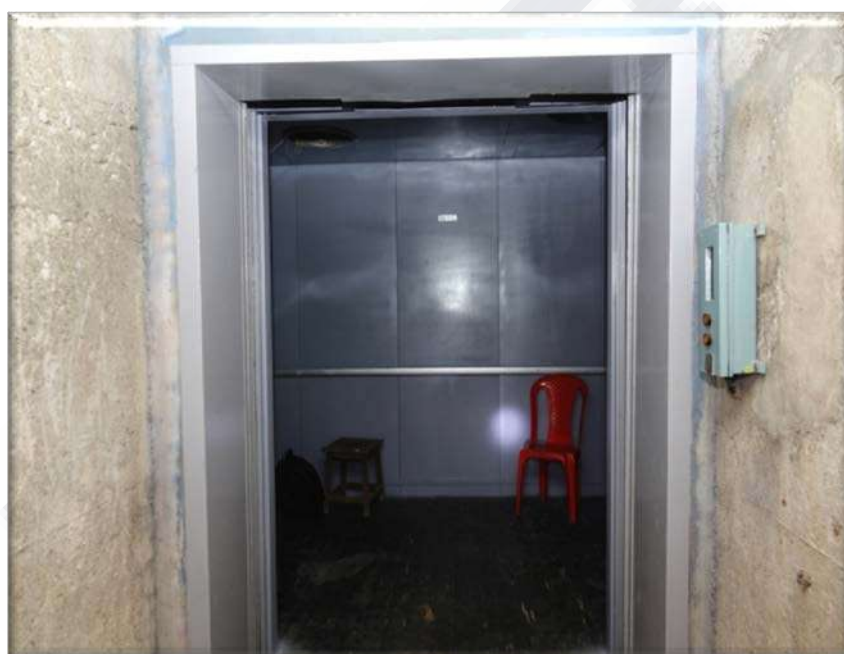
Fig 1.26 Elevator at Cheruthoni dam

One passenger cum freight elevator of platform size 3650 mm wide x 2500 mm deep (outside dimensions) is installed in block 26. The car to travel from El. 2066 ft to El. 2415.62 ft i.e. about 107 meters stopping at six floors and serving six openings located on the same side. The elevator's rated capacity is 3628 kg and its travel speed is 30 m/minute with a constant potential at the controller of 400 volts, 9 phases, 50 cycles A.C. Photograph of elevator at Cheruthoni dam is shown in **Fig 1.26**.

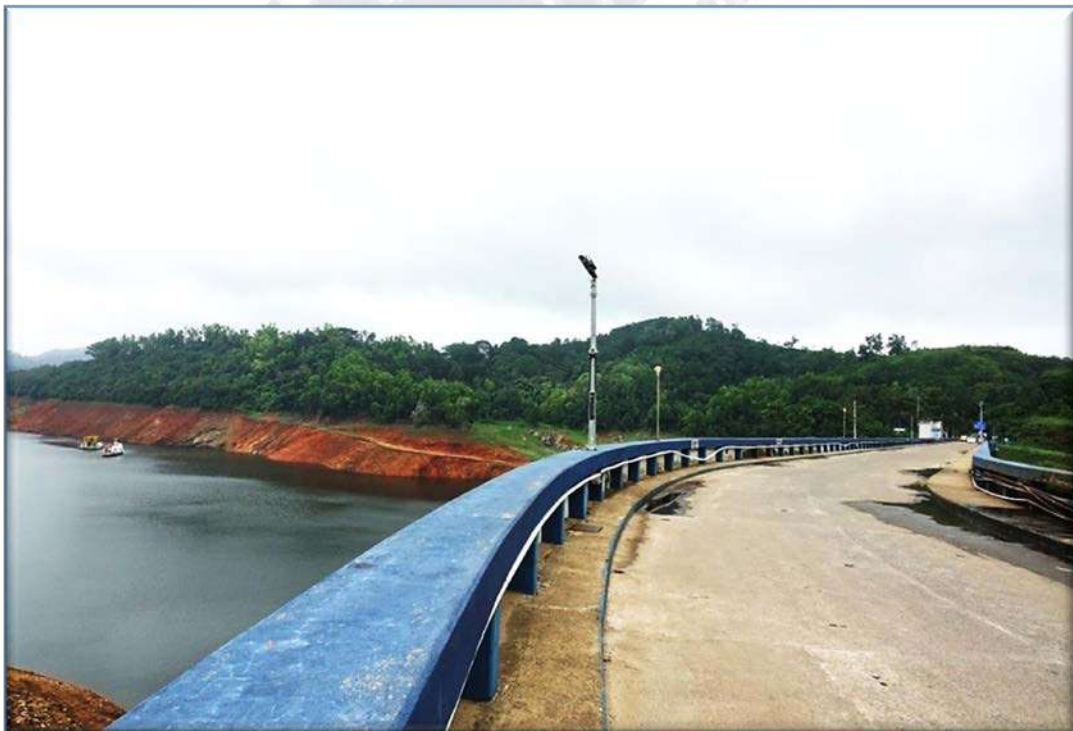
Fig 1.29 Kulamavu Dam Top view

A Google view of the Kulamavu dam is shown below in **Fig 1.28**. The dam top and downstream view of Kulamavu dam are given in **Fig 1.29** and **Fig 1.30**.

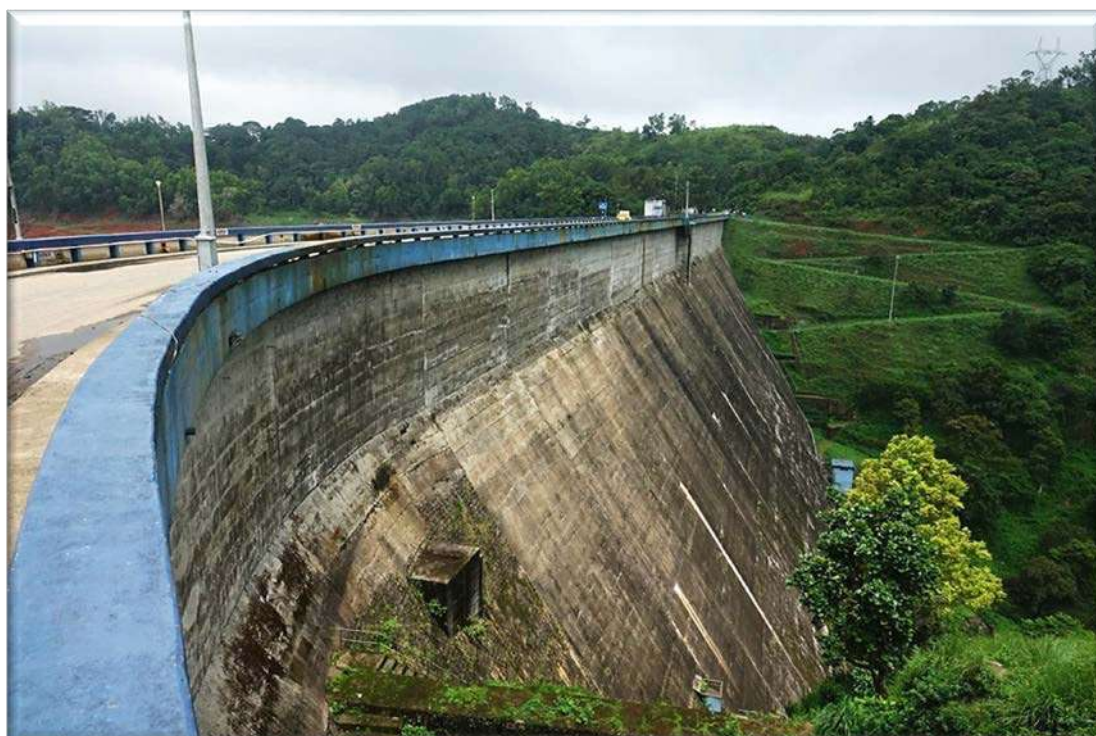
Fig 1.30 Kulamavu Dam Downstream view

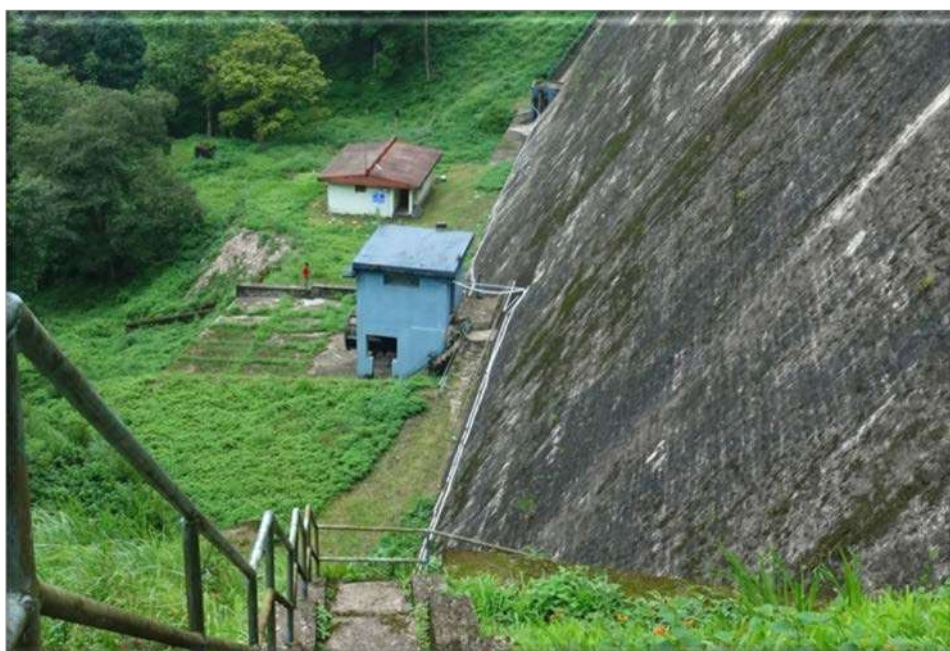
Fig 1.31 Disperser Valve House

A 6 ft diameter outlet, controlled by an upstream emergency gate and a downstream hollow jet valve has been installed in block No. 7 of Kulamavu dam. The central line of the outlet is at level +22010.00'. The emergency gate has a hoist structure on top of dam. Hollow jet valve is approachable on the downstream by a catwalk. The emergency outlet enables lowering the reservoir water level below the Intake level of the power tunnel in case of such necessity would arise. The outlet is lined with thick steel lining for the full length. An upstream bell mouth is provided. Photograph of disperser valve house at the downstream side of Kulamavu dam is shown below in **Fig 1.31**.

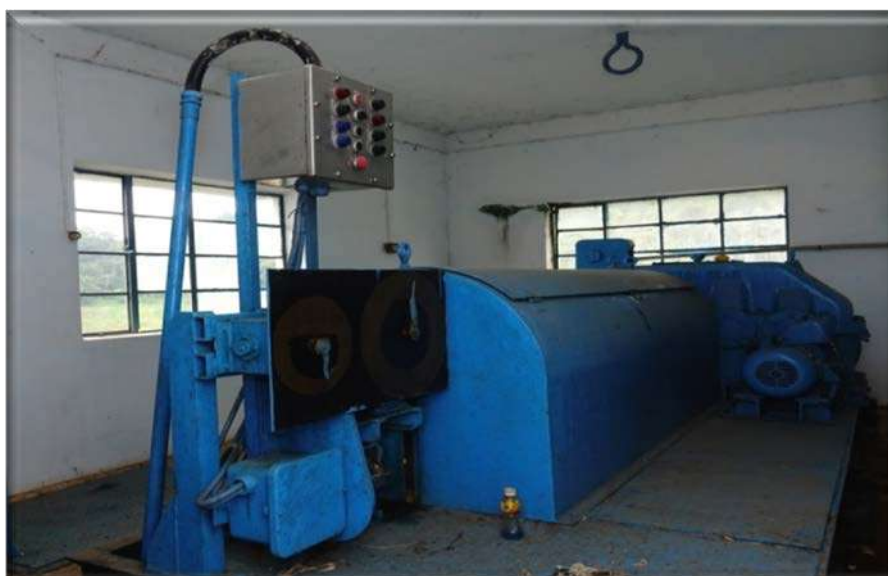
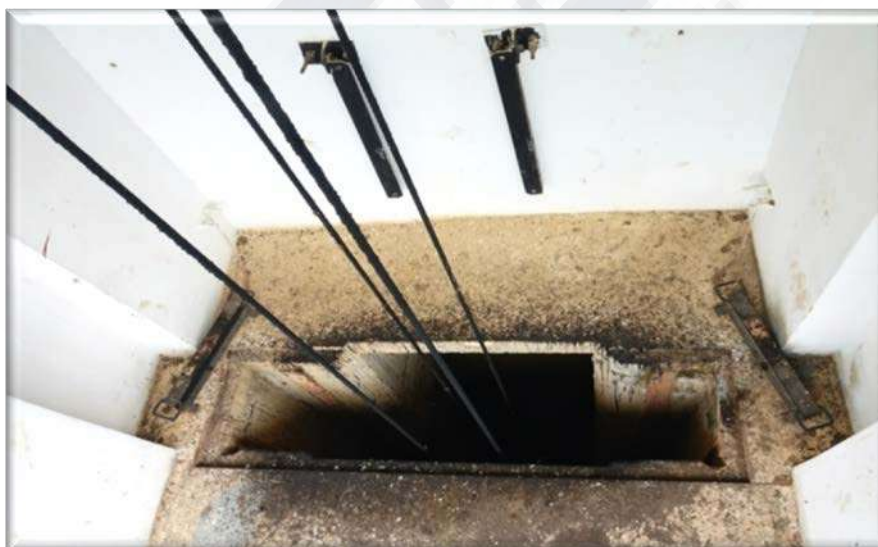
Fig 1.33 Emergency gate hoist

the discharge works for inspection, maintenance and repairs. Opening of this gate subsequent to a closure is to be done only under balanced pressure conditions. Therefore, prior to opening it completely, the gate is cracked open from 6 to 12 inches, allowing the water to fill the downstream end of the steel pipe. The hollow jet valve remains closed. In normal conditions, the emergency gate is maintained right above the opening, but it can be hoisted to the operating deck for inspection and maintenance. **Fig 1.33** shows photographs of emergency gate hoist.

The emergency gate is controlled from a push button station mounted on the hoist structure above deck elevation. This station includes four pushbuttons, labeled: "Crack", "Raise", "Lower" and "Stop". The complete procedure for the manual operation of the gate and instructions for manual operation are detailed in the "Operation and Maintenance

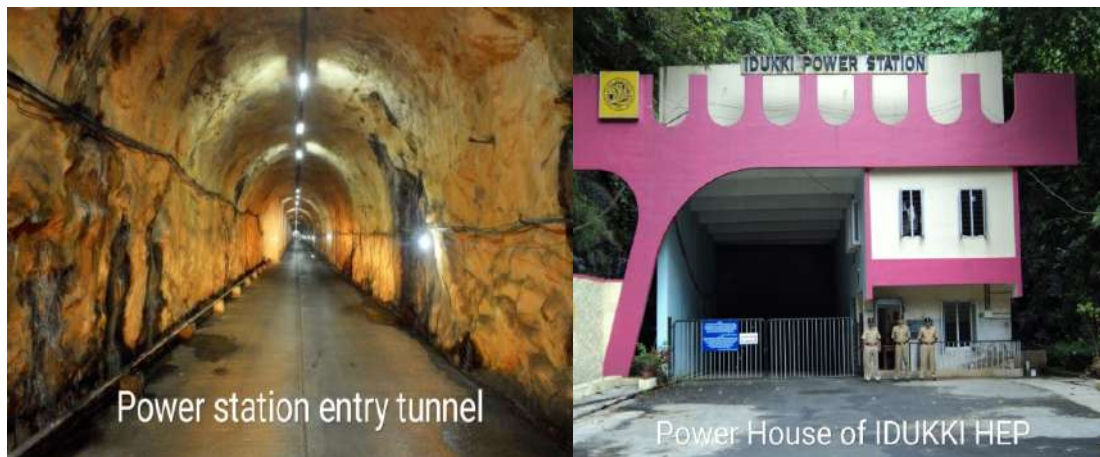
Fig 1.35 IHEP Power House

The tailrace water is released to Nachar, a tributary of Thodupuzha River through an underground tunnel of 1220 m length and is used for power generation in Malankara SHEP and for irrigation purpose with Malankara irrigation dam. Google map view, Generator rooms & entrance tunnel and front view of Power House are given below in **Fig 1.34, Fig 1.35 & Fig 1.36**.

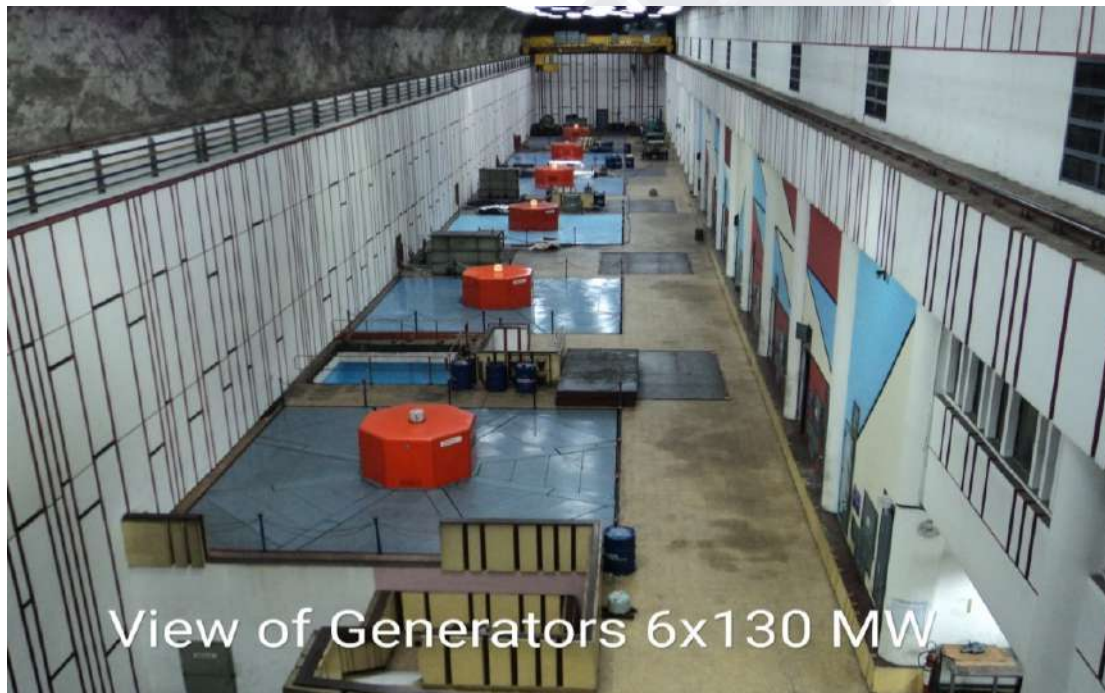
Fig 1.36 IHEP Power House Generators

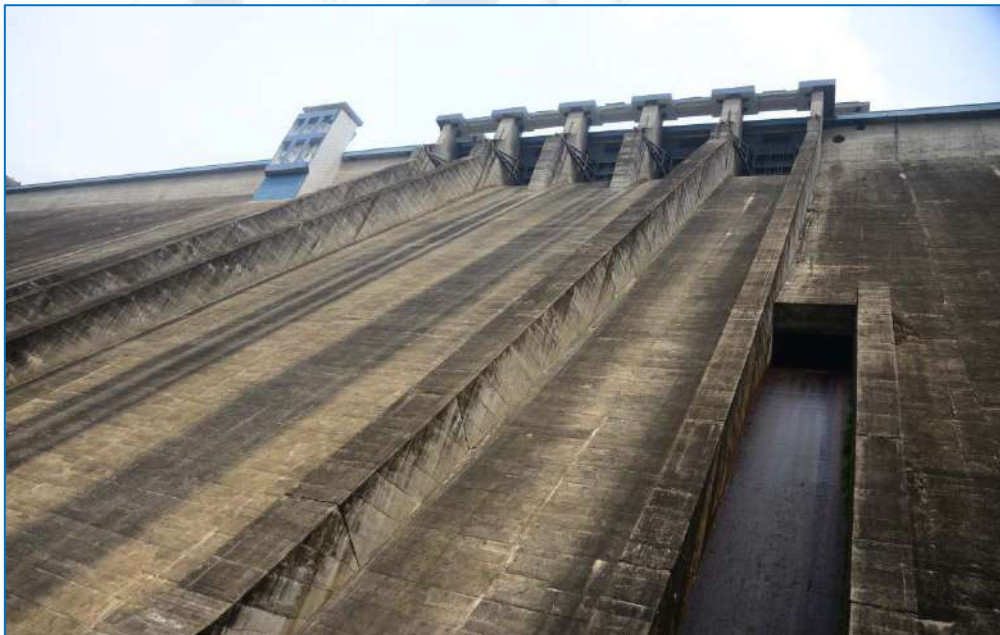
Fig 2.2a Downstream Elevation of Spillway

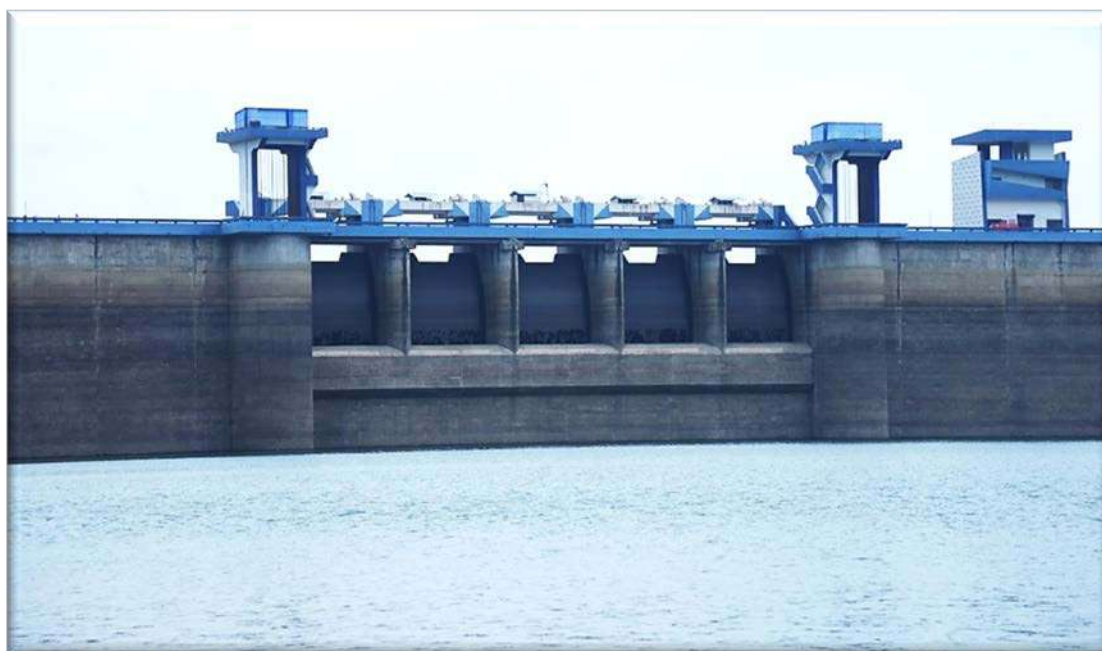
Fig 2.2b Upstream Elevation of Spillway

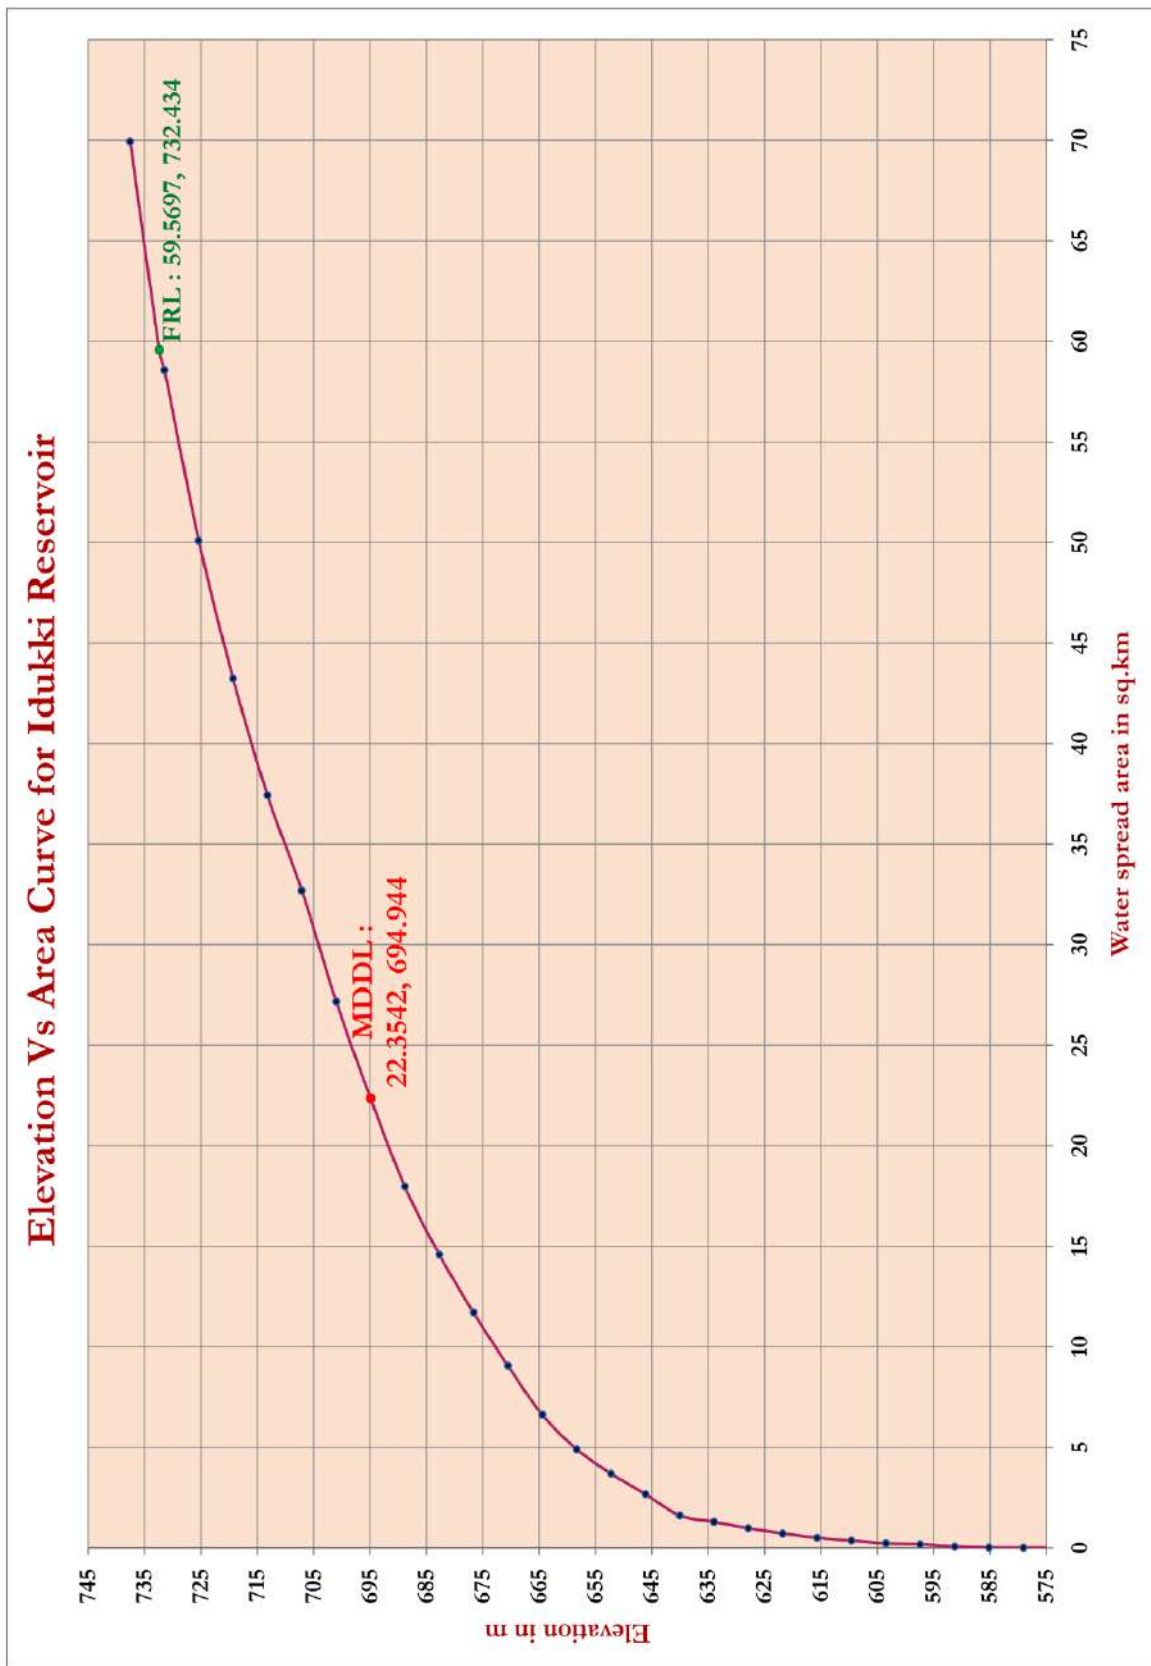
Fig 2.5 Elevation- Waterspread Area Curve

Elevation Vs. water spread area curve for Idukki Reservoir based on **Table 2.2** is shown in **Fig 2.5**.

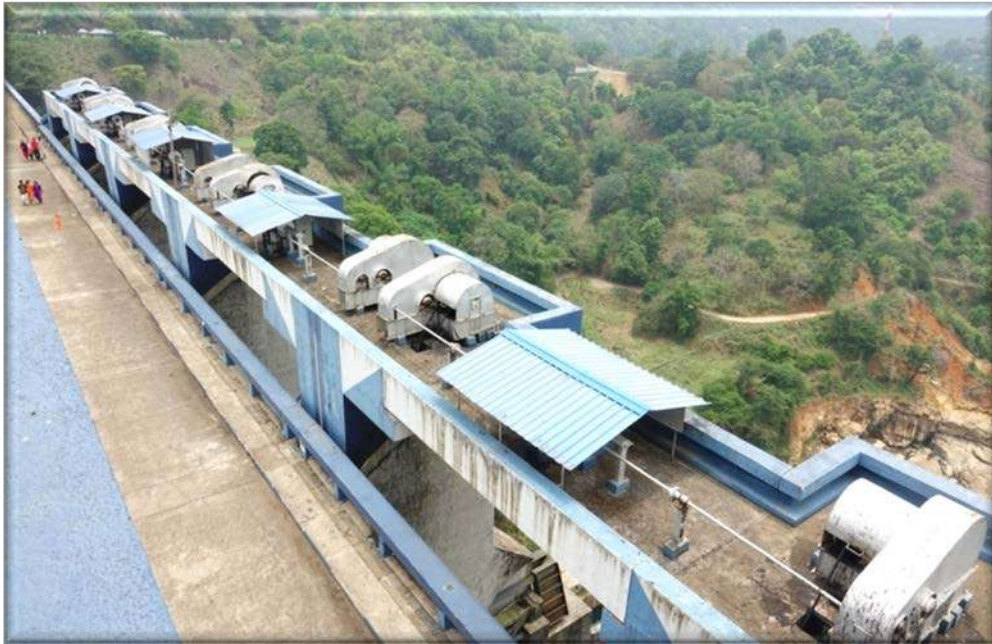
**Fig 2.7 View of Spillway Gate Operation Bridge of Cheruthoni dam
(Units #1 to #5 Left to Right)**

As detailed in **CI 2.1.2**, Cheruthoni dam has 5 spillway radial gates and 2 sluice gates (**Fig 2.6**). The key plan of Hoist Bridge for the operation of radial crest gates is given in **Drp 2.3a** of **Annexure 1**. Platform of the gate hoist structure is located at El. 2424.25 as in **Drp 2.3b** and radial crest gate in **Drp 2.3c** of **Annexure 1**. The hoisting platform is given in **Fig 2.7**.

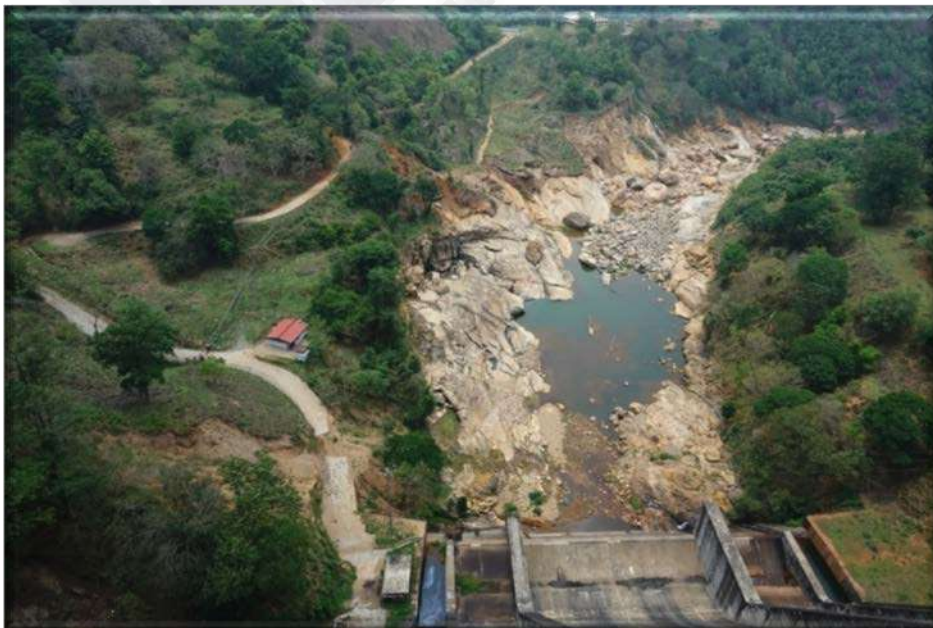
Fig 2.8 View of Spillway bucket from Hoist bridge

Photographs of spillway bucket from Hoist Bridge and from left bank are shown in **Fig 2.8** and **Fig 2.9**. **Fig 2.10** shows gear mechanism and electric control panel for operating radial gates. Photographs of control panel and measuring scale for the radial gates hoist is given in **Fig 2.11**. The hoisting mechanism with wire rope for radial gates at Cheruthoni dam is given in **Fig 2.12**.

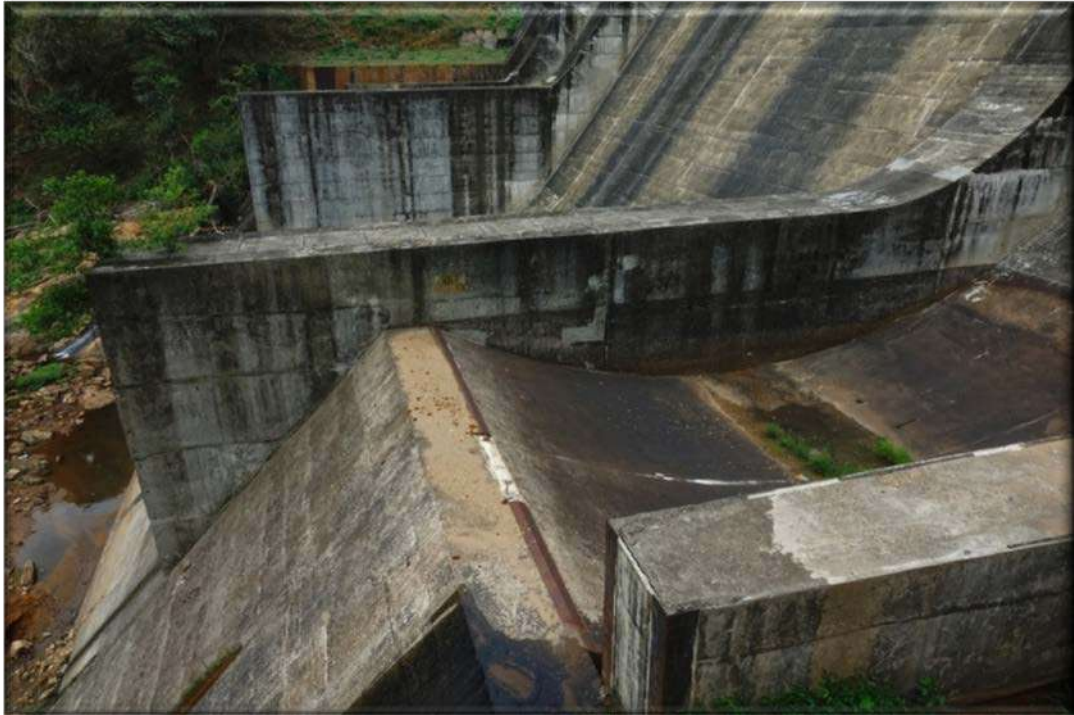
Fig 2.9 View of Spillway bucket from Left bank

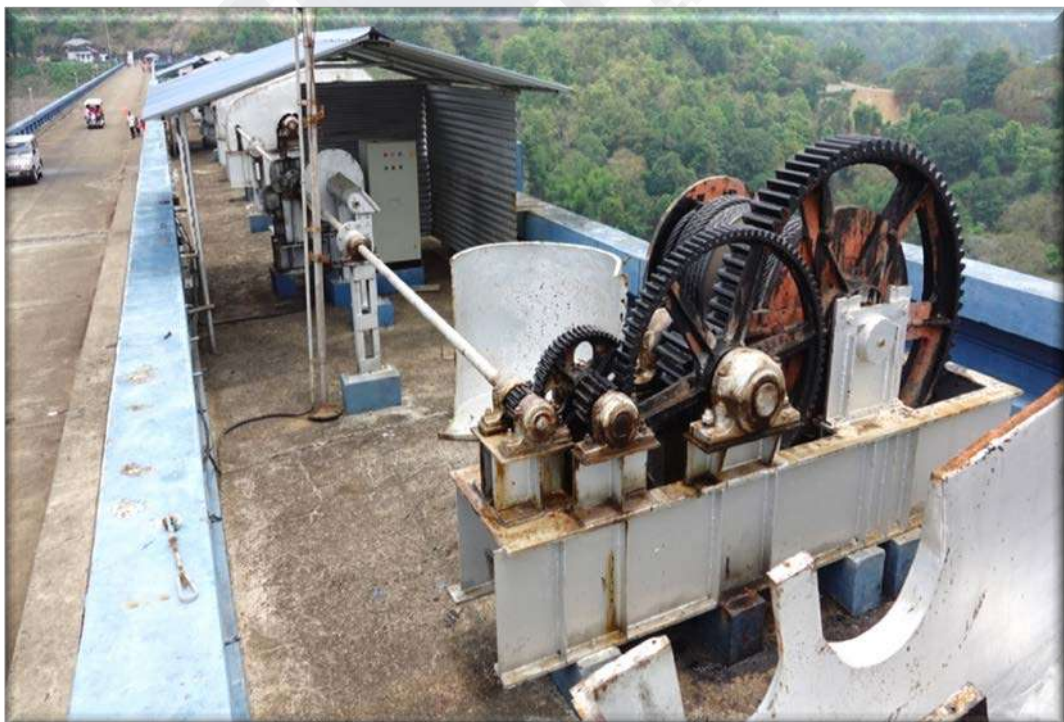
Fig 2.10 View of Gate operation Gear mechanism and Electric control panel

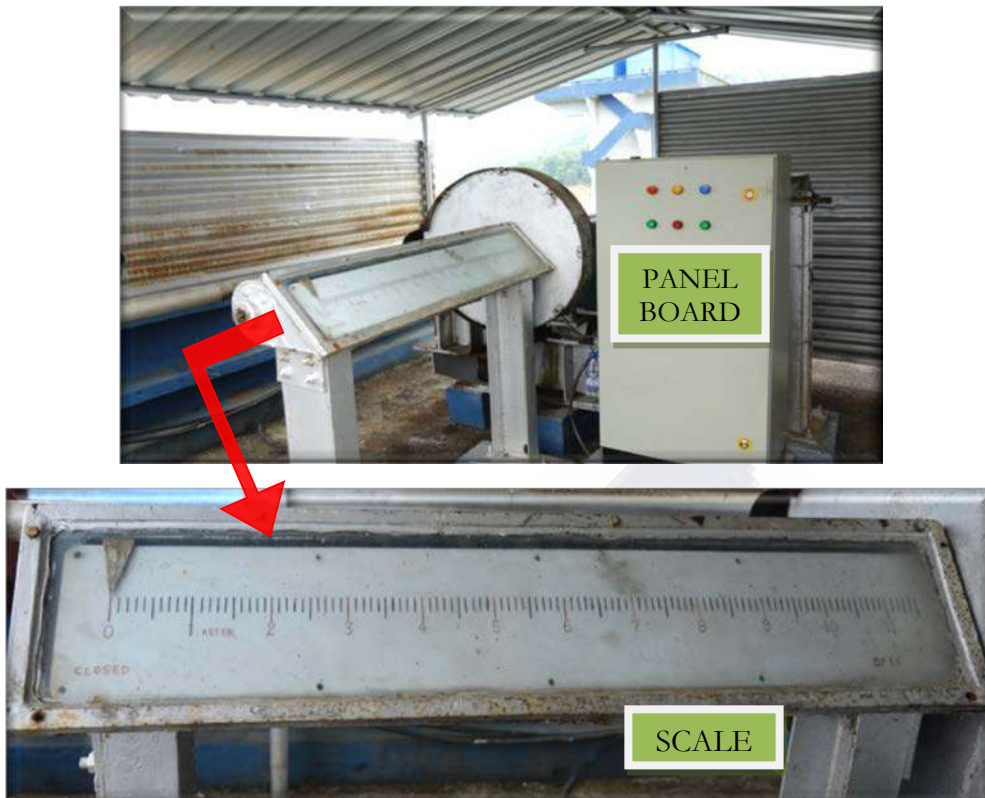
Fig 2.11 Control panel and measuring scale for the radial gates hoist

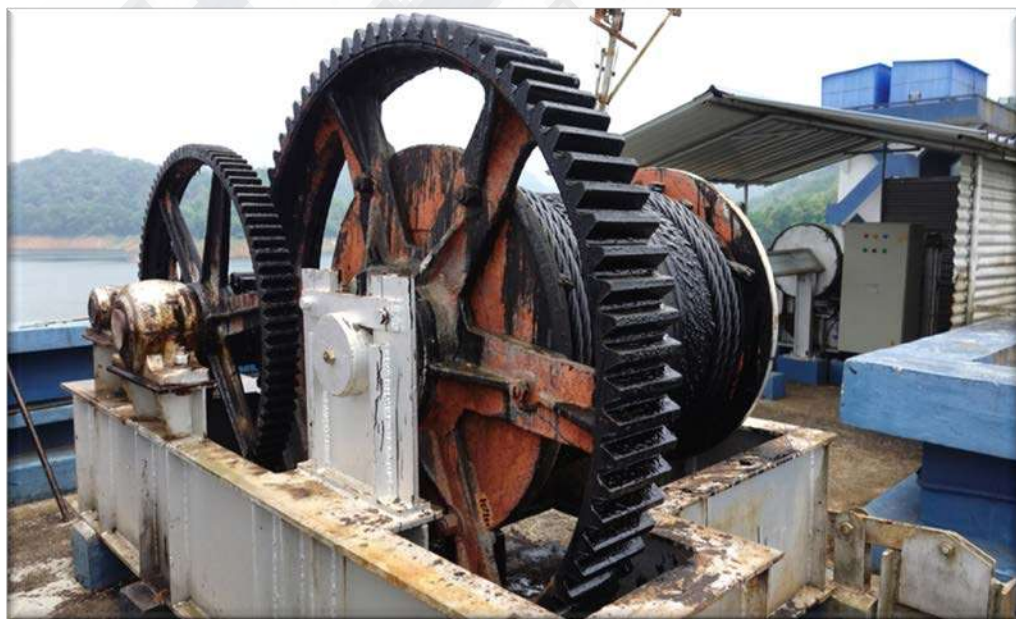
Fig 2.12 Hoisting mechanism with wire rope for radial gates
