Operation and Maintenance Manual for IDUKKI, CHERUTHONI & KULAMAVU DAMS

Doc. No. DSO_O&M_ Idukki, Cheruthoni & Kulamavu Dams
KSEBL_09_v1.0

Operation and Maintenance Manual
Of
Idukki, Cheruthoni & Kulamavu Dams

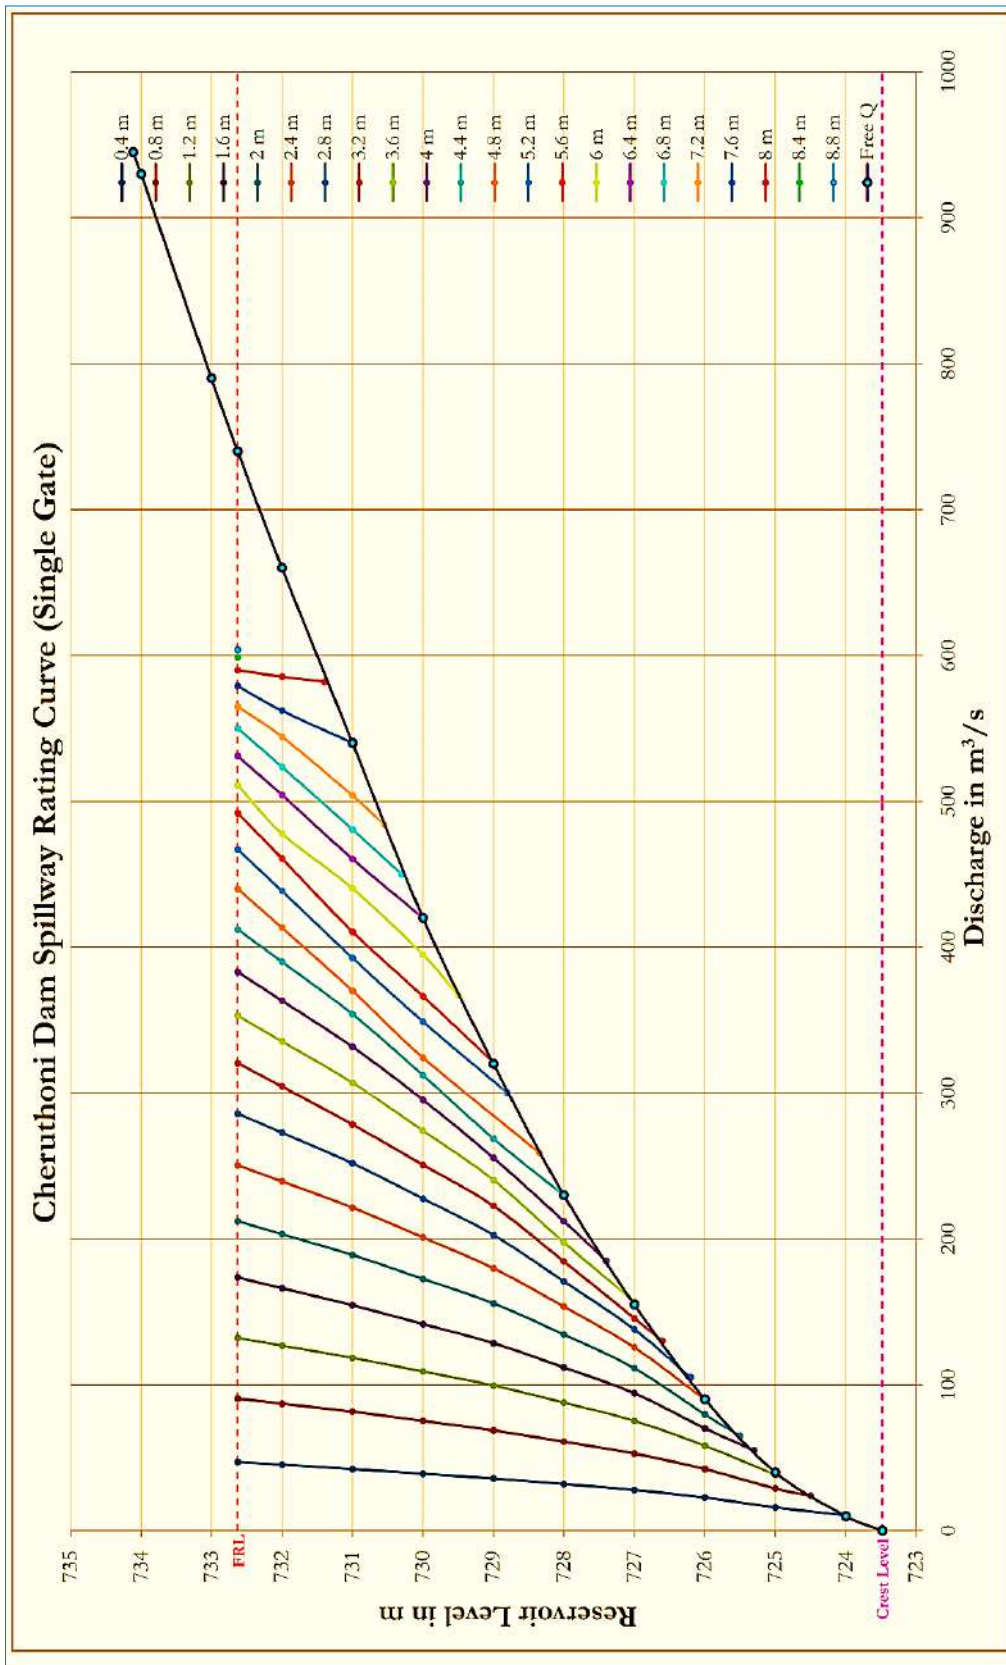
Fig 2.14 Discharge curves for Single Spillway Gate

During flood season, the reservoir water is released through spillway gates. The Full Reservoir Level is **2403 ft** and spillway crest level is **2373 ft**. The total spillway discharge (free discharge) through spillway gates (5Nos) for different reservoir levels under full opened condition is tabulated in **Table 2.5** and is given in **Fig 2.13**. Discharge (Rating) curve through single spillway for different reservoir levels with different gate openings is given in **Fig 2.14** and tabulated in **Table 2.6**.

Note:- Calculations are based on plate 7 L for one single gate (12.19 -0.2H)m where 0.2 is 2 times the pier contraction coefficient value of 0.1 and 12.19 is length of one bay (40ft)

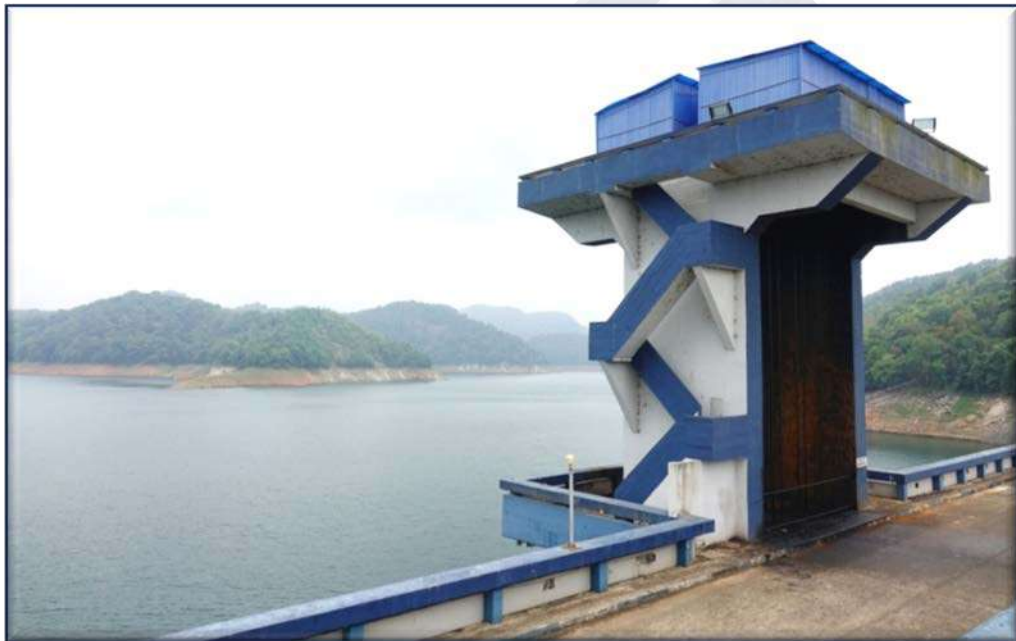
Fig 2.15 Hoist Bridge for sluice gate operation (Service and Emergency Gates)

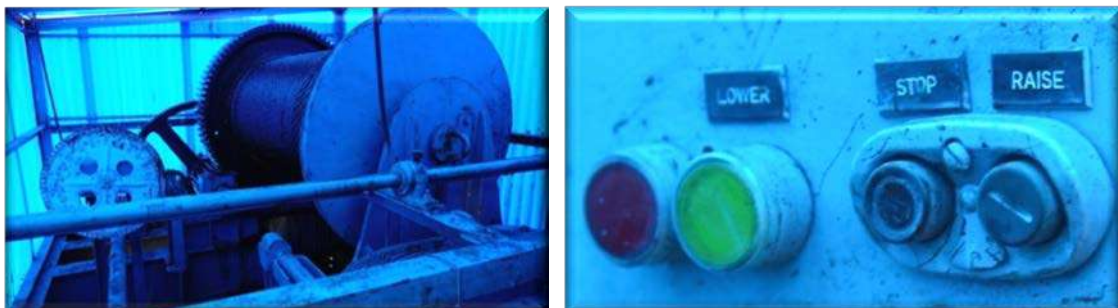
Fig 2.16 Hoist drum, gear system and panel board for sluice gate operation

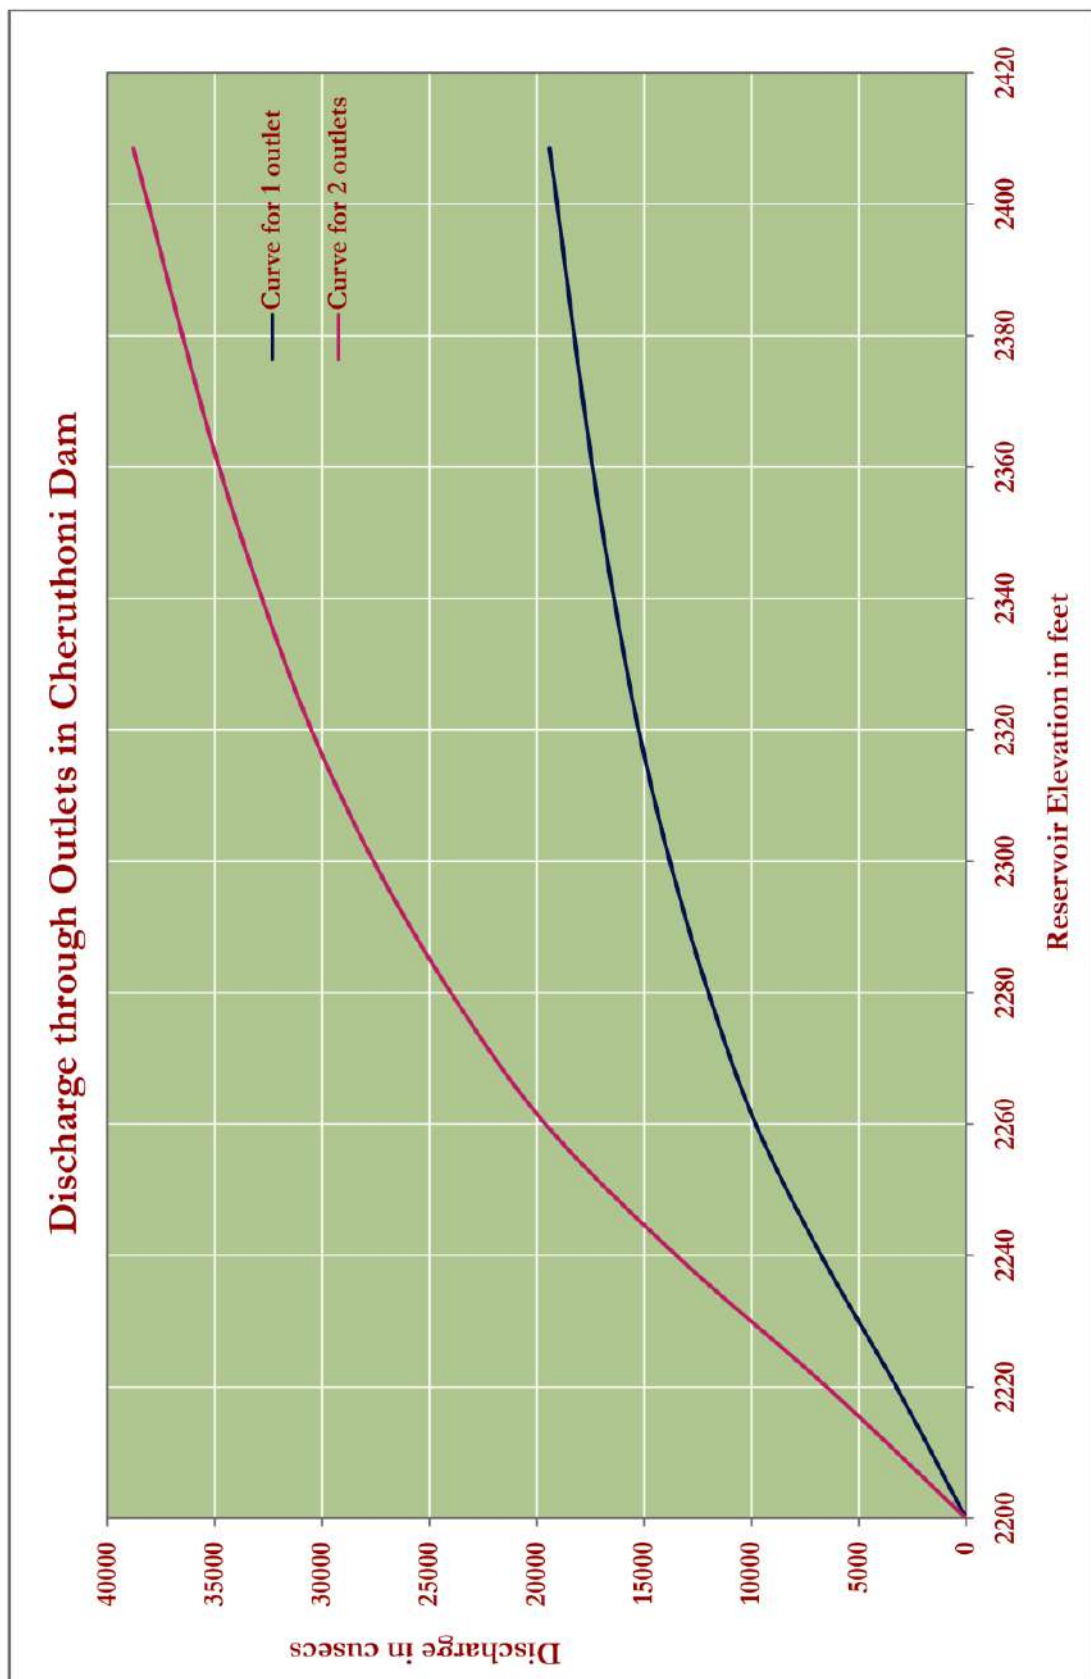
Fig 2.17 Discharge Curve for Outlets in Cheruthoni dam

There are two outlets in the dam each of size 3.05 m x 6.4 m with inlet sill at 670.43 m (2199 ft) and each having a discharge capacity of (19,700 cusecs) $557.5 \text{ m}^3/\text{s}$ at MWL Conditions. The section and sectional plan through centerline of outlet is given in **Drp 2.4a** and **Drp 2.4b** of **Annexure 1**. The outlets are controlled by a service and emergency gate (fixed wheel type) each of size 3.05 m x 6.4 m. Hoist Bridge for sluice gate operation is shown in **Fig 2.15**. Hoist drum, gear system and panel board for sluice gate operation are given in **Fig 2.16**. The discharge curve is given in **Fig 2.17**. The section through centerline of outlet at Ch.1400.00 and section at El. 2209.50 is given in **Drp 2.5a** and **Drp 2.5b** of **Annexure 1**.

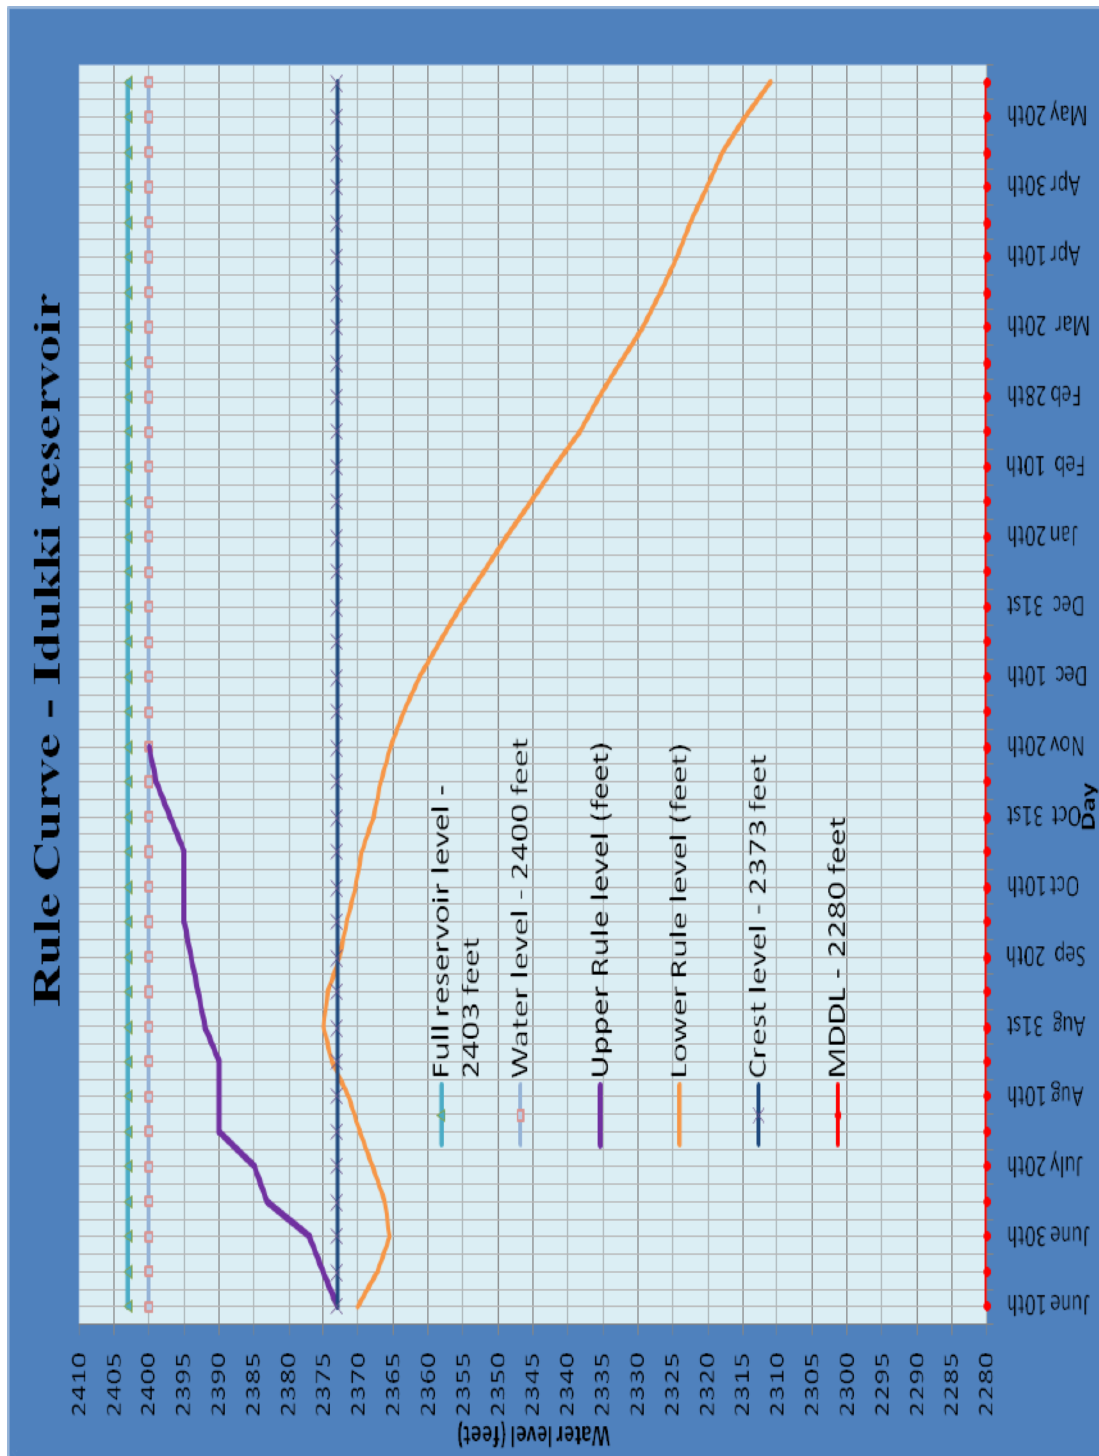
Fig 2.18 Rule Curve for Idukki Reservoir

Based on the upper and lower rule levels, rule curve arrived for the operation accordingly is shown in **Fig 2.18** and the maximum (storage) water levels of the respective months in **Table 2.7**. The reservoir water exceeding the rule curve level beyond crest level can be spilled or adjusted with power generation. This rule curve can be used till further revision.

Blue - 8 ft below rule level, Orange - 2 ft below rule level & Red - 1 ft below rule level.

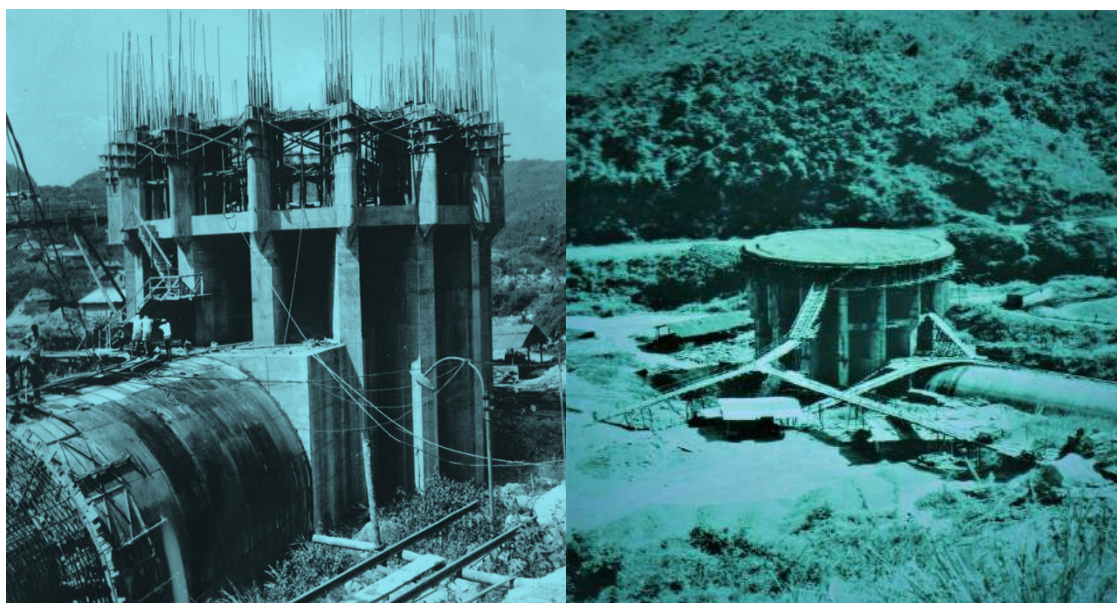
Fig 2.19 Morning Glory Intake during and after Construction

The intake tower is partly surrounded by a horseshoe shaped rock fill dyke as a protection against possible limited slope failures in the vicinity of the intake. No measures have been taken to prevent the disintegration of the laterite overburden lying adjacent to and above the base of the intake tower. However, the finished constructed grade around the intake tower is at El. 2230 ft which is about 15 ft below the sill elevation of the trash rack and thus a nominal

allowance is provided for the accumulation. Photographs of morning glory intake during and after construction are shown in **Fig 2.19**.

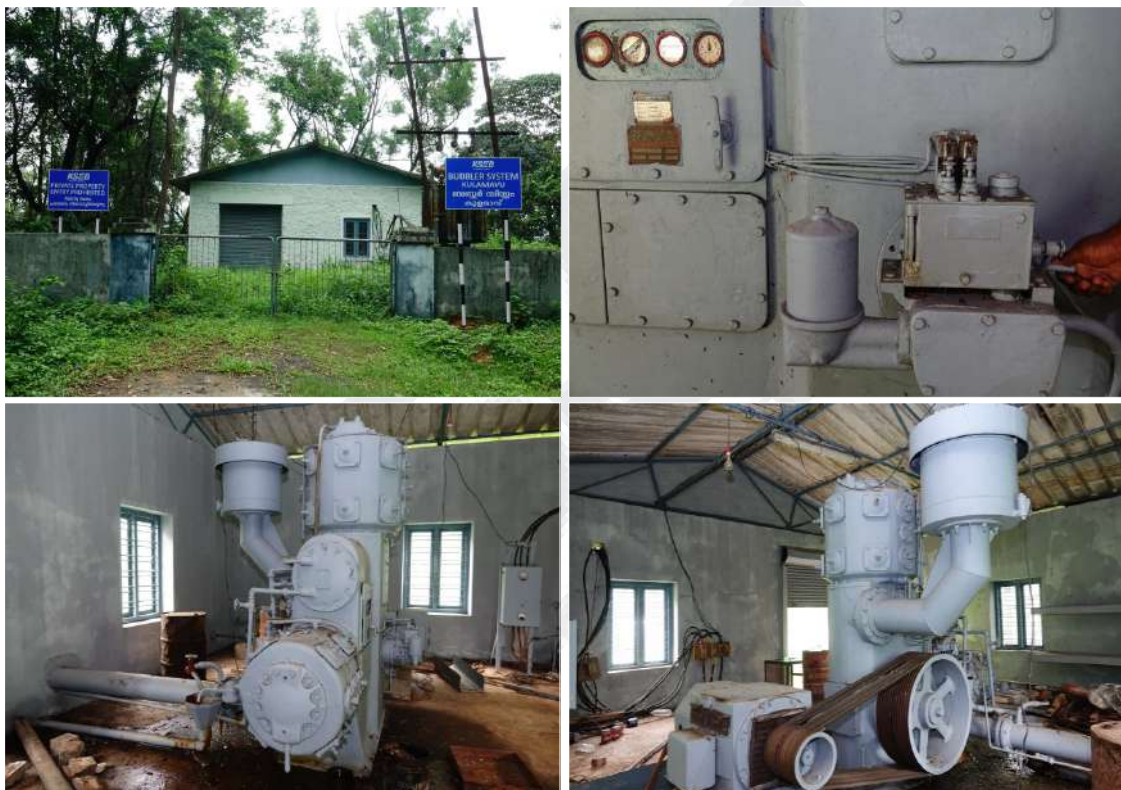
Fig 2.20 Bubbler System

Bubbler System For the effective cleaning of trash rack, bubbler system (**Fig 2.20a**) is provided. It consists of one electrically driven Compressor of 350 cfm capacity. 200 HP Induction motor is used to drive the Compressor. The compressed air is stored in two Air tanks. A filter unit is also provided in the Air tank. Whenever the large tank is filled fully, the air can be released using the valve provided. The speed of the motor can be adjusted with the regulator fixed before motor unit. A heater is also provided to heat the pump before starting. A compressor cooling system with water pump also provided. A schematic diagram of the Bubbler system is given in **Fig 2.20b** below.

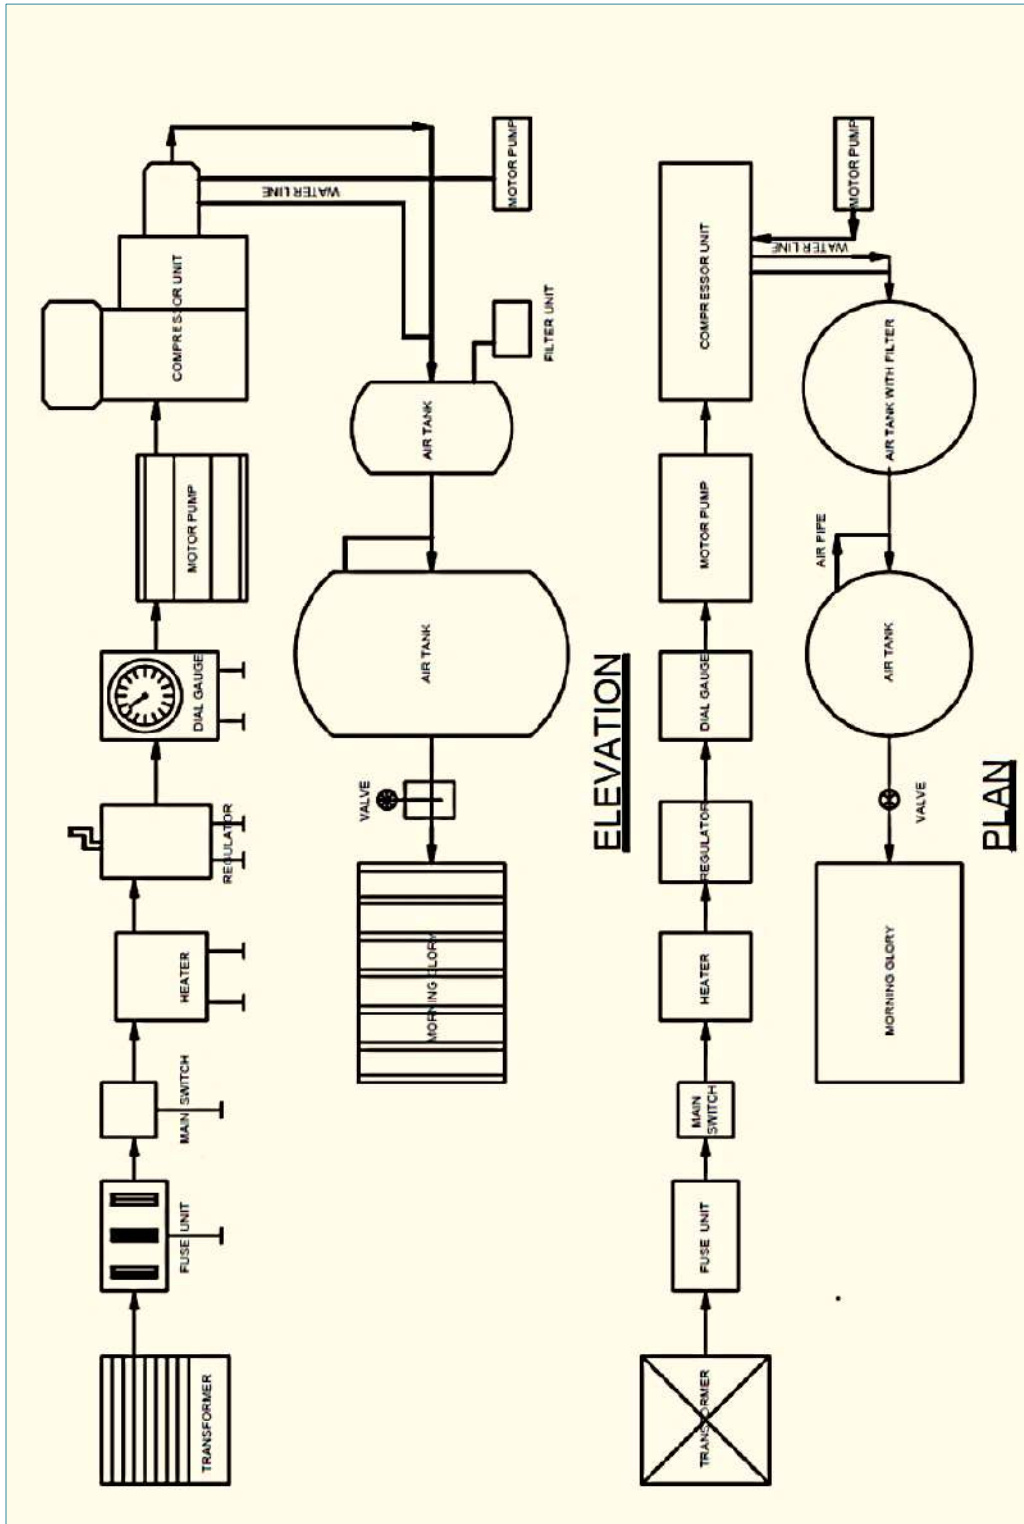
Fig 2.20b Schematic diagram of Bubbler system

- Before starting, check the Electric connection & Oil level in the Compressor.
- Check the Insulation resistance of Motor.
- Heat the windings if Insulation resistance is low.
- Adjust the Regulator to get 400V in Dial gauge.
- Start the motor in 'Star' position. After gaining the required speed, change the liver to 'Delta' position.
- Switch on the Compressor Cooling system Motor.

- Fill Air tank fully up to 10 kg/cm²
- Release the Valve, allow air to bubble up and agitate the intake tower area for 15 min.

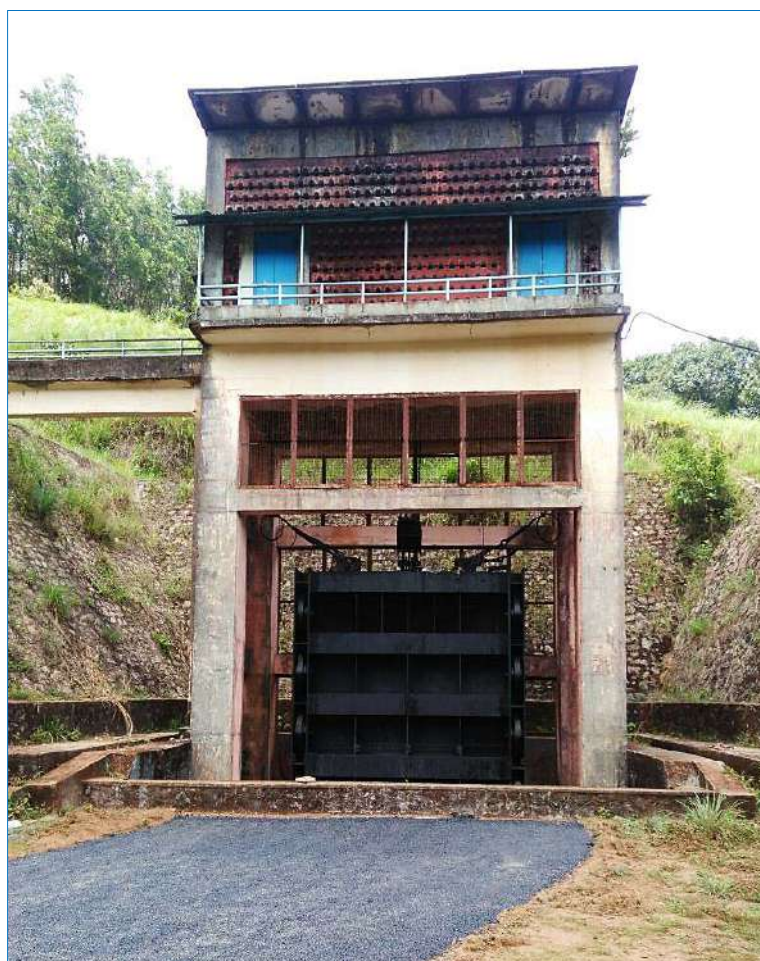
Fig 2.21a Intake gate and Hoist

A vertical shaft for the intake gate is located in the headrace tunnel, about 2380 ft (725.424 m) from the intake tower (See **Drp 2.12 of Annexure 1**). The oval shaped shaft is concrete lined. The excavation dimensions are approximately 14 ft x 24 ft (4.27 m x 7.32 m). The thickness of the liner is about 2.5 ft (0.762 m) below and 1.5 ft (0.457 m) above El. 2320 (707.14 m) respectively. Vertical steel rails are embedded in the concrete liner for guiding the intake gate. Air vents are provided in the lining below El. 2260 (688.85 m) to facilitate air escape during the filling up of the headrace tunnel. The gate platform and supporting structure for the gate hoisting mechanism is located directly above the gate shaft at El. 2423 ft (738.53 m). Photographs of intake gate and hoist are shown in **Fig 2.21a, Fig 2.21b and Fig 2.21c**.

Details of Intake Gate	
Type of Equipment	Electrically operated Lift Gate.
Gate Size	15 ft x 24 ft 6 in
Quantity	1 Set
Type of hoist	Cable Drum
Sill Level	2174' 8"
Deck Level	2423'
Max static head above sill	233.5 ft
Hoist Motor	40 HP
Lifting speed of gate by electrical operation	5 ft /min
Lowering speed of gate by electrical operation	10 ft /min
Gate speed by manual operation	1 in/min

The intake gate, permitting the closure of the headrace tunnel is installed in a concrete lined vertical shaft. This gate, operating under a head of 222 feet (67.66 m), is designed to close under emergency conditions, against the full flow passing through the power tunnel. Its second function is to isolate the downstream part of the pressure conduit, mainly the steel lined penstocks, during inspection, maintenance and possible repairs. Full opening of this gate subsequent to a closure can only be accomplished under balanced pressure conditions. Therefore, prior to being opened completely, the gate shall be cracked by 6 to 12 inches, allowing the water to fill the downstream end of the penstocks. Under normal conditions, the intake gate shall be hung immediately above the lintel, but can be hoisted periodically up to the operating deck platform for inspection and maintenance.

The gate measures 15 feet wide by 23 feet high and is made of a heavy structural steel frame welded to a skin-plate. The gate is equipped with 12 nos; 34 inch dia forged steel wheels mounted on double spherical roller bearings. The rollers are fitted onto eccentric axles to permit precise alignment of the wheel rims. The gate is provided with an upstream skin plate and upstream sealing devices. The lateral and top seals are of the "music note" shaped rubber type provided with a Teflon film cladding on the wearing surfaces. The sealing at the bottom is insured by the contact of the machined surfaces of the gate lip and the sill beam. Spring loaded side rollers mounted on self-lubricated bronze bushings are installed on each side near the top and bottom of the gate to limit its lateral movement.

The gate hoist is of the wire rope type and consists of a single drum driven through a helical gear speed reducer by an induction motor. The speed of the gate during lowering is controlled by a power absorption fan brake. An additional electro-mechanical brake holds the gate in its open position. This brake sets automatically by means of spring applied shoes when the current is cut off from the motor. In case of a failure of the electric power supply, a hand cranking system allows the manual lifting of the gate by two men. The gate position indicator consists of two circular dials mounted on the drum shaft extension. One dial, graduated in feet, indicates the position of the gate from the sill to the deck. The second dial indicates, in inches, the gate position over its first foot of travel. It is used to determine the "cracking opening" when filling the penstock.

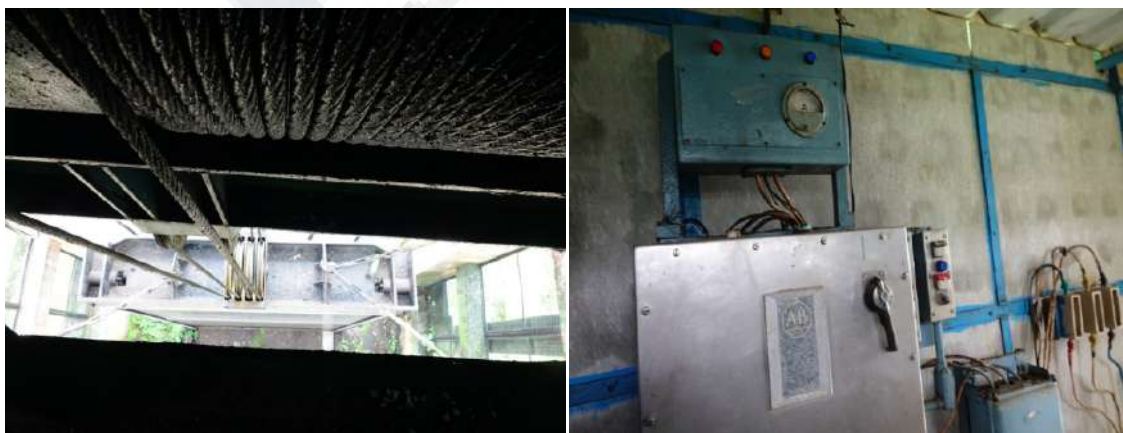
Fig 2.22 Intake Gate Hoist Wire rope and Operating Control

Fig 2.22 shows intake gate hoist wire rope and operating control. Details of Intake gate is given below in table.

includes four push-buttons labeled: "Crack", "Raise", "Stop" and "Lower". Limit switches are provided in the "Raise" and "Lower" control circuit. If required, the gate can be raised to deck level by pushing the "Raise" button to by-pass the "open" limit switch. Indicating lights are provided on the push-button station to indicate the following conditions:

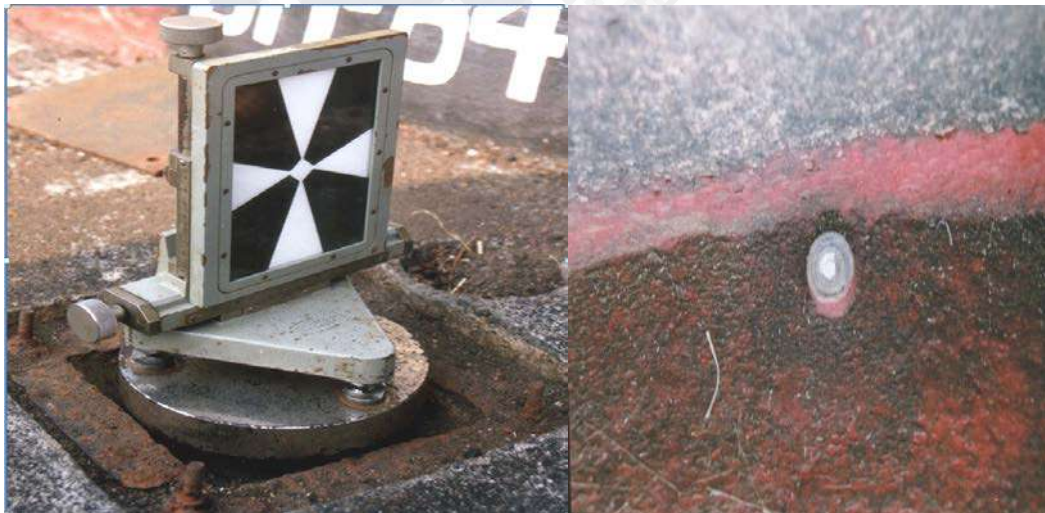
Fig 5.3 Mobile Target and Fixed Target for Crest Collimation

Collimation Method is employed to measure the deflection of the crest of the dam. A line of sight passing through two reference points on the right and left abutment rock is established in space and movements of points on the dam crest with respect to the line of

sight are determined. See Fig 5.3. There are three crest collimation stations on the crest of the dam.

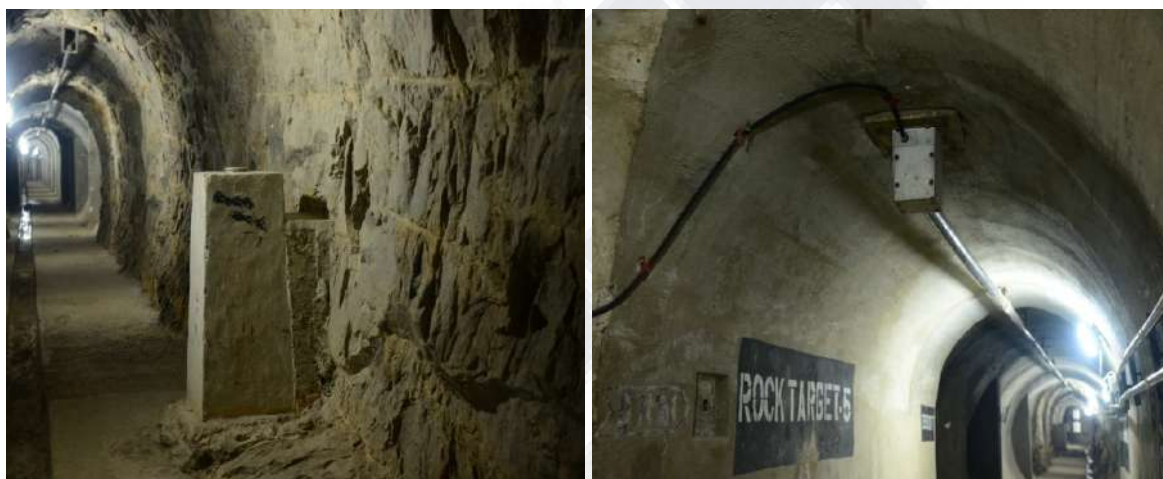
Fig 5.4 View of rock target station at galleries

There are four base meters connecting the foundation galleries to the formed galleries. Five rock-targets are there in each of the six rock galleries.

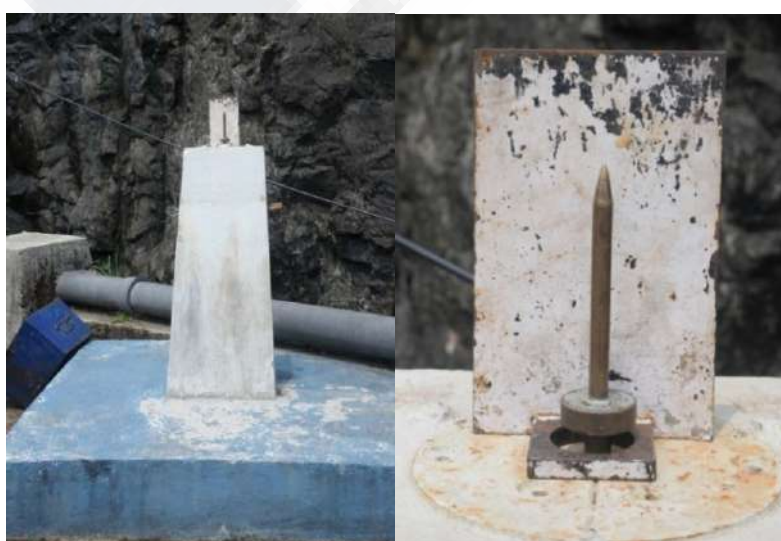
Fig 5.6a Reference monument station for crest collimation at left bank

a) **Crest Collimation:** The displacement of the crest of dam is measured by monthly collimation readings. These observations are accomplished by shifting a movable target on the crest in a direction perpendicular to a fixed line of sight. Forty numbers of targets are installed in various blocks 2, 6, 10, 13, 16, 18, 21, 25, 27, 30, 33 and 37. Photograph reference monument station at Cheruthoni dam is given **Fig 5.6a** and instrument station in **Fig 5.6b** below.

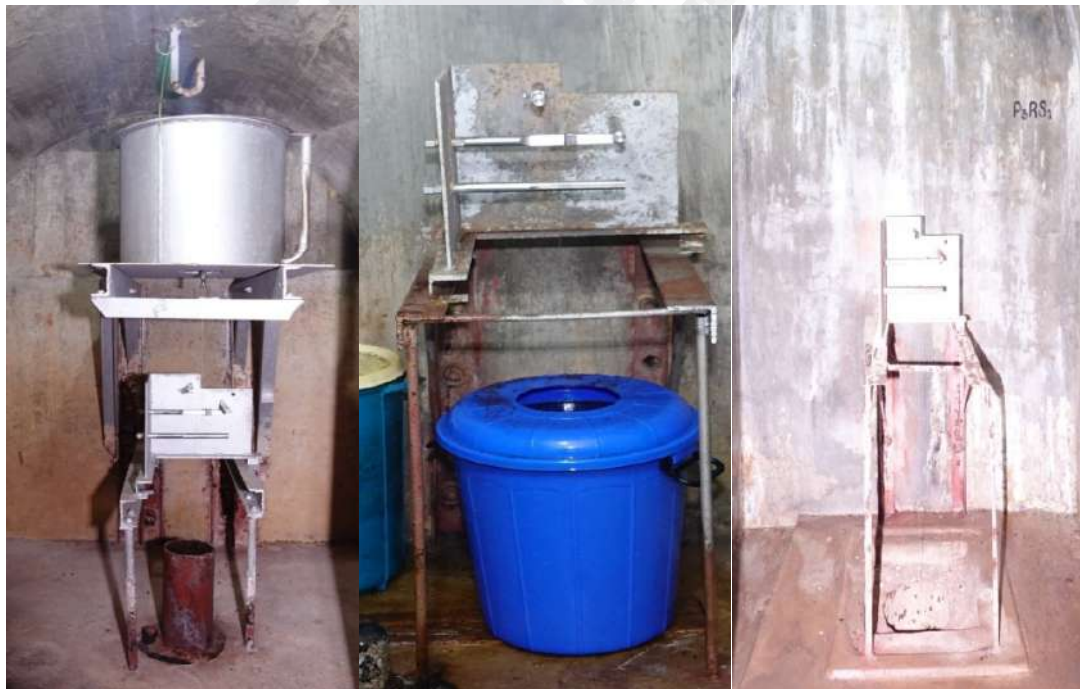
Fig 5.7 (a) Inverted Pendulum (b) Pendulum Station (c) Reading Station

b) Pendulums - Simple and Inverted Type: There are four simple (upright) pendulums in blocks 16, 21, 27 and 33 with reading stations in intermediate galleries. In addition there is an inverted pendulum in block 21 with reading station at El. 2000. Readings are taken fortnightly. The inverted pendulum, pendulum station and reading station are shown in **Fig 5.7**. Also the anchor point of pendulum at dam top is given in **Fig 5.8**.

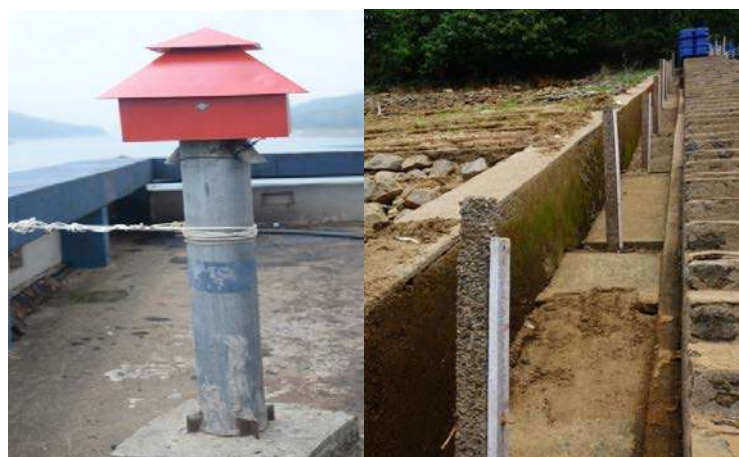
Fig 5.9 Automatic water level reader and manual reading scales

- f) Water Level Recorder: One automatic water level recorder to monitor the variation of the reservoir water level is installed in block 19.

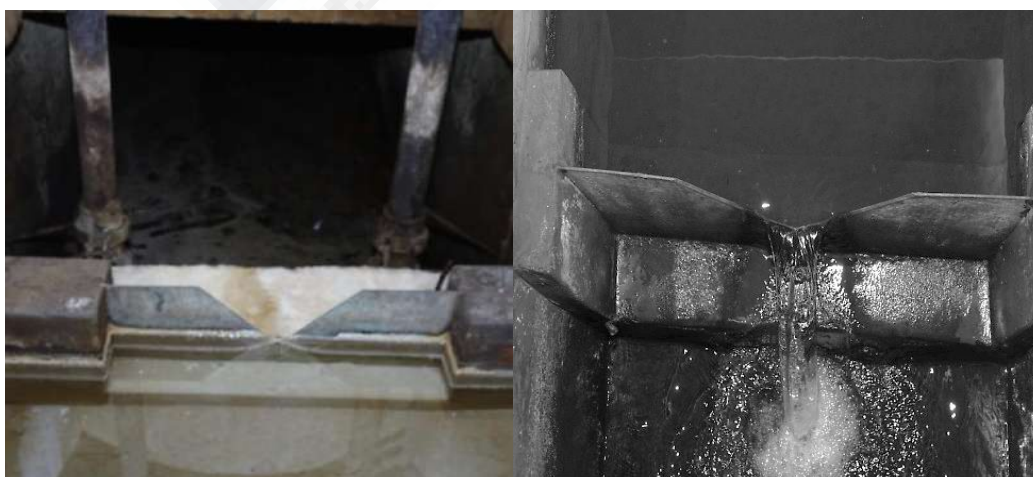
Fig 5.10 V-notches at foundation gallery at BL.18, BL.20 and BL.25

- i) Drainage Flows: V notches, to measure the total volume of water from infiltrations through concrete and through drilled drains are constructed and measured at specified intervals, at foundation gallery at BL.18 - El. 2050', BL.20 - El.2000' and BL.25 - El.2050'

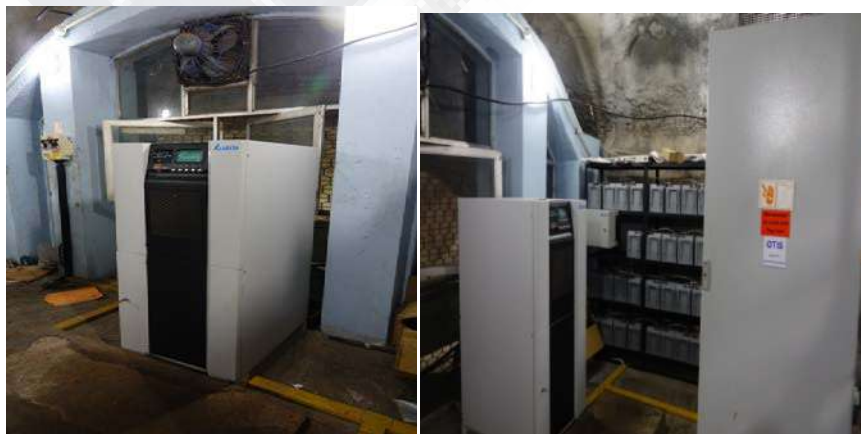
Modernization of Elevator with ARD (power backup) and control systems

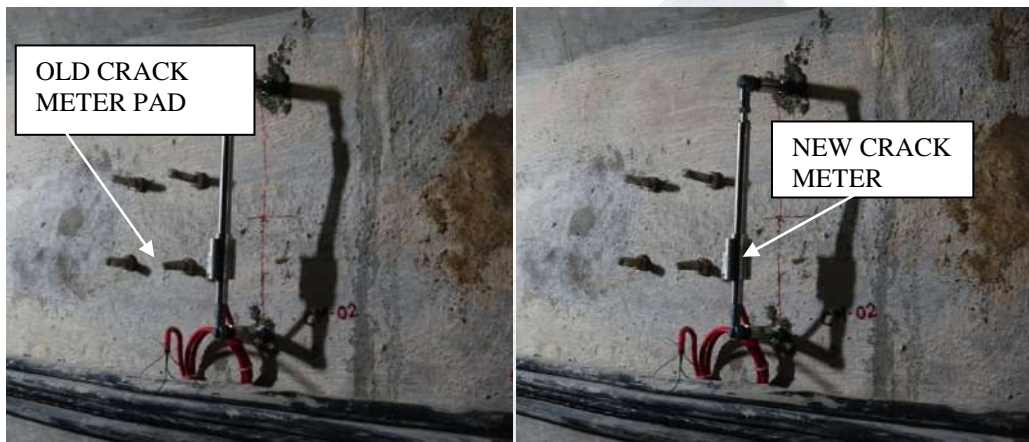
Crack meter old and new fixed at old cracked wall of gallery at El.2300 ft

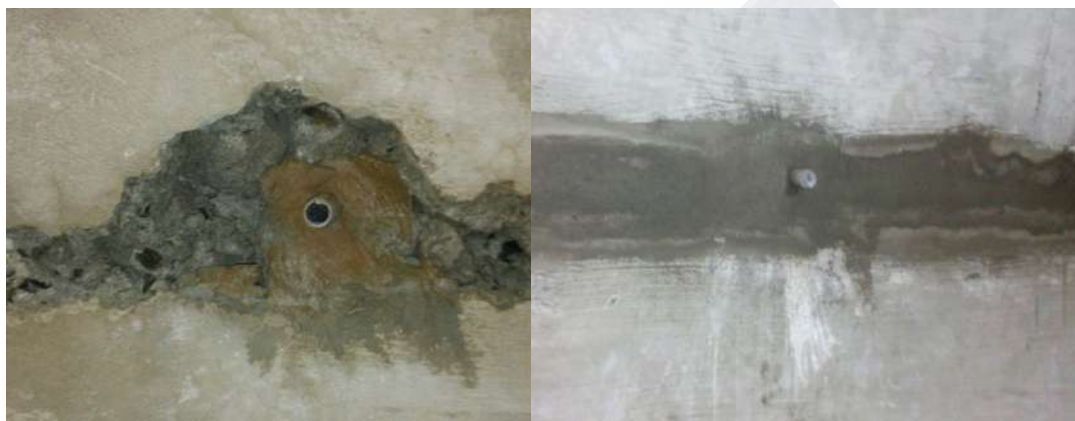
Crack Treatment in Gallery at El.2300 ft (before & After)

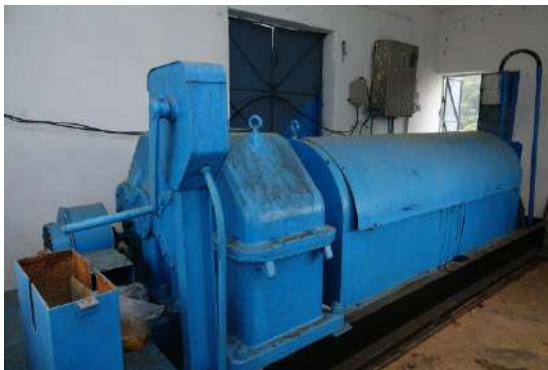
Emergency Gate Hoisting Machine

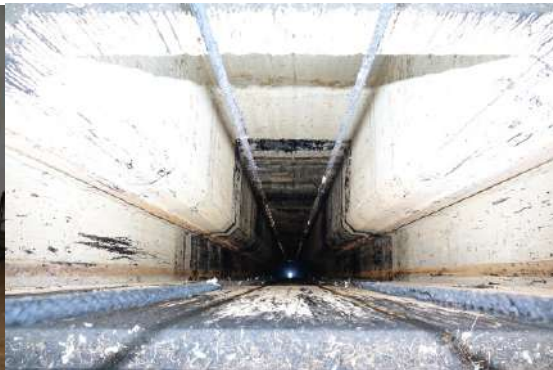
Emergency gate wire rope

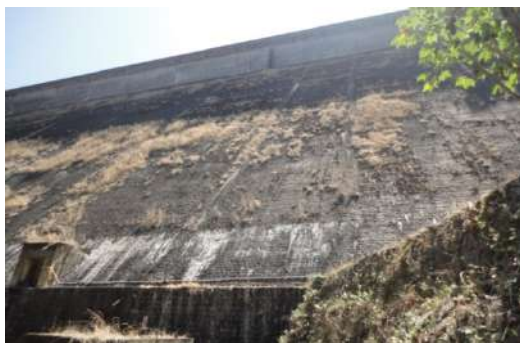
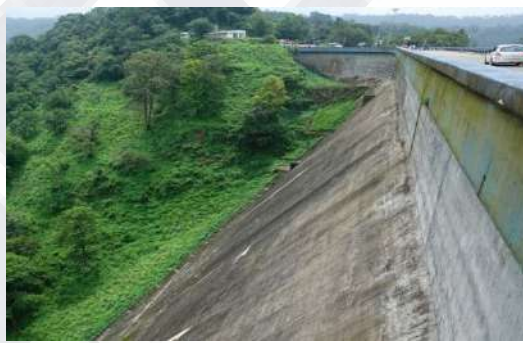
Kulamavu dam Downstream (Before & After)

- Cleaning and pressure washing the downstream face
- Construction of a guard room for Kulamavu dam
- Reaming of foundation drain holes: Out of the 39 foundation drain holes, 25 reamed up to 64m depth.
- Formation of new road to intake at Kulamavu
- Improvement of road to Kulamavu dam bottom
- Repairs to sluice gate of Kulamavu dam
- Repairs to intake gate Kulamavu

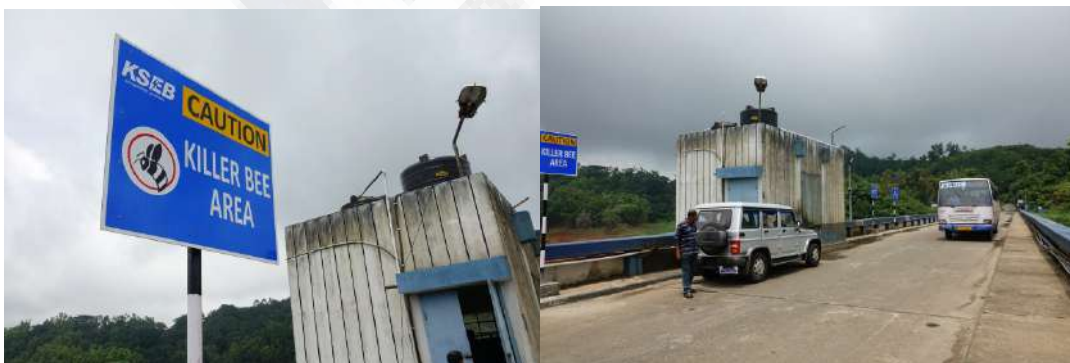
Emergency gate hoisting machine room

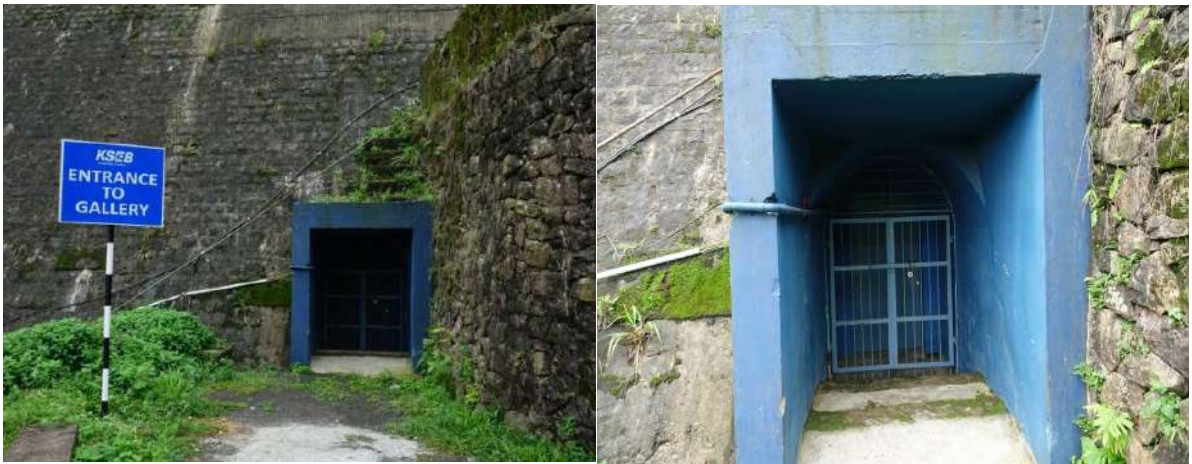
Entrance to Inspection Gallery

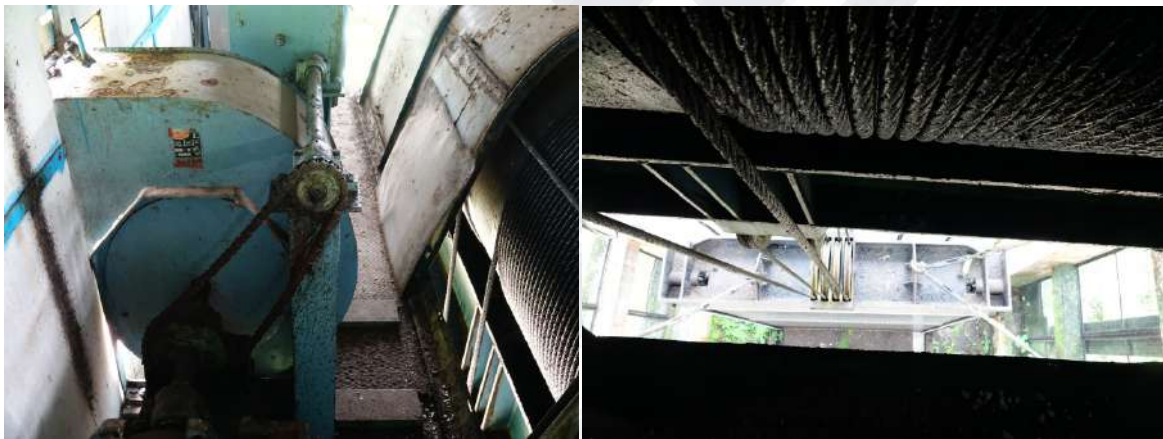
Control shaft Intake Gate hoist
